Signalling irregularity involving train DP41

Eagle Junction, Queensland, on 23 September 2018

ATSB Transport Safety Report

RO-2018-020

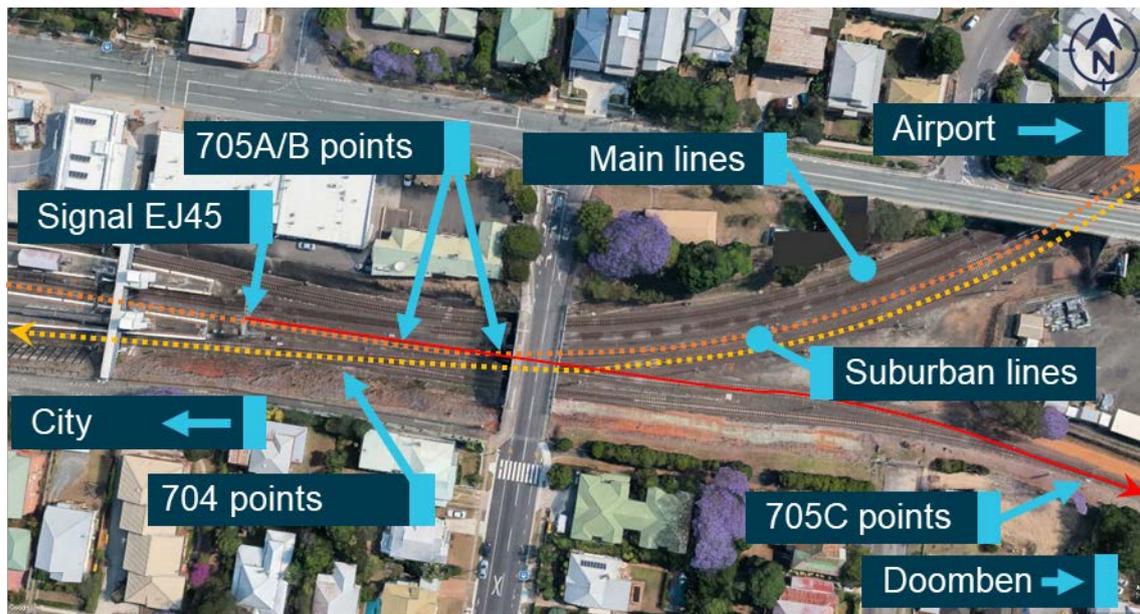
Figure 1: Overview of Eagle Junction showing the location of the points

At about 0633, the PO clipped and locked the 704 and 705A/B (Figure 1) points at Eagle Junction in the normal position.⁵ For the 705A/B points, this meant that trains from the city were being directed towards the Airport Line and were prevented from entering the worksite at the 705C points on the Doomben Line. In addition, the 705C points were electrically isolated⁶ from the signalling system to prevent the work affecting train operations over the 705A/B points on the suburban line. About an hour later, after the work group had completed a pre-work safety brief, the planned work commenced on 705C.
