Driveshaft failure and hard landing involving Overseas Aircraft Support UH-1H helicopter, VH-OXI

near Crawford River, New South Wales, on 7 December 2019

ATSB Transport Safety Report
Aviation Occurrence Investigation
AO-2019-070
Final – 16 July 2020
Addendum – 28 January 2021

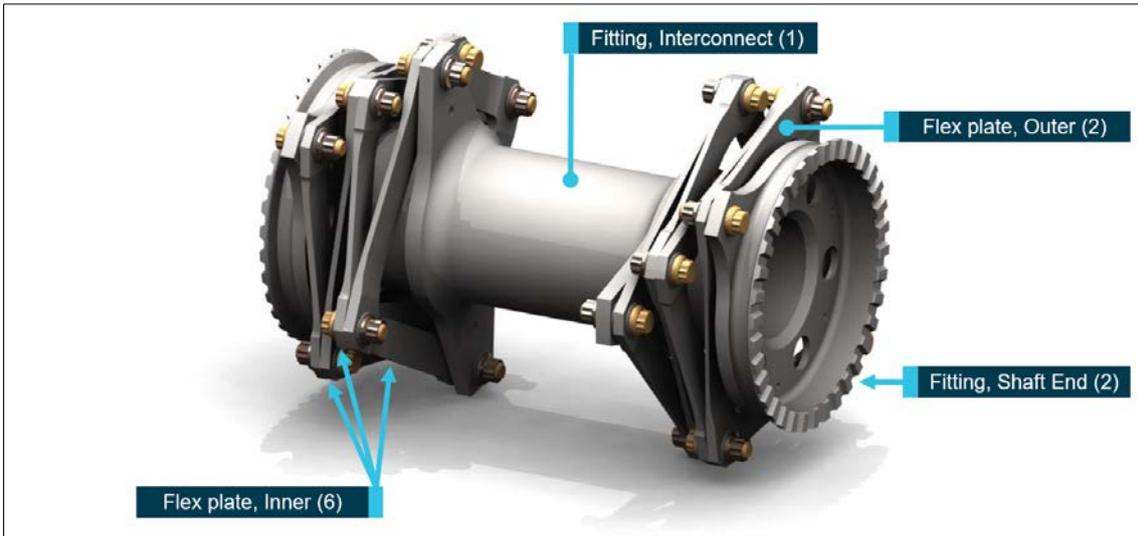
Figure 2: KAflex® driveshaft – key parts identified with the number of each part fitted annotated in brackets

The KAflex® driveshaft (part number: SKCP2281-103), which transmits the drive power from the engine output to the main gearbox input, was found to have fractured into multiple pieces. The driveshaft uses flexible plates (Figure 2) to accommodate relative movement between the engine and gearbox, and was designed with an integral failsafe feature for continued flight in the event of a single flex frame fracture. It will permit a limited continued power operation (20 minutes demonstrated during qualification), enabling pilots to safely land the helicopter.

The visual inspection of the driveshaft noted a failure of one of the outer flex plate bolt holes, where the plate was bolted to the main gearbox-end fitting. In addition, there were five recessed washers missing from various fasteners. The rear transmission mount support assembly exhibited scoring below the location of the driveshaft gearbox-end fitting (Figure 3). Discoloration of a section of the failed outer flex plate was consistent with the scoring to the support assembly. The ATSB retained the helicopter's KAflex® driveshaft (serial number 2136) for materials examination.
