Taxiing excursion involving Fokker F100, VH-FKD

Laverton Airport, Western Australia, on 28 September 2021

ATSB Transport Safety Report

AO-2021-041

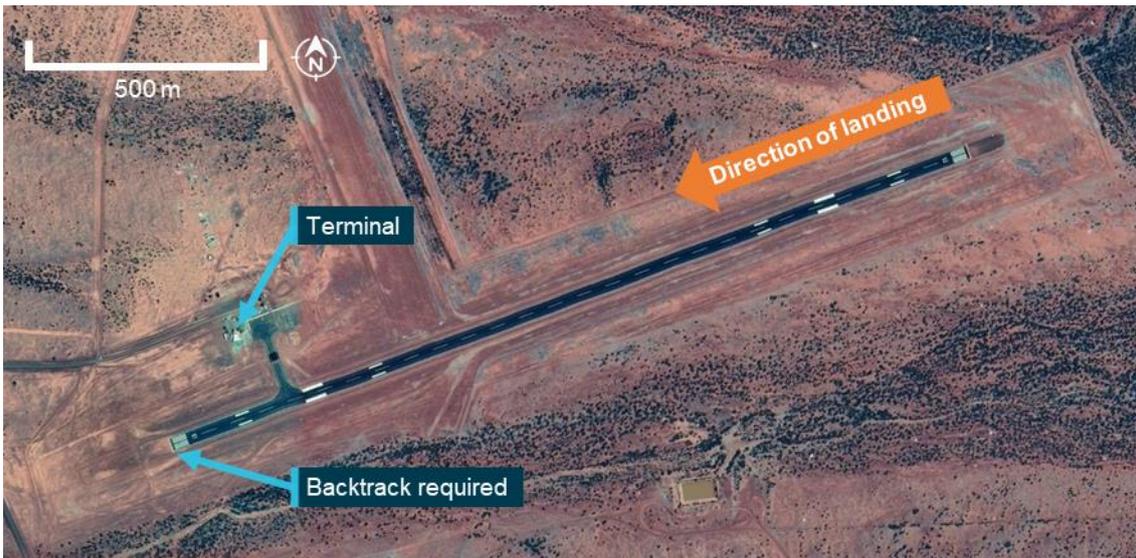
Figure 2: Laverton Airport

Following an uneventful landing at about 1536, the captain took control of the aircraft to taxi towards the end of the runway and complete the routine backtrack manoeuvre³ (Figure 2). The aircraft was positioned on the left-side at the end of the runway consistent with operator guidance, and the captain commenced a right turn by rotating the nose-wheel handwheel (tiller). The captain was unable to achieve full tiller rotation, even when using the force of both hands, and attempted to tighten the turn by applying the right inboard brake, and asymmetric thrust, but this did not have the desired effect. During the turn, the aircraft nose-wheel briefly left the side of the runway, and onto the runway strip⁴ – the ground area adjacent to the runway – before returning to the runway and taxiing to the terminal (Figure 3).

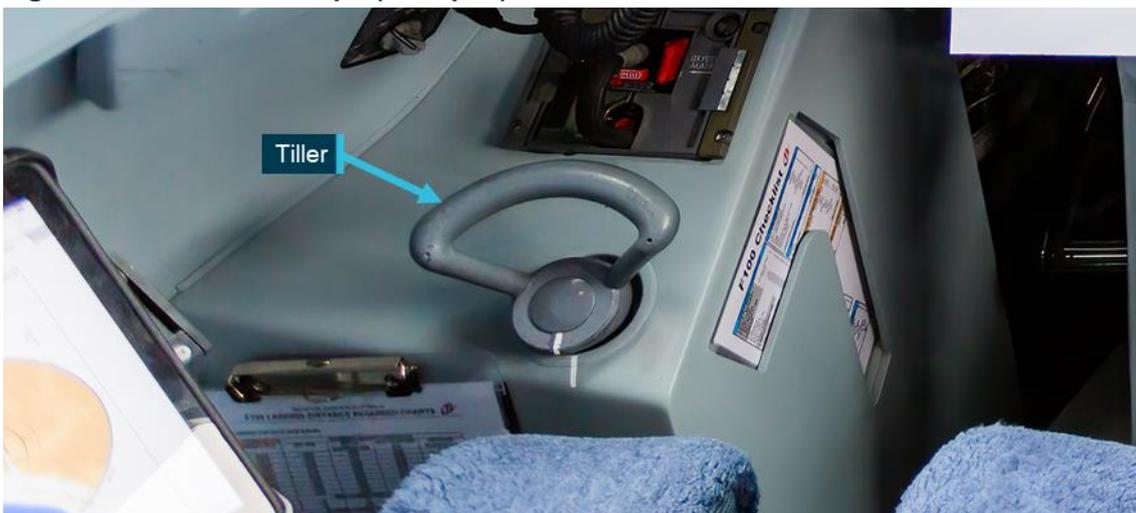
Figure 4: Fokker 100 cockpit (exemplar)

The aircraft’s nose-wheel steering system comprised various shafts, pulleys, and cables, which direct hydraulic pressure to turn the nose-wheel when the tiller is rotated, or when the rudder pedals are pushed. The rudder pedals provide a very limited turning angle, so the tiller is used when making most turns, and is located on the left side (captain’s side) of the aircraft cockpit (Figure 4). The tiller is connected to the steering system via a shaft fitted with two universal joints (upper and lower). The universal joints are covered by protective boots.⁵

The post-flight examination of the steering system at Laverton identified a correctly secured, but torn insulation blanket, which was contacting the nosewheel cable drum (Figure 5). A torn protective boot on the upper universal joint was also found (Figure 6). The insulation blanket was taped at the torn section and re-secured away from the cable drum, and the torn boot was removed. A taxi test was then successfully carried out before the return flight to Perth.

- Based on torn insulation blanket’s inspection, the reinforcing strands of the blanket covering material were not considered to have sufficient strength to cause the tiller resistance felt by the captain.
- The torn boot was suspected to have been caught in the joint universal joint, causing the resistance in the right turn and was subsequently freed during the two left turns while taxiing taxi to the terminal.

During subsequent maintenance, the torn blanket and handwheel assembly were replaced. The aircraft operator made the following findings with respect to the incident.
