Australian Government
Australian Transport Safety Bureau

Crew member burnt on board ship off Carnarvon, Western Australia

21 April 2005

Crew member burnt in explosion while working on hydraulic pipeline on board *Hui Shun Hai*

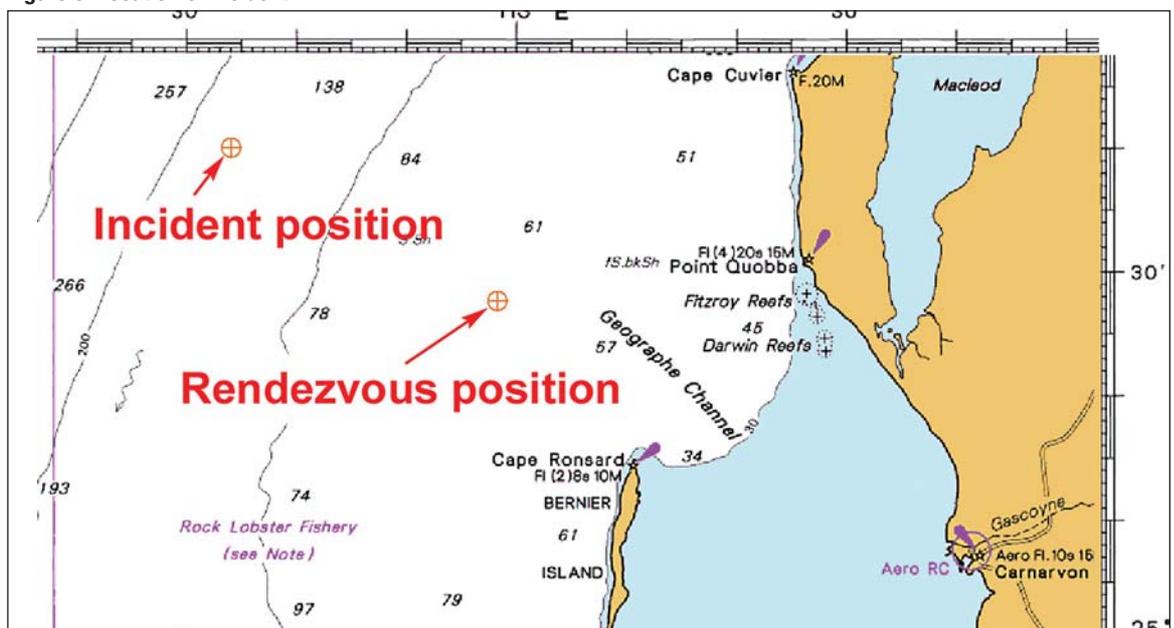
Figure 3: Location of incident

That morning, the first engineer, welder and a motorman were tasked to replace a section of deck hydraulic pipe which supplied oil to number four hatch cover (forward) operating system. This section of pipe was on the hatch's starboard side just above the ship's main deck. A new section of pipe had been prefabricated the day before in the ship's engine room workshop.

In order to access the after flange on the section of pipe which was to be replaced, the welder had to lie on the deck, on his left side, and angle the oxygen-acetylene cutting head up behind another hydraulic pipe (Figure 2).

Although the welder had removed two corroded bolts using the oxygen-acetylene cutting gear, the force exerted by the remaining two bolts, and years of corrosion, still held the two flanges together. However, as he proceeded to cut through the third bolt, the evidence indicates that the flanges separated. This allowed the hydraulic oil in the pipe, under pressure, to escape. The oil, probably as a fine mist, then made contact with the oxygen-acetylene flame and ignited. This resulted in the fireball which engulfed the welder and the equipment on the deck near him.
