# Partial power loss and collision with terrain involving Dynaero MCR-01 VLA, VH-SIP

near Serpentine Airfield, Western Australia, on 28 December 2020

## **ATSB Transport Safety Report**

AO-2020-065

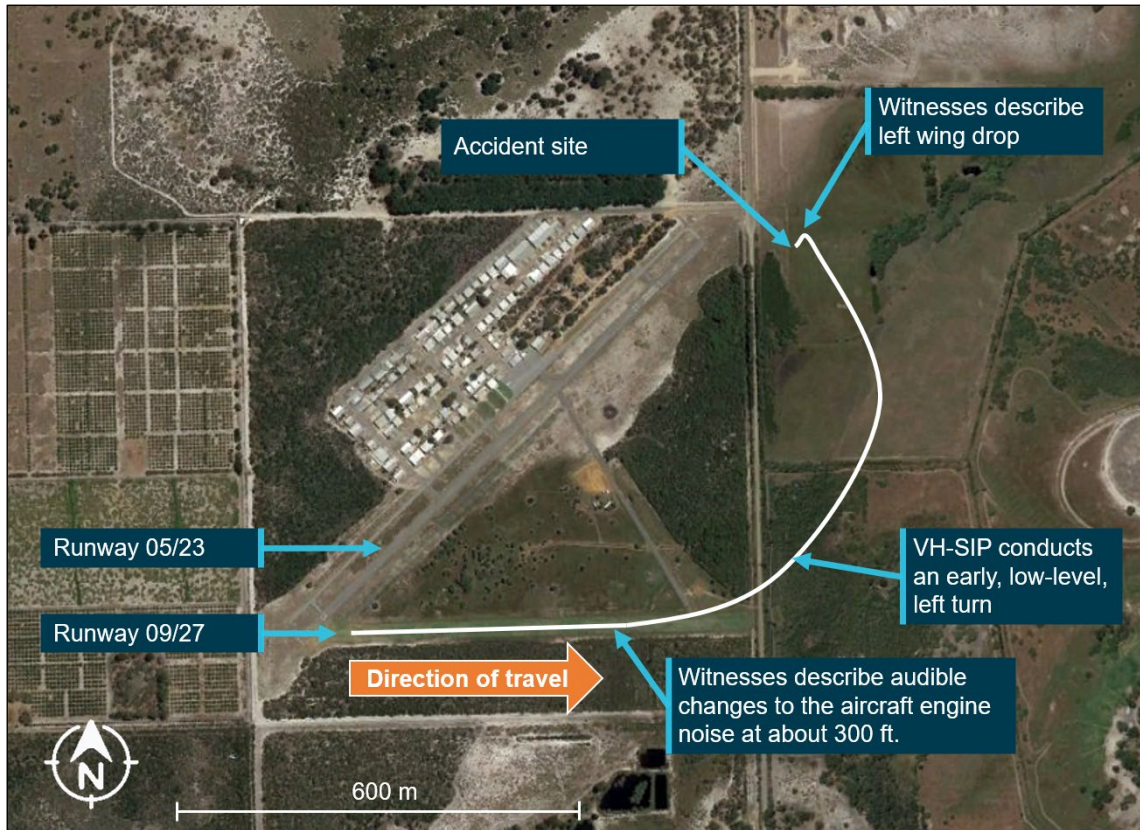
**Figure 1: Aircraft's flight path and accident site location**

At about 1438, the pilot conducted a further post-maintenance troubleshooting flight from runway 09 (Figure 1). The LAME stated that they expected the aircraft operation to be a high-speed ground run. At about 300 ft AGL, witnesses described audible changes in the aircraft engine noise, and observed a noticeable change in aircraft performance. They observed the aircraft visibly slow and begin a left turn. Further change in the engine noise was heard before the aircraft was described to commence another left turn towards runway 23. At about 200 ft AGL, witnesses described the left turn beginning to tighten and the aircraft visibly slowing with a nose-high attitude. At about 150 ft AGL, the aircraft's left wing dropped and the aircraft entered a steep rotating descent to the left. The pilot was unable to recover control of the aircraft before it impacted with terrain.

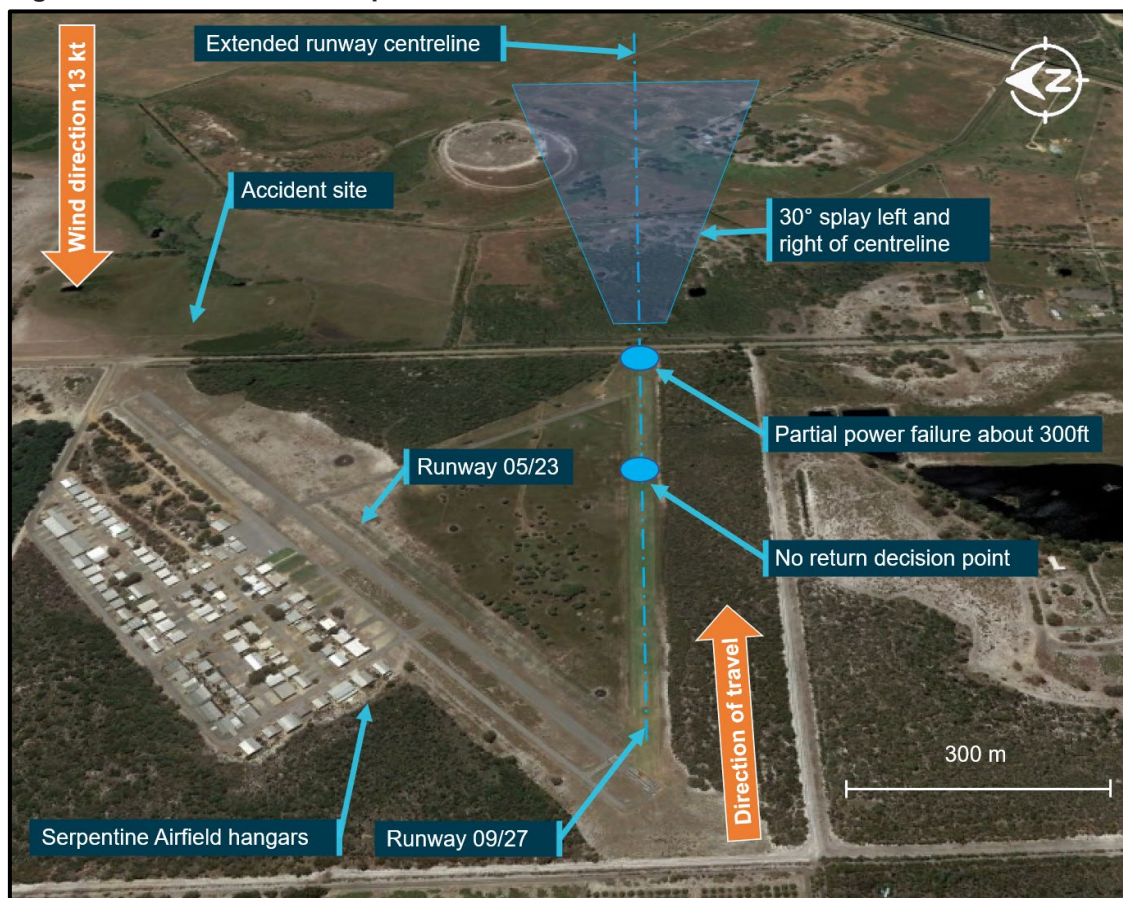
**Figure 4: No return decision point**

On take-off, once the aircraft climbs to a point where it does not have enough runway to land straight ahead, but is not high enough to safely return to the aerodrome for a landing, it has reached a 'no return' to the runway decision point (Figure 4). From this point, until the aircraft climbs to a height allowing safe return to the runway, the pilot is faced with conducting a forced landing beyond the prepared surface of the airfield. Decisions made by the pilot in command can be critical to the safety of flight at this point.

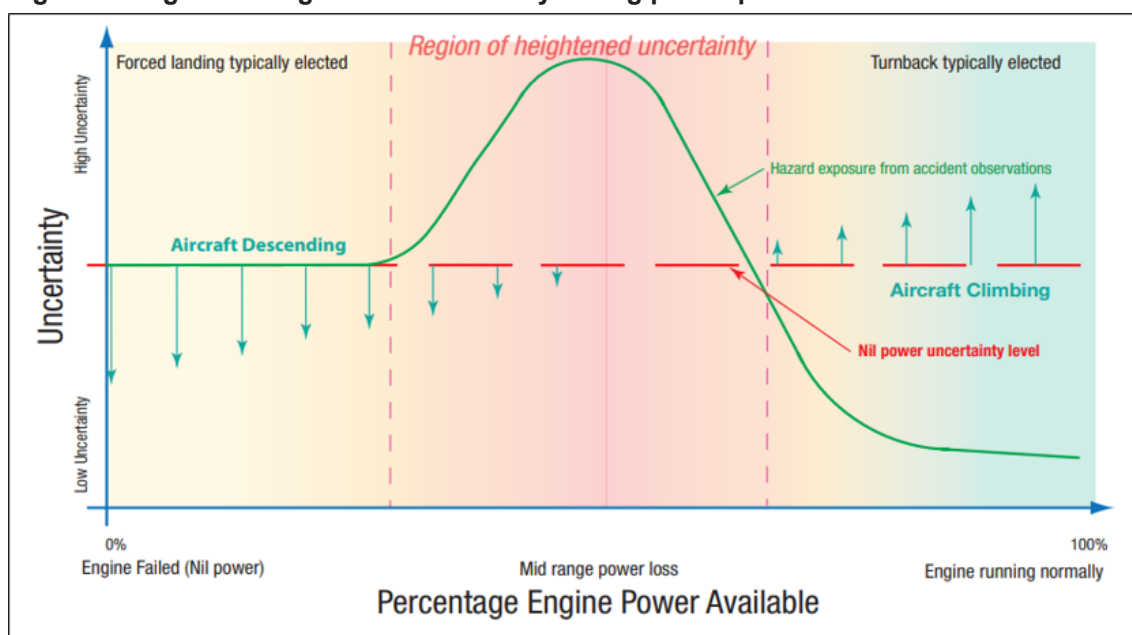
**Figure 5: Region of heightened uncertainty during partial power failures on take-off**

However, the ATSB identified a period between these 2 areas that represented a region of heightened uncertainty (Figure 5). In this region, excess power was not available to climb but there was sufficient power to prevent appreciable descent, resulting in a period of flight uncertainty where the aircraft may not be able to maintain height without bleeding off airspeed, eventually resulting in the aircraft slowing to maintain or gain height and increasing the risk of aerodynamic stall.

The ATSB identified that 8 out of 9 partial power loss accidents resulting in fatal injuries occurred with mid-range power loss. Inconsistent power or engine surging from high to low RPM present complex problems to the pilot. Inability to maintain height with partial power loss usually leads to aircraft stall and loss of control, mostly resulting in collision with terrain.
