# In-flight break-up, Robinson R44 Raven I helicopter, VH-NBY

3 km north of Broome Airport, Western Australia on 4 July 2020

## **ATSB Transport Safety Report**

AO-2020-033

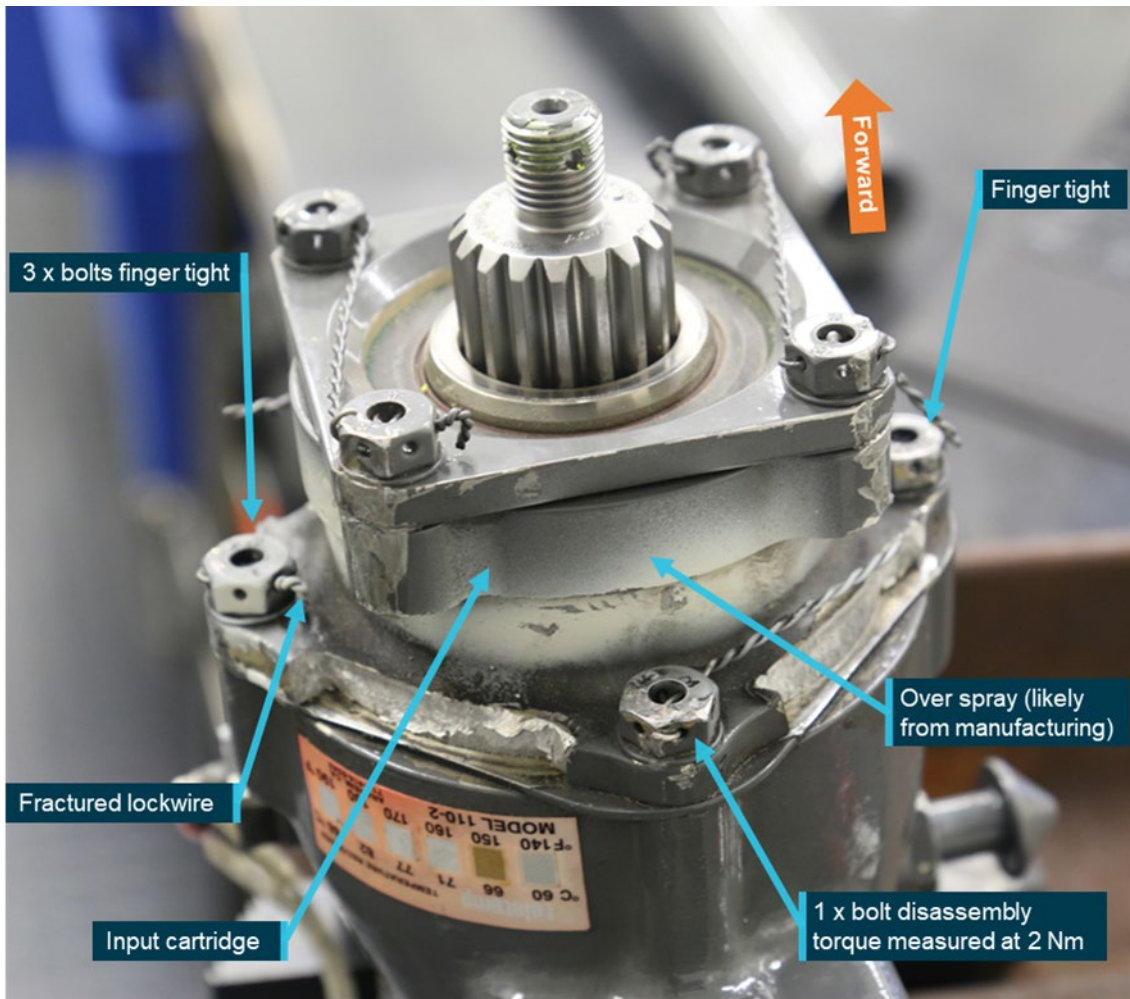
**Figure 18: Tail rotor gearbox and input cartridge**

The fastening torque of the bolts joining the input cartridge to the tail rotor gearbox casting was identified to be very low. Additionally, the adjoining lock wire that formed a secondary security to the keep the bolts tensioned and in place had been pulled away from the security hole on to the bolt head (Figure 18). The anodised surface at the interface of the input cartridge to the TRGB displayed no wear to the finished surfaces. The contact surfaces for each of the washers was examined and there was no evidence of significant fretting.

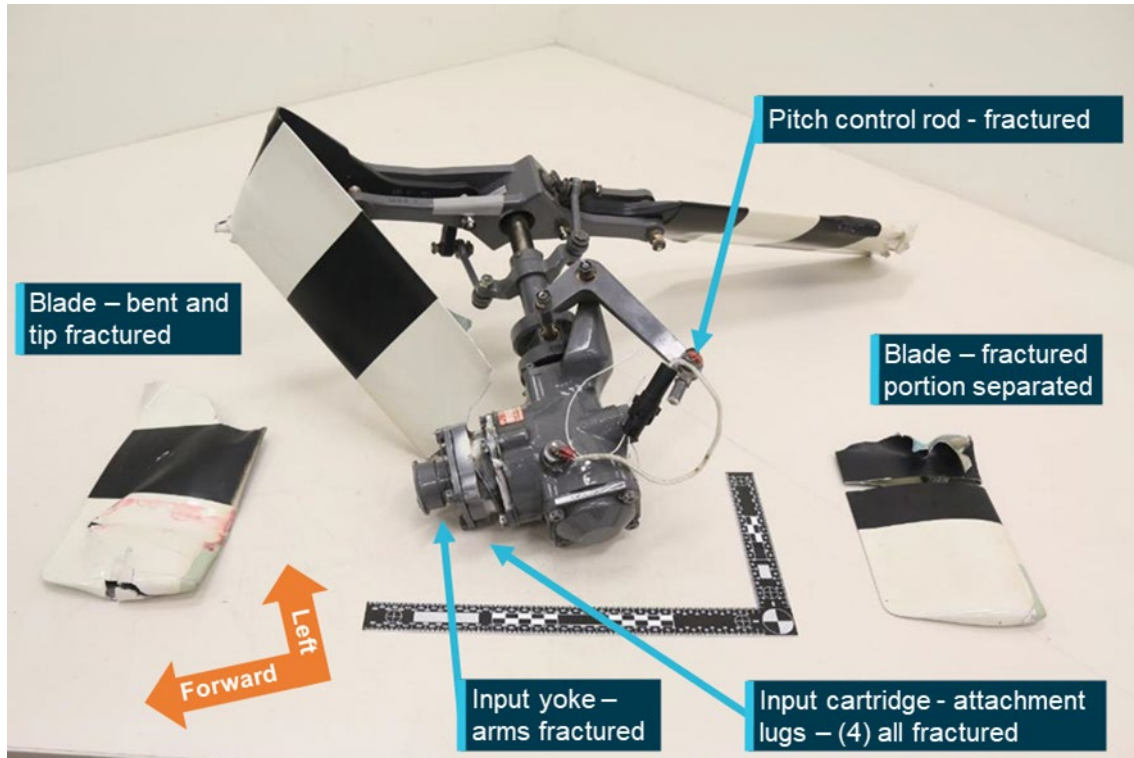
**Figure 21: Tail rotor system (underside view)**

The examination identified that one tail rotor blade had struck the underside of the tail cone (Figure 20), and tail rotor guard, and a prominent hole had been pierced through the bonded tip cap (Figure 21). The other blade had struck the lower vertical fin (Figure 22).

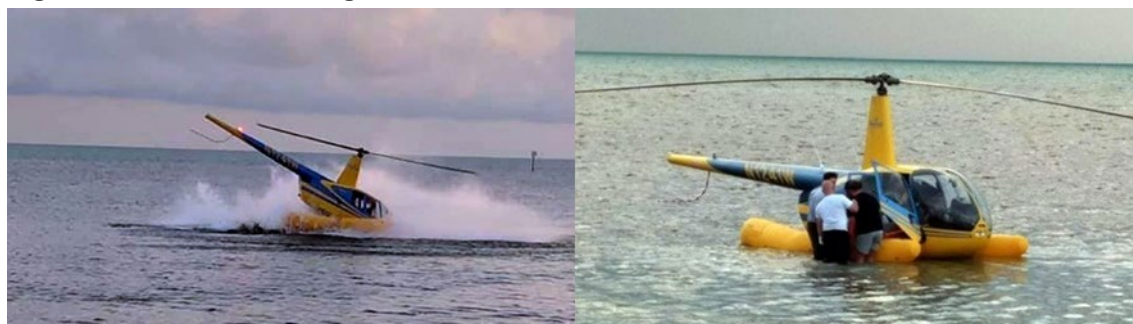
**Figure 23: N1241W ditching and evacuation**

The pilot of N1241W made a successful ditching following loss of empennage and TRGB (Figure 23). The 3 occupants sustained minor injuries. The NTSB found that 2 of the input cartridge attachment bolts were loose.
