# In-flight break-up, Stolp Acroduster II SA-750, VH-YEL

16 km north-east of Caboolture airfield, Queensland, on 18 August 2021

**ATSB Transport Safety Report**

AO-2021-032

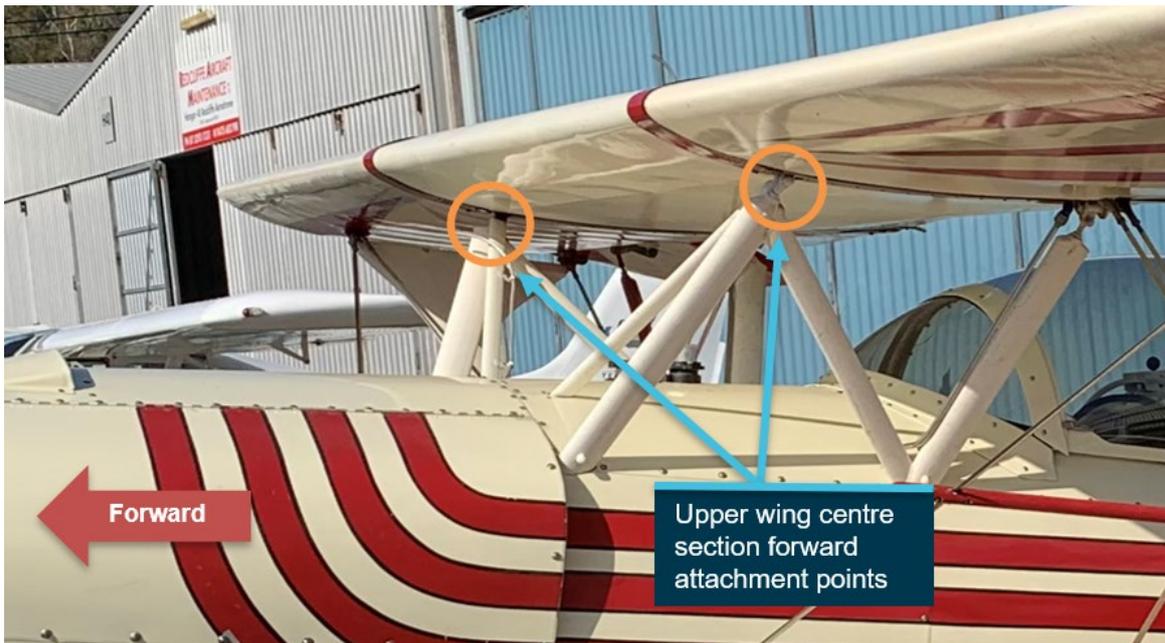
**Figure 4: Upper wing centre section attachment**

The cabane struts and roll braces were provided to support and attach the centre section of the upper wing to the fuselage. Eye bolts had been manufactured to thread into the upper portion of each cabane strut and completed the attachment between the upper wing centre section and the struts (Figure 4). The eye bolts were adjustable in length through their threaded section.

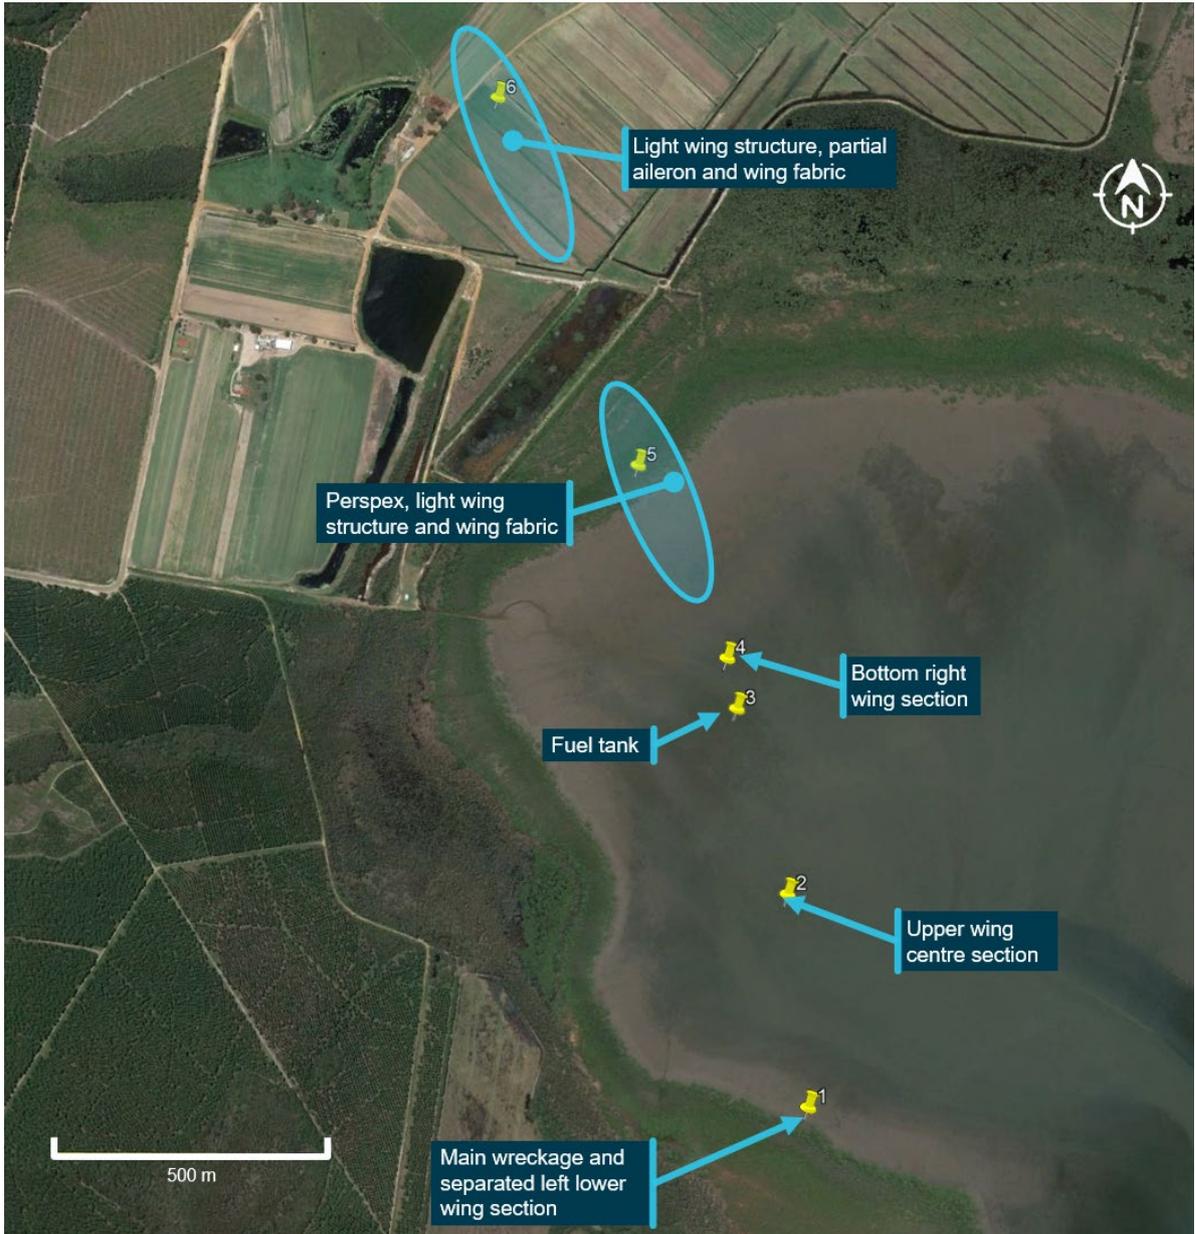
Figure 5: Wreckage trail distribution over mud flats and farmland

The main wreckage consisted of the fuselage, tail, and outer-wing sections still attached to the fuselage by the flying and landing wires. The left lower inboard wing section had separated from the aircraft but was located adjacent to the main wreckage. The upper wing centre section was located about 500 m away from the main wreckage. The majority of the remaining scattered debris consisted of light wooden sections of wing structure, wing skin fabric, panels and windshield fragments (Figure 5).
