# Collision with terrain involving Aquila AT01, VH-OIS

Coombing Park Airstrip, 27 km south of Orange, New South Wales on 4 November 2020

ATSB Transport Safety Report

Aviation Occurrence Investigation (Defined) AO-2020-059 Final – 4 May 2023 Released in accordance with section 25 of the Transport Safety Investigation Act 2003

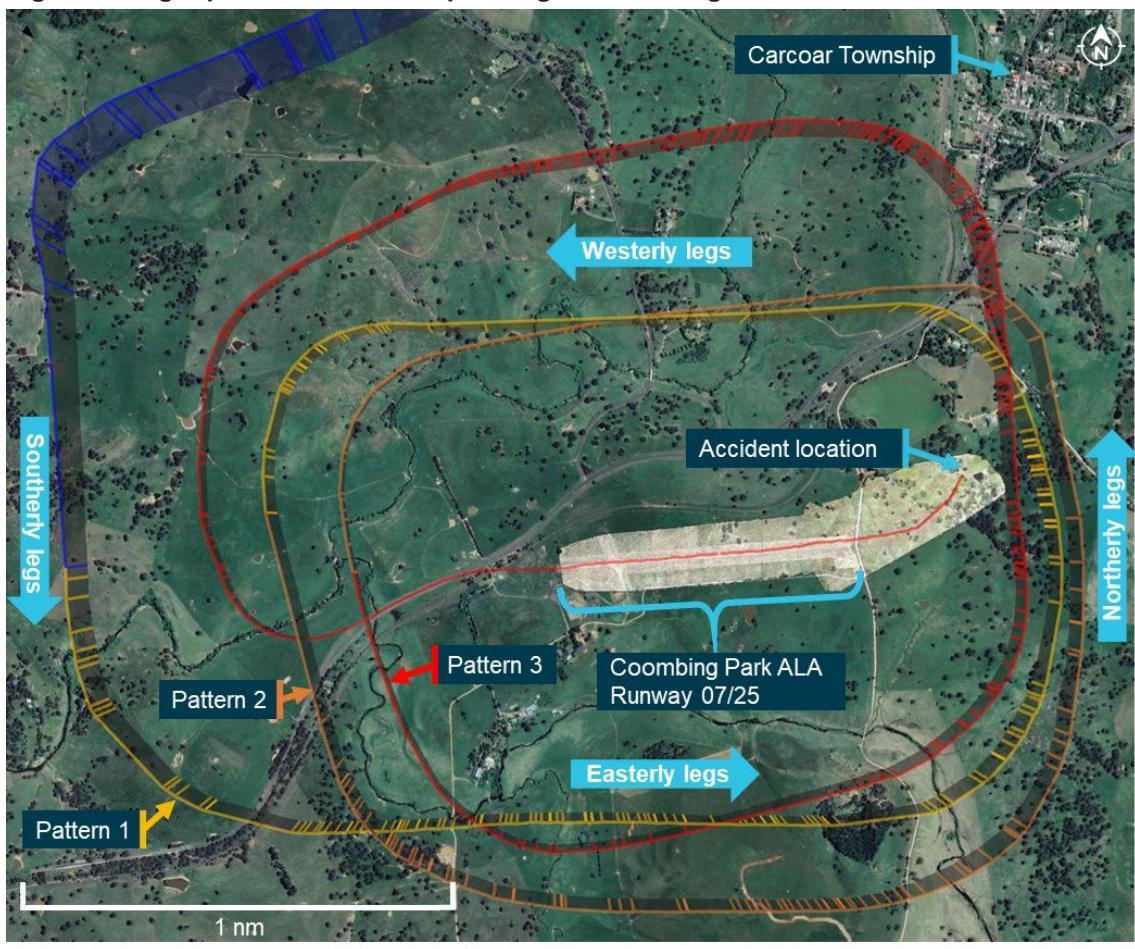
Figure 3: Flight path of OIS while operating at Coombing Park ALA

At 1653 a descent was commenced when OIS was abeam Coombing Park ALA, approximately 3 km to the north of the main east-west runway (runways 07 and 25) as shown in Figure 3. The pilots conducted 3 nominally rectangular patterns around Coombing Park runway 07.

Flight data indicated that OIS passed over the runway 07 threshold at 1708, touched down and rolled along the runway surface. About 30 seconds after passing over the runway threshold, OIS become airborne again and commenced a climb, passing through 50 ft AGL approximately 900 m from the start of runway 07.

- Pattern 1 (Figure 3 yellow lines): OIS descended to a minimum height of 750 ft AGL, and 400 ft above the ridge on the extended centreline for runway 07 (the ridge), during the easterly leg before returning above 1,000 ft AGL.

- Pattern 2 (Figure 3 orange lines): OIS descended to 850 ft AGL (500 ft above the ridge) during the easterly leg before climbing above 1,000 ft AGL for the northern leg and descending throughout the western leg.

- Pattern 3 (Figure 3 red lines): OIS levelled out between 450 and 475 ft AGL (100 to 125 ft above and 3.3 km from the ridge), before commencing a climb just after crossing over the extended centreline of runway 07/25 (start of pattern 3 in Figure 3). OIS continued to climb through the third easterly facing leg from about 500 to a peak height of 1,200 ft AGL mid-way along the third northern leg. The flight instructor sought permission to conduct a touch-and-go from the property manager of Coombing Park ALA at some time along the southerly and/or easterly legs of this pattern.

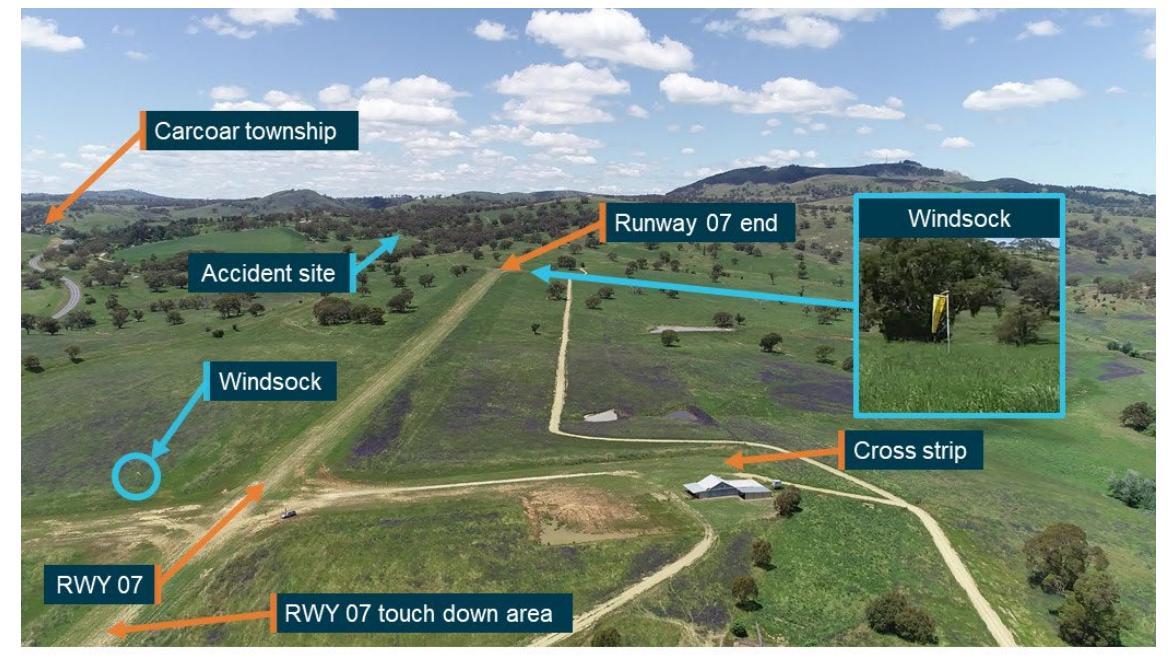
#### Figure 5: Coombing Park ALA facing north-east

The primary runway had a cleared area of more than 30 m on each side of the runway centreline that was free of obstacles. The runway at Coombing Park appeared in good condition at the time of the accident, with the surface being firm, the grass relatively short, and the conditions dry. The gradient of the runway matched the contours of the ground, rising in the direction of runway 07. Rising terrain existed to the east of the field, increasing to a local peak about 350 ft above the runway elevation about 1 km from the end of runway 07.

Two windsocks were present, one near the intersection of the 2 runways and the other near the end of runway 07 on the southern side, as shown in Figure 5. Both windsocks appeared complete, free to move, and in good condition. Powerlines were present about 200 m from the end of runway 25 crossing the extended centreline in a north-south direction less than a 5% gradient from the runway 25 threshold.

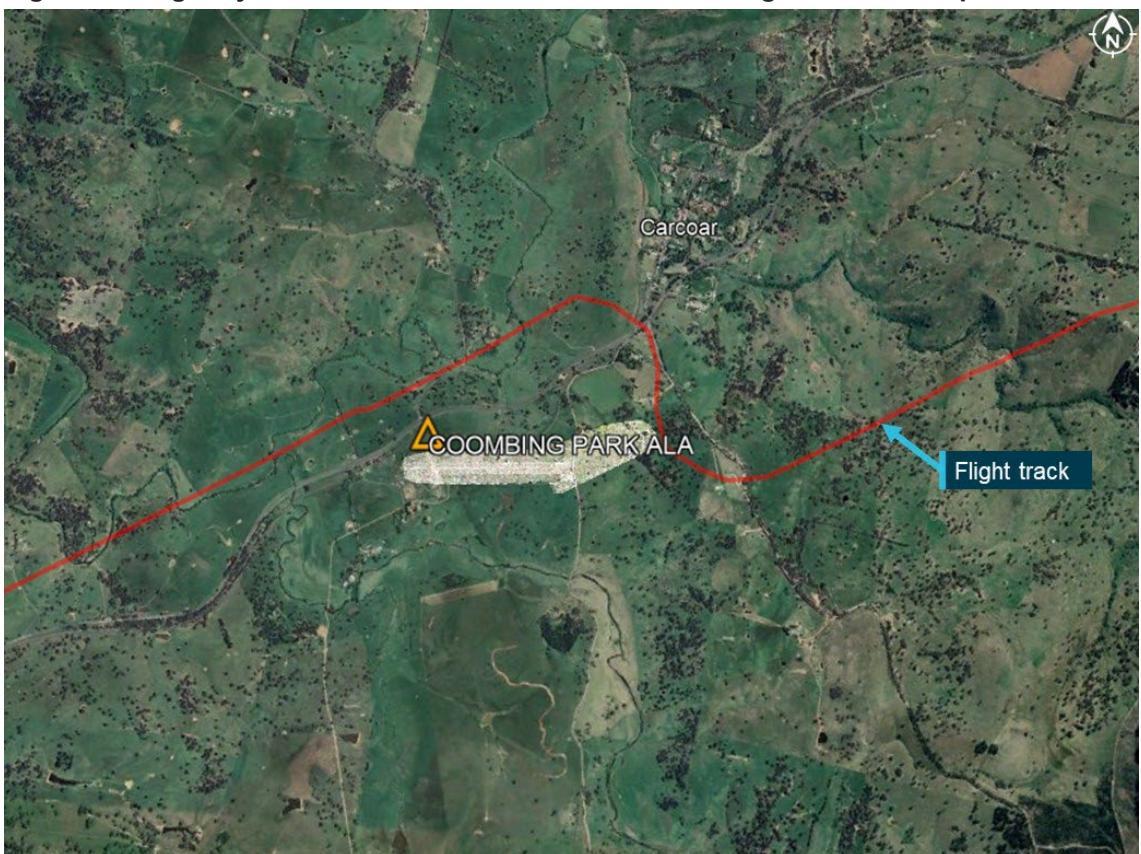
Figure 14: Flight by the instructor within 5.5 km of Coombing Park on 21 September 2018

Coombing Park was passed once by the instructor on 21 September 2018, with 2 heading changes occurring as the aircraft passed overhead (Figure 14). However, there was no evidence to suggest that any circuit or landing (including a precautionary search) was conducted at that time. No other evidence was identified for flights by the instructor to Coombing Park.

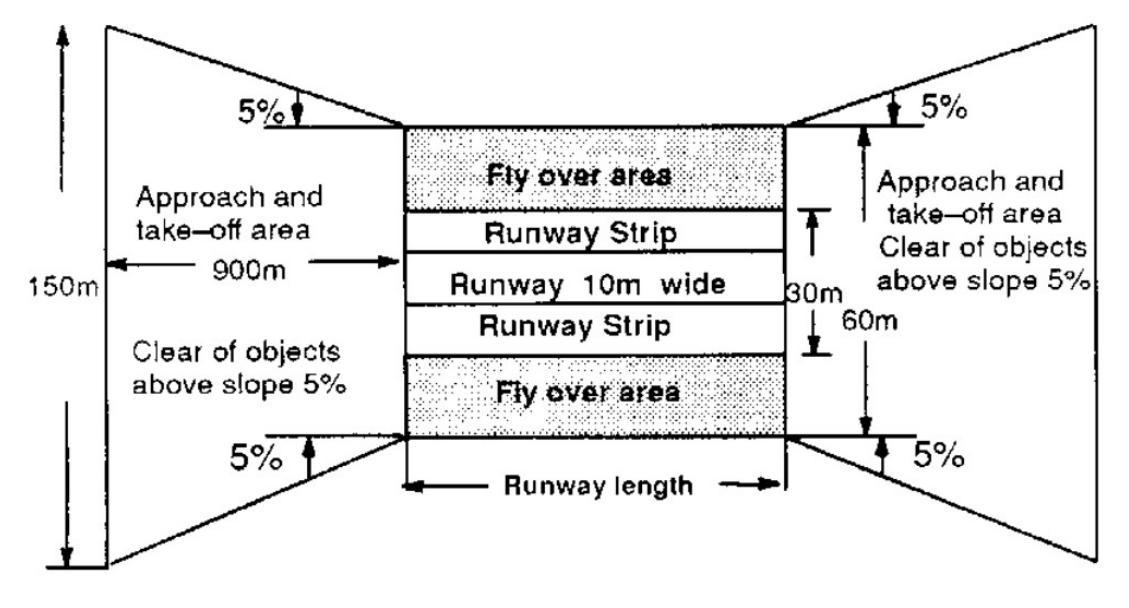
The ATSB assessed Coombing Park ALA against the obstacle clearance recommendations of the CAAP. This recommended the 'approach and take-off areas to be clear of objects above a 5% slope for day...operations'. This was an area extending 900 m beyond the end of the runway and is illustrated in Figure 15. The accident flight path was within this area prior to the final left turn (Figure 10).

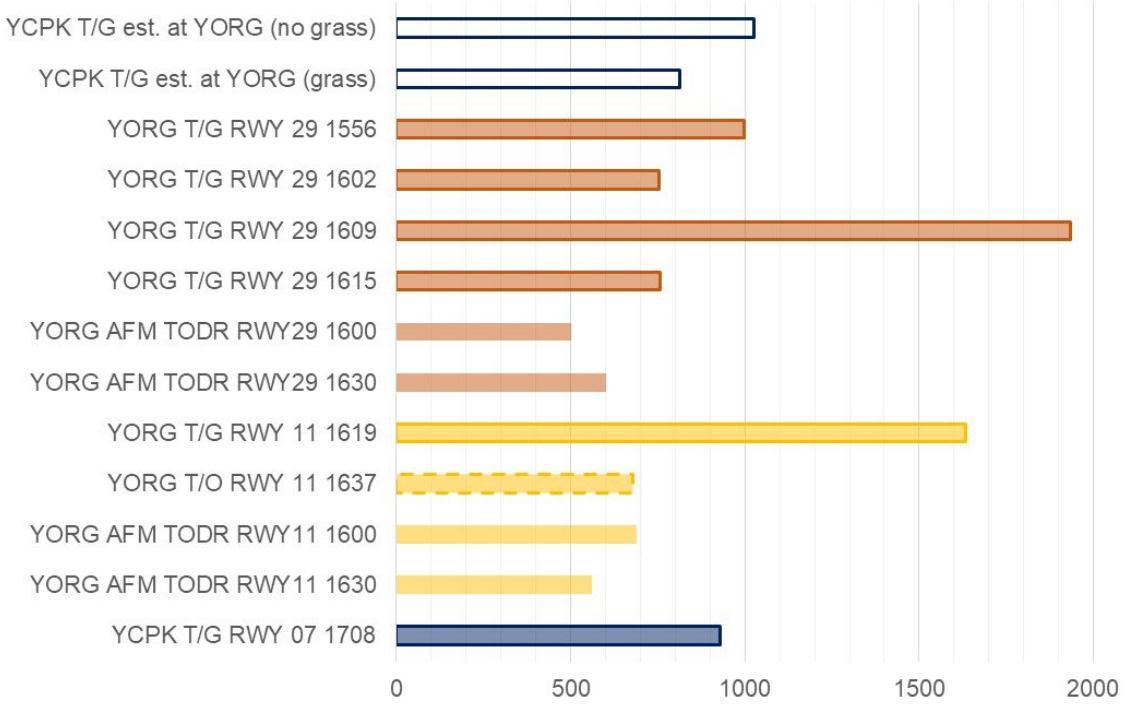
# Figure 17: Distance from runway threshold to take-off for VH-OIS at Orange Airport and Coombing Park ALA, 4 Nov 2020

The horizontal axis of Figure 17 shows the distance between the runway threshold, at the beginning of the takeoff run, and climb to 50 ft above ground level. Values associated with Orange Airport are prefixed with 'YORG' and are colour coded as orange for runway 29, and yellow for runway 11. The touch-and-go at Coombing Park is indicated in purple and prefixed 'YCPK'. Bars indicating touch-and-goes include 'T/G' in the label, with the standing take off at Orange Airport labelled 'YORG T/O RWY 11 0537UTC'.

Figure 17 also shows calculated take-off distance required for each runway used at Orange Airport from the aircraft flight manual for OIS, with the label of these calculated values prefixed by 'YORG AFM TODR'. These are based on the reported winds, density altitude and aircraft weight at Orange Airport at 1600 and 1630. Labels are all suffixed with the local time at the start of each run or the time of weather observation. Further, the open blue bars prefixed with 'YCPK T/G est. at YORG' show an estimated range of the Coombing Park touch-and-go distance if conducted at Orange Airport. The bar labelled 'grass' includes a correction for the dry grass runway, as required

Corrections for aircraft mass, density altitude and surface type were applied to the measured touch-and-go distance at Coombing Park to compare the length of the touch-and-go conducted at Coombing Park with those conducted at Orange Airport, as shown by the open blue bars in Figure 17. No correction was performed for wind to show potential variation from this as a factor. These corrections were performed as follows. The take-off distance required by the AFM (the AFM TODR) were calculated for Orange Airport and Coombing Park ALA based on the estimated aircraft take-off mass, pressure altitude and temperature at each location. The ratio between the AFM TODR between Orange Airport and Coombing Park ALA was calculated, and this was multiplied with the actual touch-and-go distance at Coombing Park, measured from OIS flight data, and is summarised by the following equation.

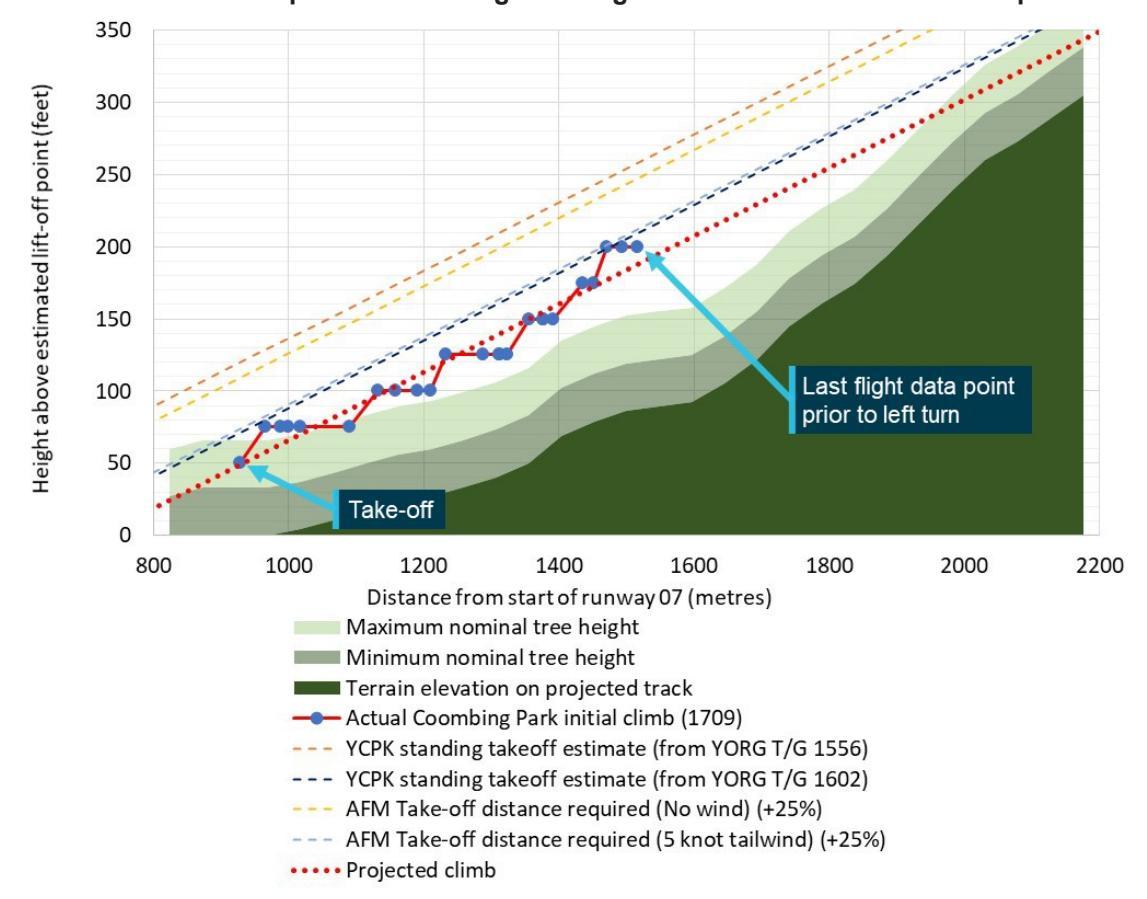
Figure 18: Height of initial climb profile for OIS at Coombing Park ALA, including estimations for climb profiles following standing take-off and estimated terrain profile

The ATSB evaluated the potential influence of a standing take-off on the height of OIS during the initial climb. This analysis used the estimated standing take-off distances described in the section above and is illustrated in Figure 18. The vertical axis shows the height above the estimated point of lift off and the horizontal axis shows the distance from the start of runway 07 at Coombing Park ALA, and also corresponds to the markers shown in Figure 6. Terrain elevation is shown by the solid dark green area, with typical tree heights indicated by the translucent dark green (minimum 10m) and light green (maximum 20m) areas.
