# Engine failure and collision with terrain involving S.E.D.E. Morane-Saulnier MS.893A, VH-UQI

22 km south-west of Archerfield Airport, Queensland, on 6 November 2020

## **ATSB Transport Safety Report**

AO-2020-060

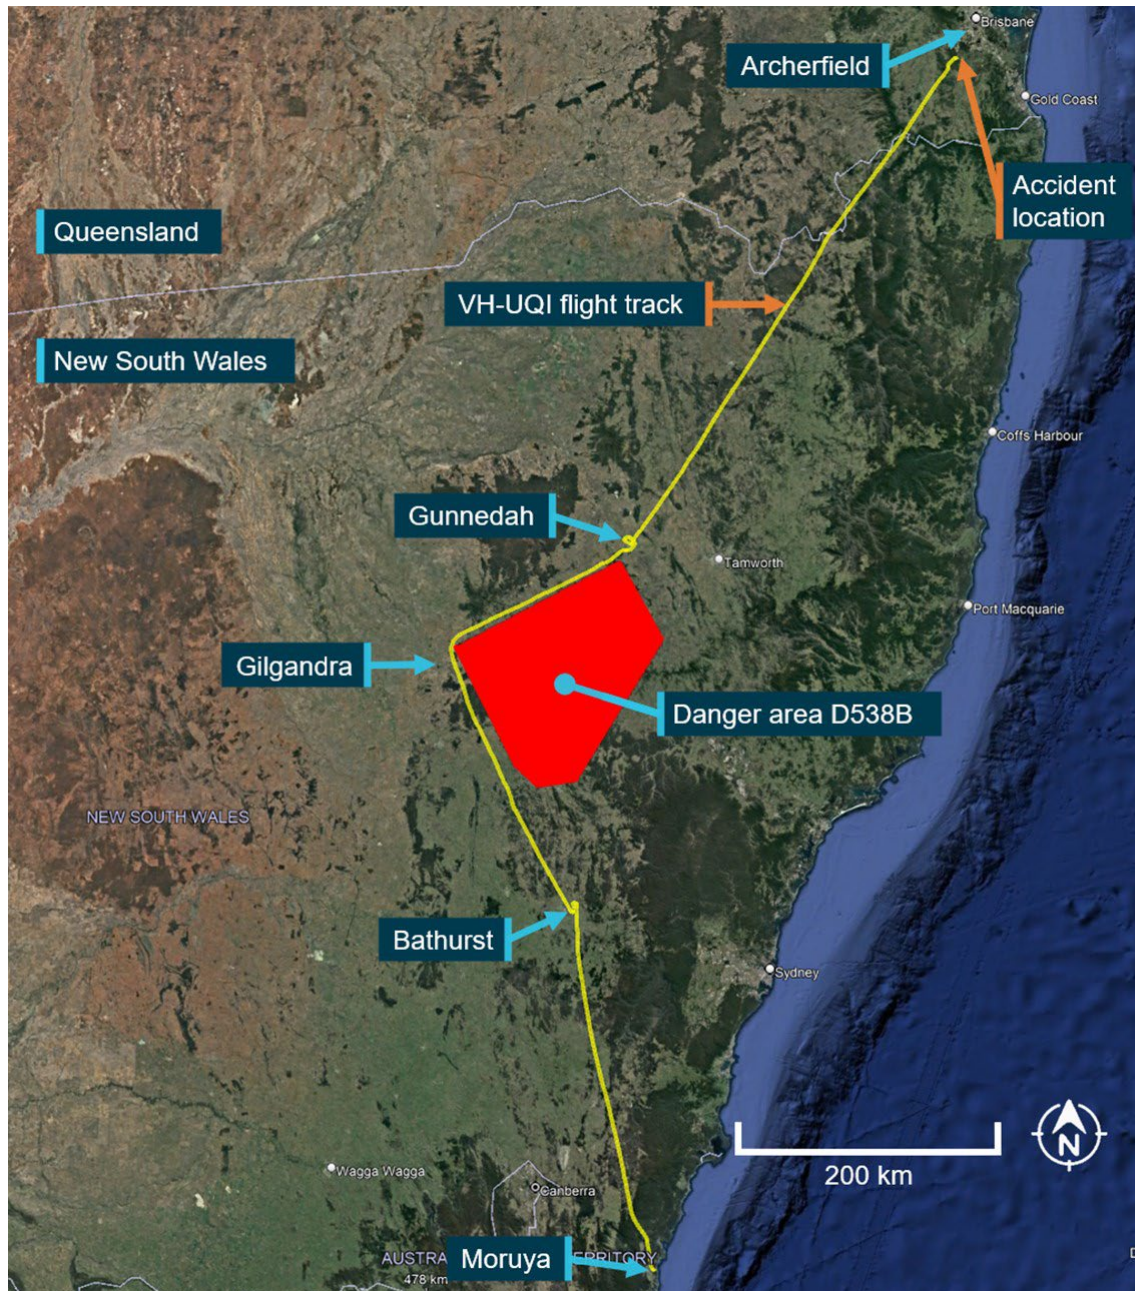
**Figure 1: Recorded flight track of VH-UQI from Moruya, NSW to accident site**

Figure 1 shows the flight track for the aircraft. The pilot flew to Bathurst without incident, where the aircraft was refuelled. Departing Bathurst, the aircraft tracked toward Gilgandra, before changing course to Gunnedah. The pilot recalled tracking around Danger area<sup>3</sup> 538B, a military flying area, as the reason for this indirect route.

Danger area D538B (Figure 1), located between Bathurst and Gunnedah was visible on the OzRunways application when active on RWY, however there was no evidence that the pilot had previously considered avoiding D538B during pre-flight planning. A direct route to Gunnedah was possible at the planned altitude on the day of the flight.

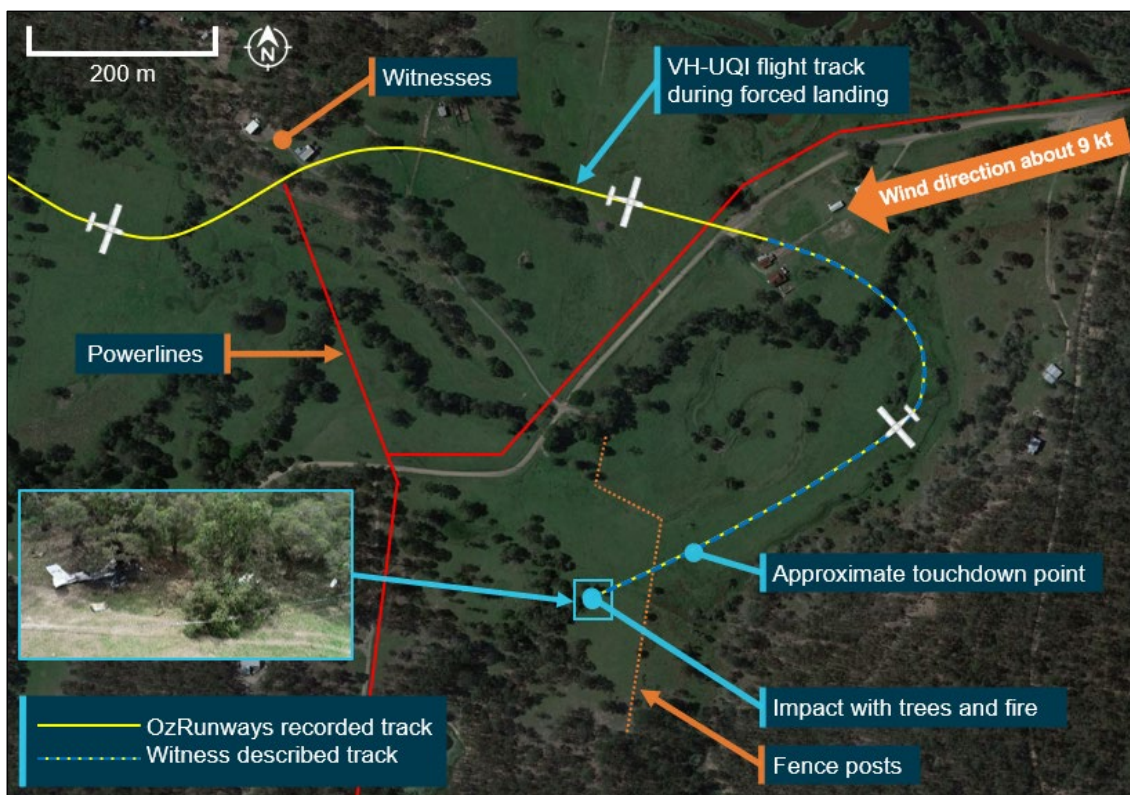
**Figure 2: VH-UQI flight path and forced landing area**

The pilot recalled that the aircraft ran rough and lost engine power, before complete engine stoppage. At the time, VH-UQI was approaching numerous built-up areas and the pilot had limited suitable forced landing area options. The pilot reported that their forward vision was obscured by black smoke and oil emanating from the engine. The recorded flight path showed that the aircraft conducted a right turn towards an open paddock (Figure 2).

paddock and then became temporarily airborne due to ground undulations before impacting trees. The impact resulted in significant disruption to the aircraft structure and initiated a post-impact fire.
