# In-flight break-up, Stolp Acroduster II SA-750, VH-YEL

16 km north-east of Caboolture airfield, Queensland, on 18 August 2021

**ATSB Transport Safety Report**

AO-2021-032

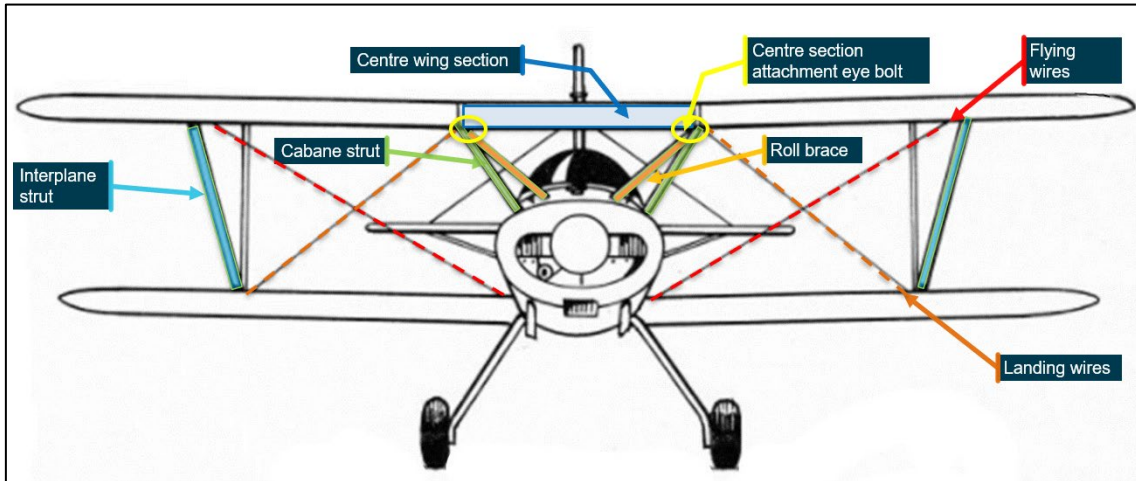
**Figure 3: Wing bracing and attachment**

The lower wings of the Acroduster SA-700/750 were directly attached to the lower fuselage at 2 wing root attachment points on each side. The upper wings incorporated the left, right and centre sections (Figure 3). The centre section was attached to the fuselage by eye bolts (yellow) that then connected to the forward cabane struts (green) and roll braces (light orange). The wings were externally braced against each other using flying wires (red), landing wires (dark orange), and interplane struts (blue). In-flight, the lower wing outboard sections were supported by the upper wing outboard sections through the interplane struts and flying wires.

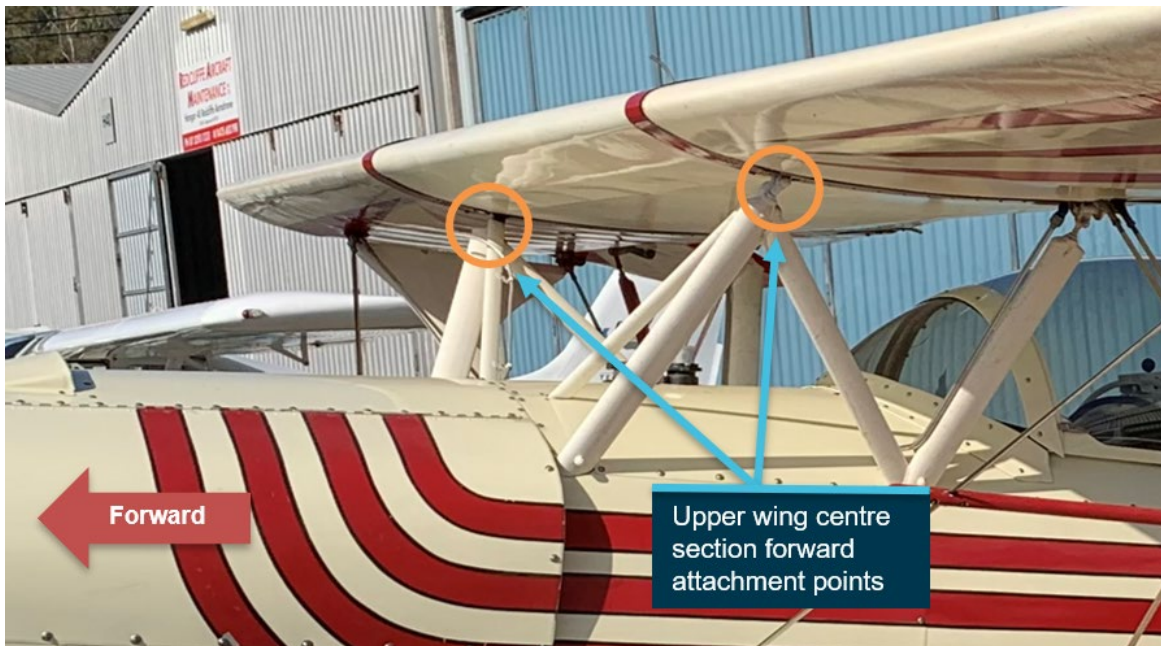
**Figure 4: Upper wing centre section attachment**

The cabane struts and roll braces were provided to support and attach the centre section of the upper wing to the fuselage. Eye bolts had been manufactured to thread into the upper portion of each cabane strut and completed the attachment between the upper wing centre section and the struts (Figure 4). The eye bolts were adjustable in length through their threaded section.

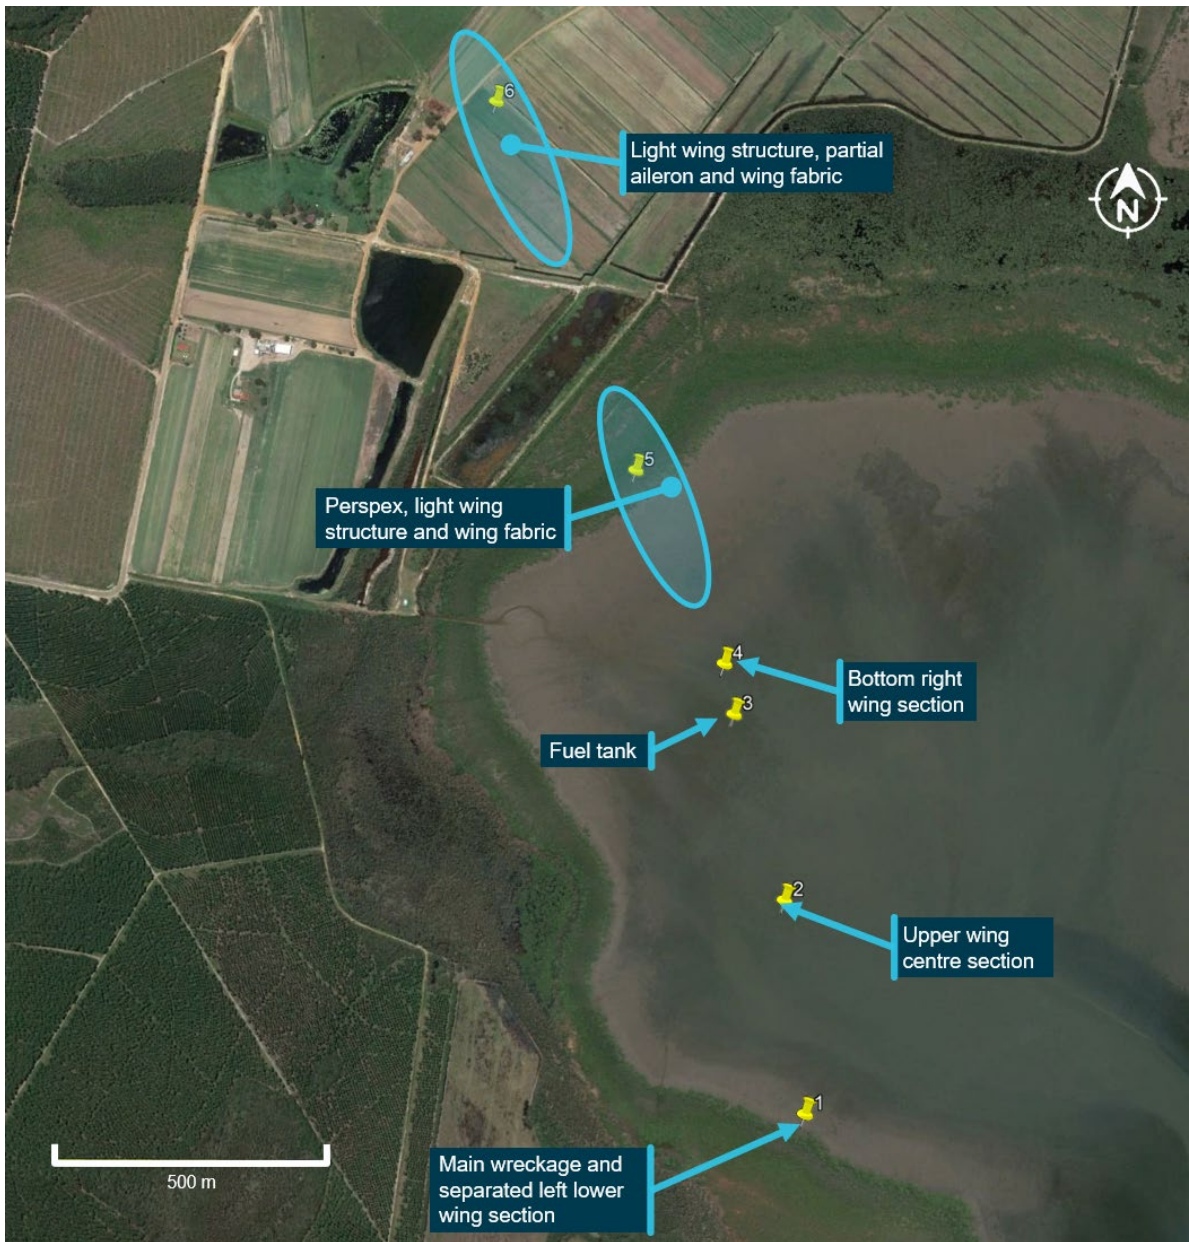
Figure 5: Wreckage trail distribution over mud flats and farmland

The main wreckage consisted of the fuselage, tail, and outer-wing sections still attached to the fuselage by the flying and landing wires. The left lower inboard wing section had separated from the aircraft but was located adjacent to the main wreckage. The upper wing centre section was located about 500 m away from the main wreckage. The majority of the remaining scattered debris consisted of light wooden sections of wing structure, wing skin fabric, panels and windshield fragments (Figure 5).
