# In-flight fire and collision with terrain involving Beechcraft B58 Baron, VH-NPT

near East Kimberley Regional Airport, Kununurra, Western Australia on  
16 April 2022

## **ATSB Transport Safety Report**

AO-2022-026

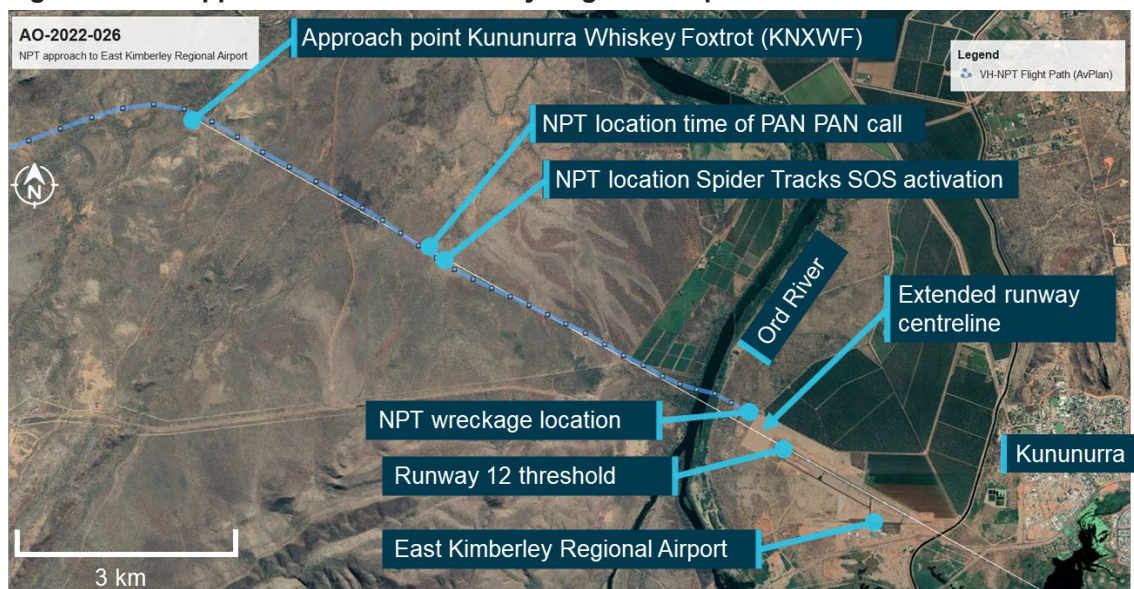
**Figure 3: NPT approach to East Kimberley Regional Airport**

The pilot then expended the entire contents of the aircraft's handheld portable fire extinguisher, while continuing the straight in approach to runway 12 (Figure 3). However, the fire almost

immediately returned, emanating from the same location, with flame and significant smoke in the cockpit. The pilot reported difficulty maintaining control of the aircraft as their left hand and leg were exposed directly to the flames and the smoke prevented them seeing both the instruments and the outside environment. In response, they opened the aircraft's storm window<sup>4</sup> in an attempt to clear the smoke and obtain a visual reference.

Recorded flight data indicated that, at 0837, the aircraft started diverging left of the extended runway centre line, crossing the Ord River at low level approximately 1.5 km from the threshold of runway 12. The aircraft subsequently collided with terrain, coming to rest inverted about 600 m beyond the river and about 800 m from the runway 12 threshold (Figure 3) and was consumed by a significant post-impact fire.

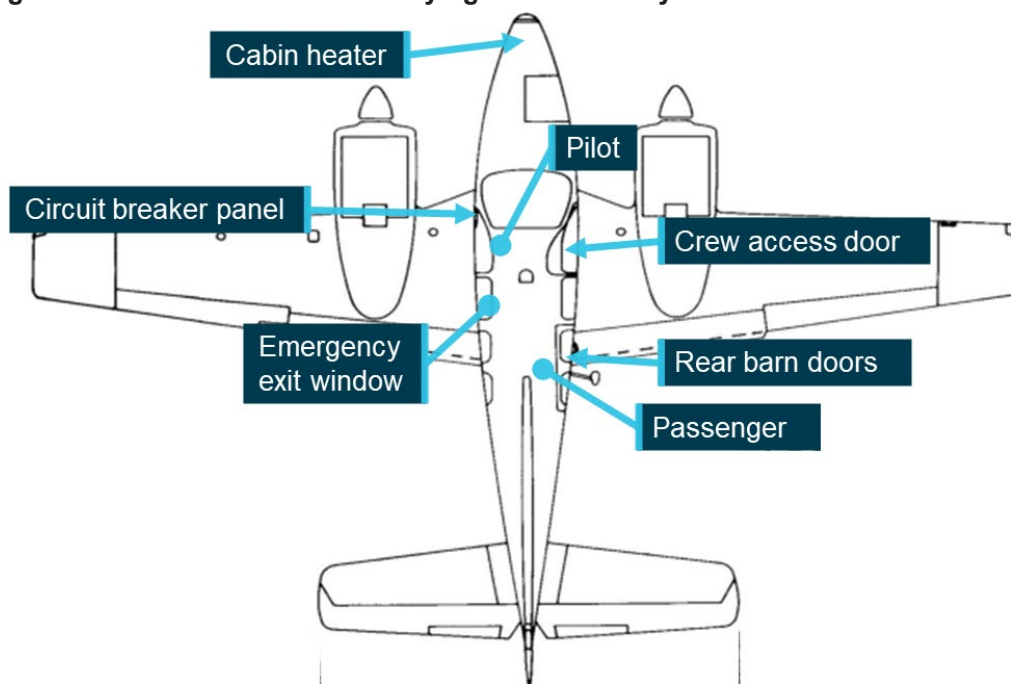
**Figure 5: Aircraft schematic identifying location of key elements**

The B58 is fitted with a fuel-burning cabin heater in the nose of the aircraft (Figure 5). Maintenance records indicated that the heater was infrequently used, and the pilot advised that the heater was not utilised during the accident flight. In the 12 months leading up to the most recent 100 hourly inspection the heater had been used for 102.5 of the aircraft's accumulated 1,077 hours, of which only 3.3 had been accrued in the last 6 months. The heater's hour count following the 100 hourly inspection was unable to be determined due to the post impact fire.

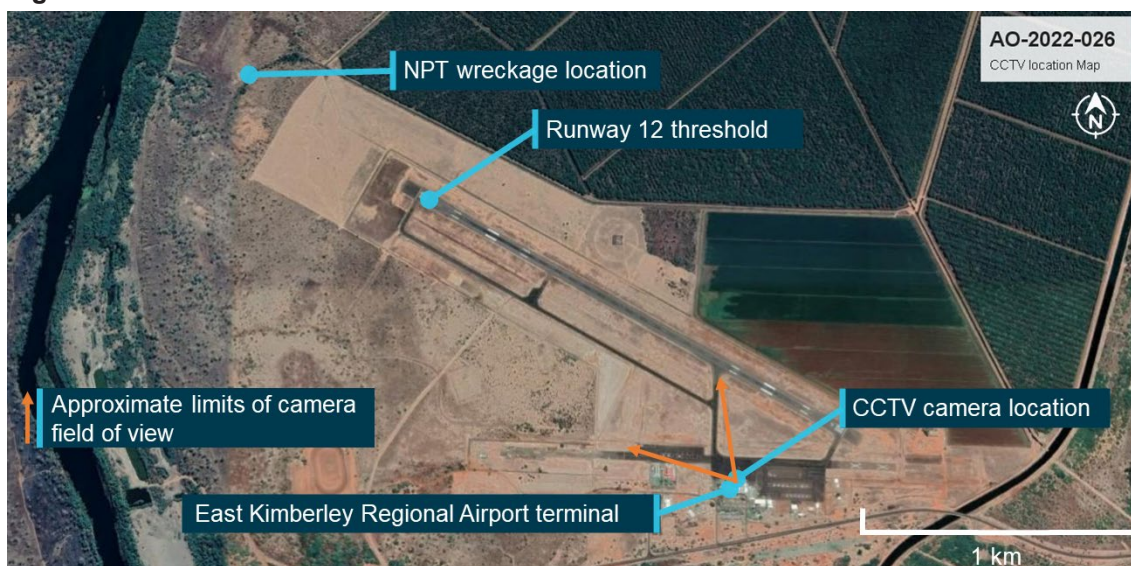
**Figure 12: Location of CCTV camera**

The ATSB also reviewed CCTV footage from the East Kimberley Regional Airport, which captured the smoke plume from the accident. Figure 12 shows the location of a camera covering the regular public transport apron. The camera image showed a smoke plume rising near-vertically from the accident site approximately 3 minutes after the accident indicating little to no wind immediately after the accident, consistent with the METAR.
