Fuel starvation involving Cessna 310R, VH-JQK

Sunshine Coast Airport, Queensland, on 18 August 2022

ATSB Transport Safety Report

AO-2022-040

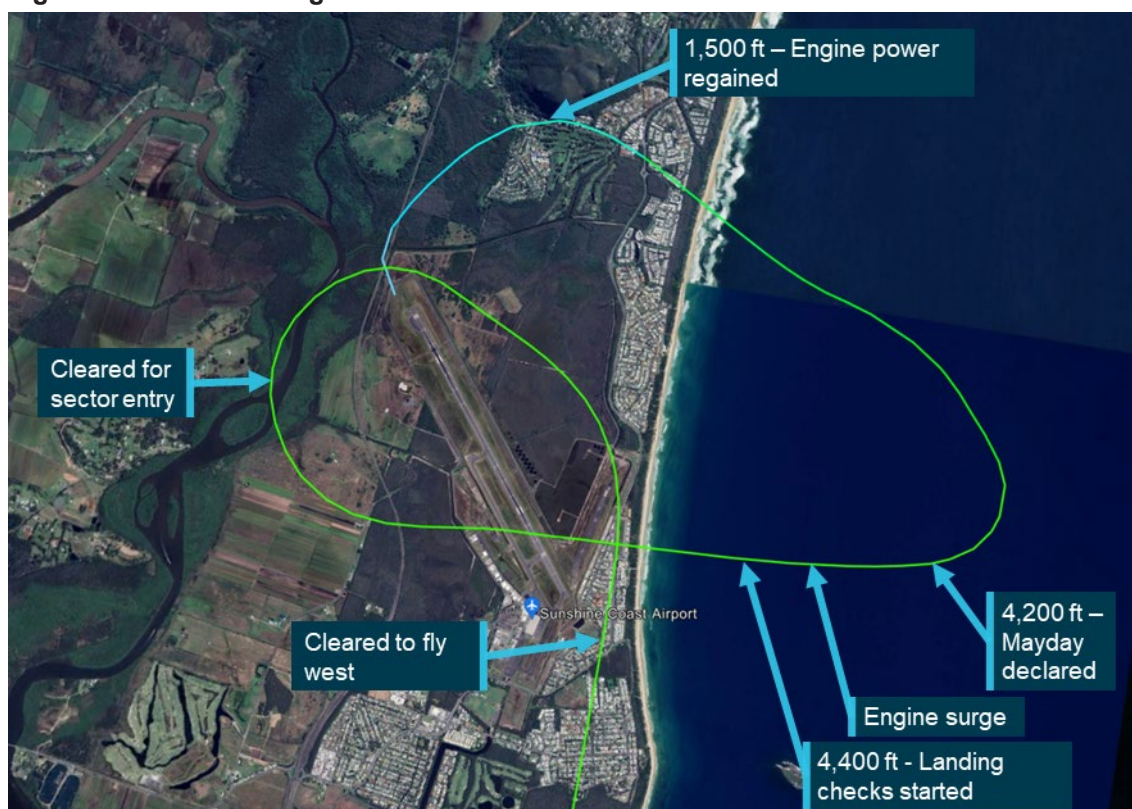
Figure 1: Occurrence flight

At 1517 the instructor began pre-landing checks and the flaps⁴ were extended to 15°. At about that time, both engines began to surge, and the instructor conducted the first 5 steps of the emergency checks including flap retraction and then unsuccessfully attempted to determine the affected engine (Figure 1). The trainee instructor noticed fuel streaking from the main tank vents, indicating fuel venting.⁵ Shortly after, the engines began to operate normally for about 20 s before they started to surge alternatively with a corresponding reduction in power and yawing⁶ of the aircraft.

At about 4,200 ft and tracking in an easterly direction, the instructor declared a MAYDAY on the tower frequency and requested direct track for runway 13.⁷ The controller cleared the aircraft to descend to 1,500 ft and to track for runway 13.
