# Drive belt tensioning motor failure involving Robinson R44 helicopter, VH-ZUJ

Hamilton Island Airport, Queensland 8 January 2023

Aviation Occurrence Investigation (Short)

AO-2023-005

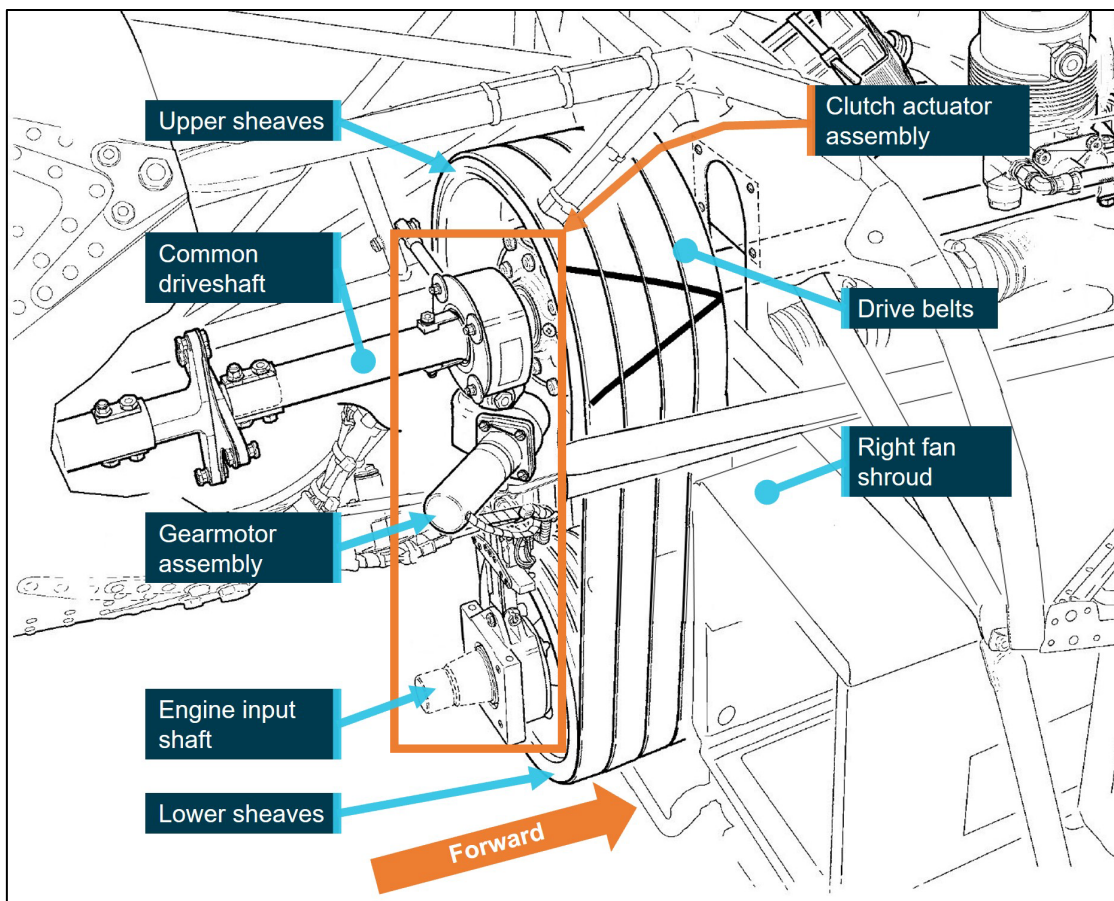
**Figure 2: R44 clutch assembly**

The Robinson R44 helicopter's rotor drive system incorporates a belt driven common shaft for main and tail rotor drive. Power is transmitted from the engine to the main and tail rotors through vertically mounted sheaves (also commonly called drive pulleys) and a v-belt arrangement (Figure 2). The drive assembly carries 4 double-banded v-belts. Each drive belt consists of 2 single v-belts that are bonded by a common rubber backing (tie-band). The lower drive sheave is bolted to the output flange of the engine crankshaft, while the upper sheave is located immediately above on the common main and tail rotor driveshaft.

Before the engine is started, the clutch actuator is placed in the disengaged position, which leaves the v-belts slack and allows the engine to start and run freely without the load of the main and tail rotors. A pilot-operated, electrically-driven actuator progressively tensions the drive belts and enables power transfer from the engine to the rotor system.
