Loss of control involving Cessna Aircraft Company U206G, VH-FRT

Caboolture Airfield, Queensland | 22 March 2014

ATSB Transport Safety Report

Aviation Occurrence Investigation AO-2014-053 Final – 23 June 2017

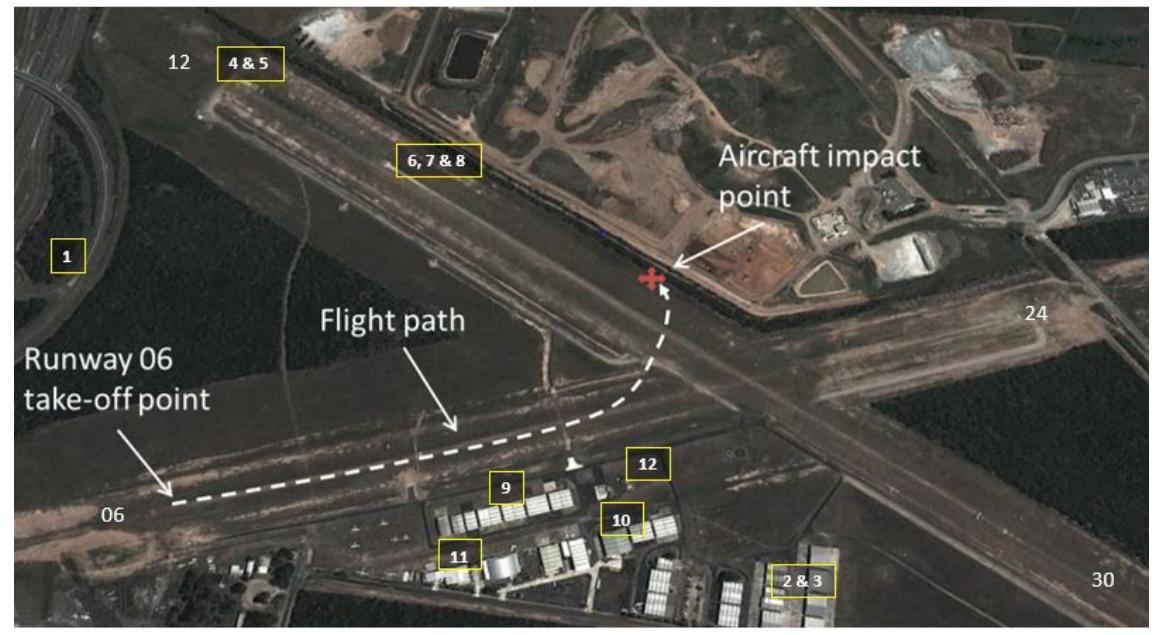
Figure 1: Caboolture Airfield overview showing a number of witness locations (highlighted in yellow and numbered 1–12) and the approximate aircraft flight path and impact point

At about 1124, the aircraft took off from runway 06² with the pilot, two parachuting instructors and two tandem parachutists on board. Witnesses at the airfield observed that, shortly after take-off, the aircraft climbed to about 200 ft above ground level before commencing a roll to the left. The left roll steepened and the aircraft adopted a nose-down attitude until impacting the ground in an almost vertical, left-wing low attitude. All of the occupants on board were fatally injured. A post-impact, fuel-fed fire destroyed the aircraft.

Figure 1 shows an overview of Caboolture Airfield and the aircraft's approximate take-off point, flight path, impact point and the locations of a number of witnesses to the accident.

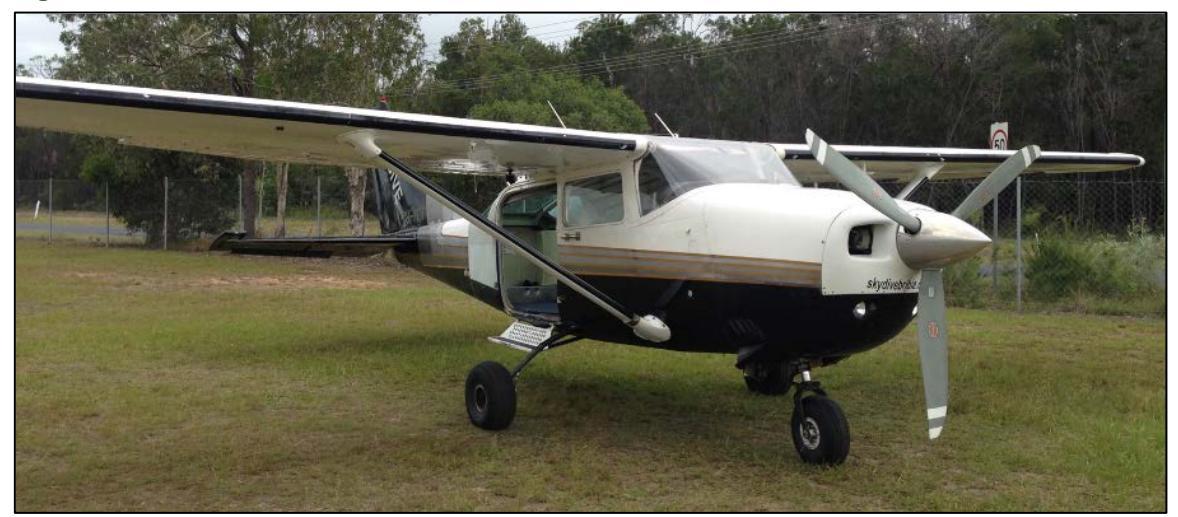
Figure 2: VH-FRT

The accident aircraft, serial number U20604019, was manufactured in the United States (US) in 1977 and was first registered in Australia as VH-FRT (FRT) that year (Figure 2). The owner/operator at the time of the accident purchased the aircraft, and had it modified for parachuting operations, in September 2010. FRT, the operator's only aircraft, was used for parachute training operations from that time until the accident.

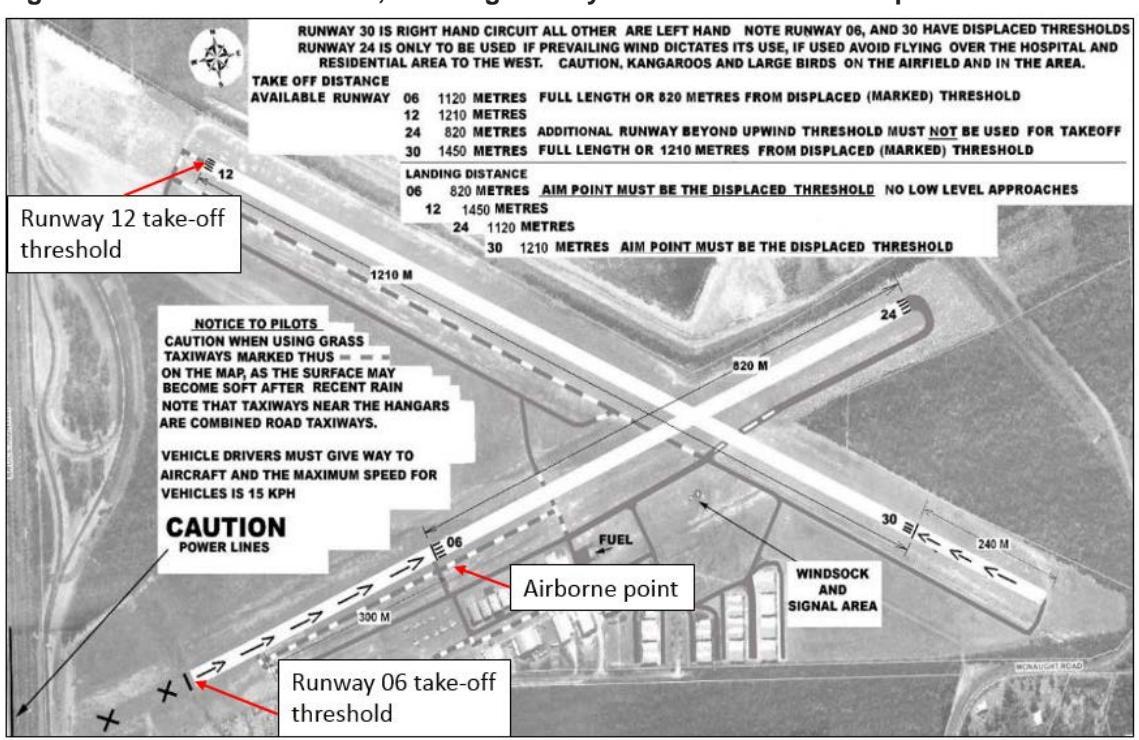
Figure 13: Caboolture Airfield, showing runways 06 and 12 and the respective thresholds

Witnesses indicated that the pilot commenced the take-off at the runway 06 threshold, allowing use of the runway's full length of 1,120 m (Figure 13). It was estimated that a slight crosswind from the right and a 10 kt headwind component affected the take-off. As the pilot reportedly became airborne by the displaced threshold markers, about 820 m of useable runway remained at that time in case of an aborted take-off.

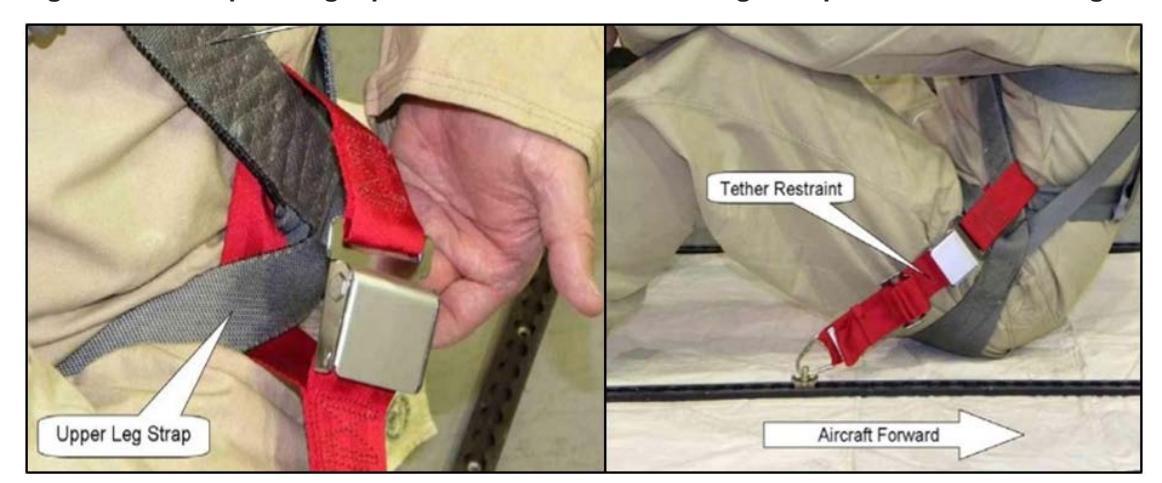
Figure 23: Exemplar single-point restraint secured through the parachutist's webbing

- seatbelt
- safety harness
- or
- parachute that was connected to an approved single-point restraint (Figure 23).

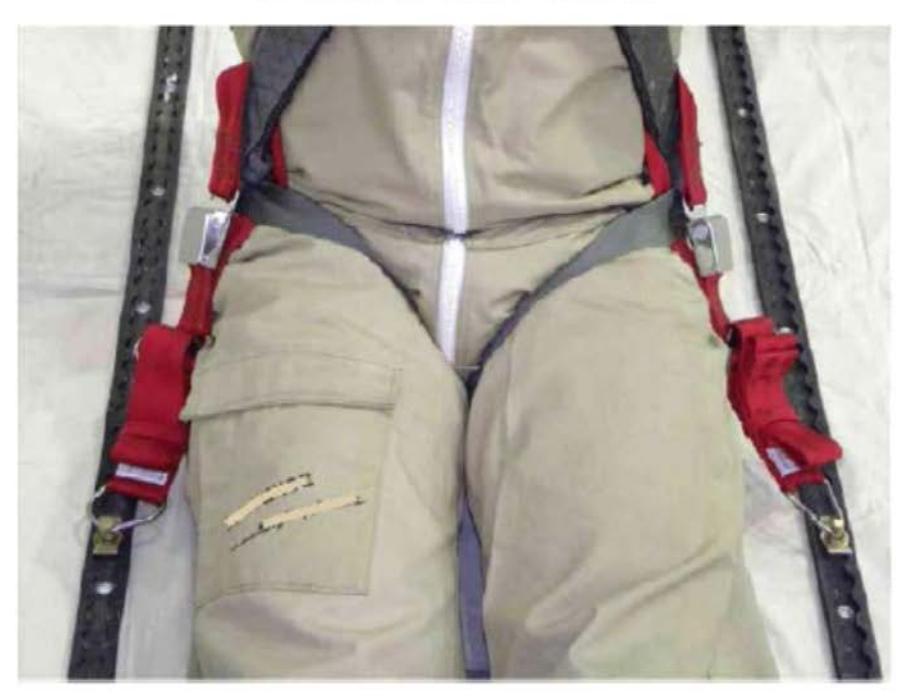
FIGURE 8. DUAL POINT, DUAL TETHER RESTRAINT CONFIGURATION FOR REAR-FACING FLOOR SEATS

(4) Dual point, dual tether restraints offer superior restraint compared to single point, single tether restraints. This restraint method consists of two straps, each connecting the parachute harness to the aircraft floor on both sides of the parachutist as shown in Figures 7, Tether Restraint Attachment To Floor For Rear-Facing Floor Seats, Figure 8, Dual Point, Dual Tether Restraint Configuration For Rear-Facing Floor Seats, and Figure 9, Dual Point, Dual Tether Restraint Attachment To Floor For Rear-Facing Straddle.

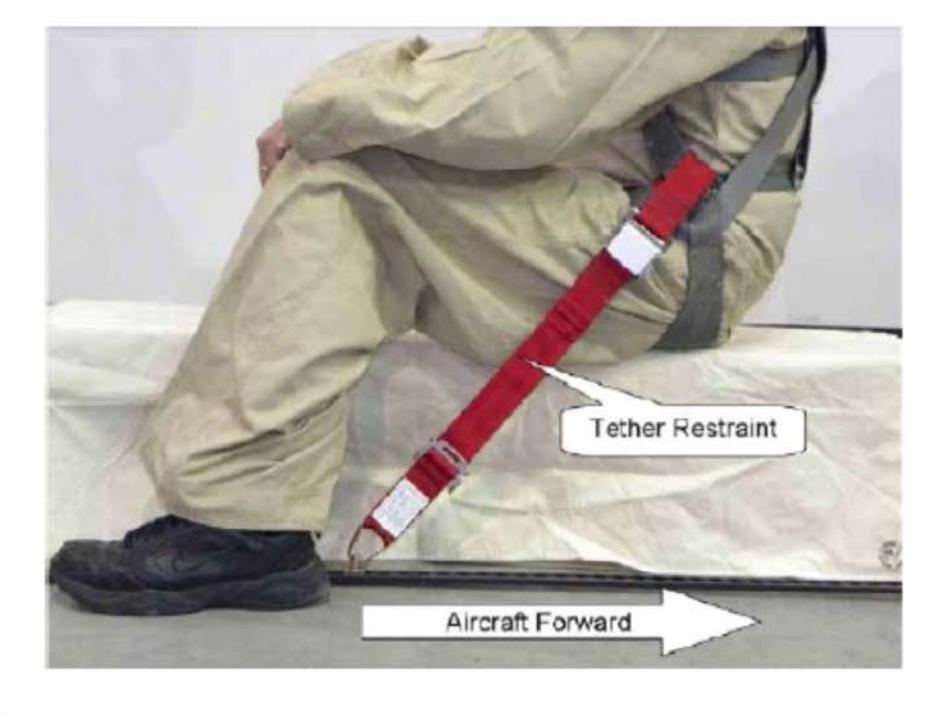
FIGURE 9. DUAL POINT, DUAL TETHER RESTRAINT ATTACHMENT TO FLOOR FOR REAR-FACING STRADDLE

(3) Restraint effectiveness is improved if the tether strap is attached to the floor such that it is at an approximately 45 degree angle, as shown in Figure 9.
