# Derailment of freight train 4BM4

Nana Glen, New South Wales, on 25 February 2021

**ATSB Transport Safety Report**  
Rail Occurrence Investigation (Systemic)  
RO-2021-004  
Final – 6 June 2023

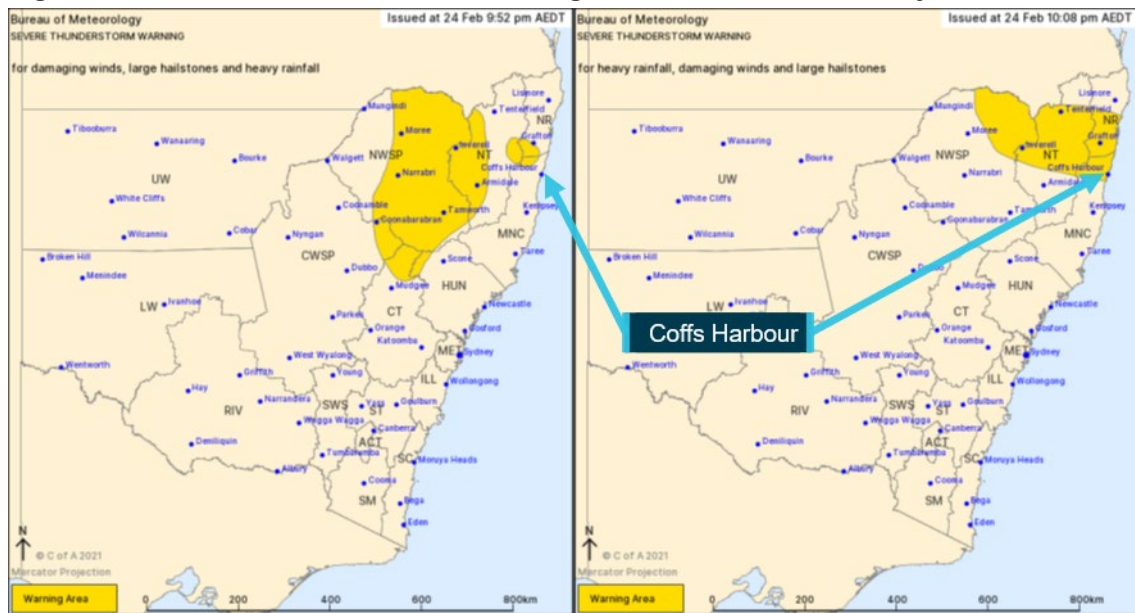
**Figure 11: BoM severe thunderstorm warning 2152 and 2208 24 February 2021**

This warning was identified by the EWN as relevant and EWN communicated the alert to ARTC at 2159. The warning stated that heavy rainfall may lead to flash flooding and listed Glenreagh as an area that may be affected. The initial warning was communicated by the EWN to ARTC as an amber alert within 7 minutes of the BoM issuing the warning. The BoM threat map as depicted in the warning did not appear to show that the rail line would be affected by the weather event (Figure 11).

The second alert issued by the BoM at 2208 provided similar information to the first alert however the threat map showed the warning area over a larger portion of the north coast and could impact the rail line (Figure 11). The warning escalated the threat to 'Severe thunderstorms are likely to produce intense<sup>21</sup> rainfall that may lead to dangerous and life-threatening flash flooding'.

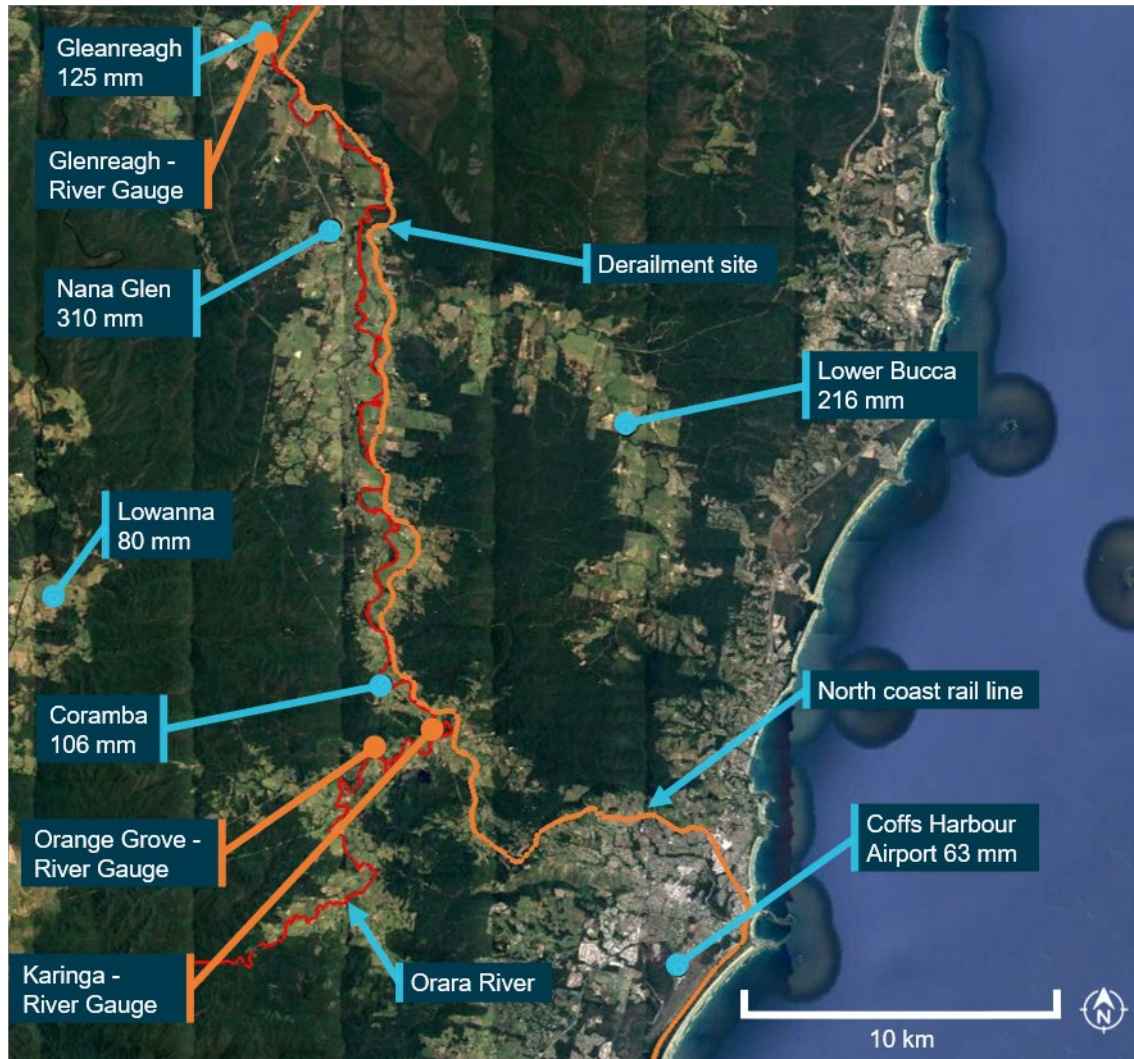
**Figure 12: Record rainfall at 0900 on 25 February 2021 and river height monitoring locations**

Weather stations surrounding the area recorded between 80 mm and 216 mm while Coffs Harbour recorded 63 mm in 24 hours (Figure 12).

Between 0000 and 2000 on 24 February 2021 the Orara River at Glenreagh<sup>23</sup> rose from 1.83 m to 2.75 m, the height then rapidly rose to 8.59 m by 0130 on 25 February 2021. Rises in river height were also recorded at Orange Grove and Karangi<sup>24</sup> in the same period (Table 4 and Figure 12). The Orara River at Glenreagh peaked at 10.59 m after the derailment at 0930 on 25 February before beginning to recede. The river height would likely have peaked earlier at Nana Glen as the gauge at Glenreagh was approximately 8.8 km further downstream.

There was no river height monitoring for the Bucca Bucca Creek which joined the Orara River about 2 km south-west of the derailment site. Lower Bucca recorded 216 mm of rain which would have very likely contributed to the rapid rise in the river height at Glenreagh (Figure 12).

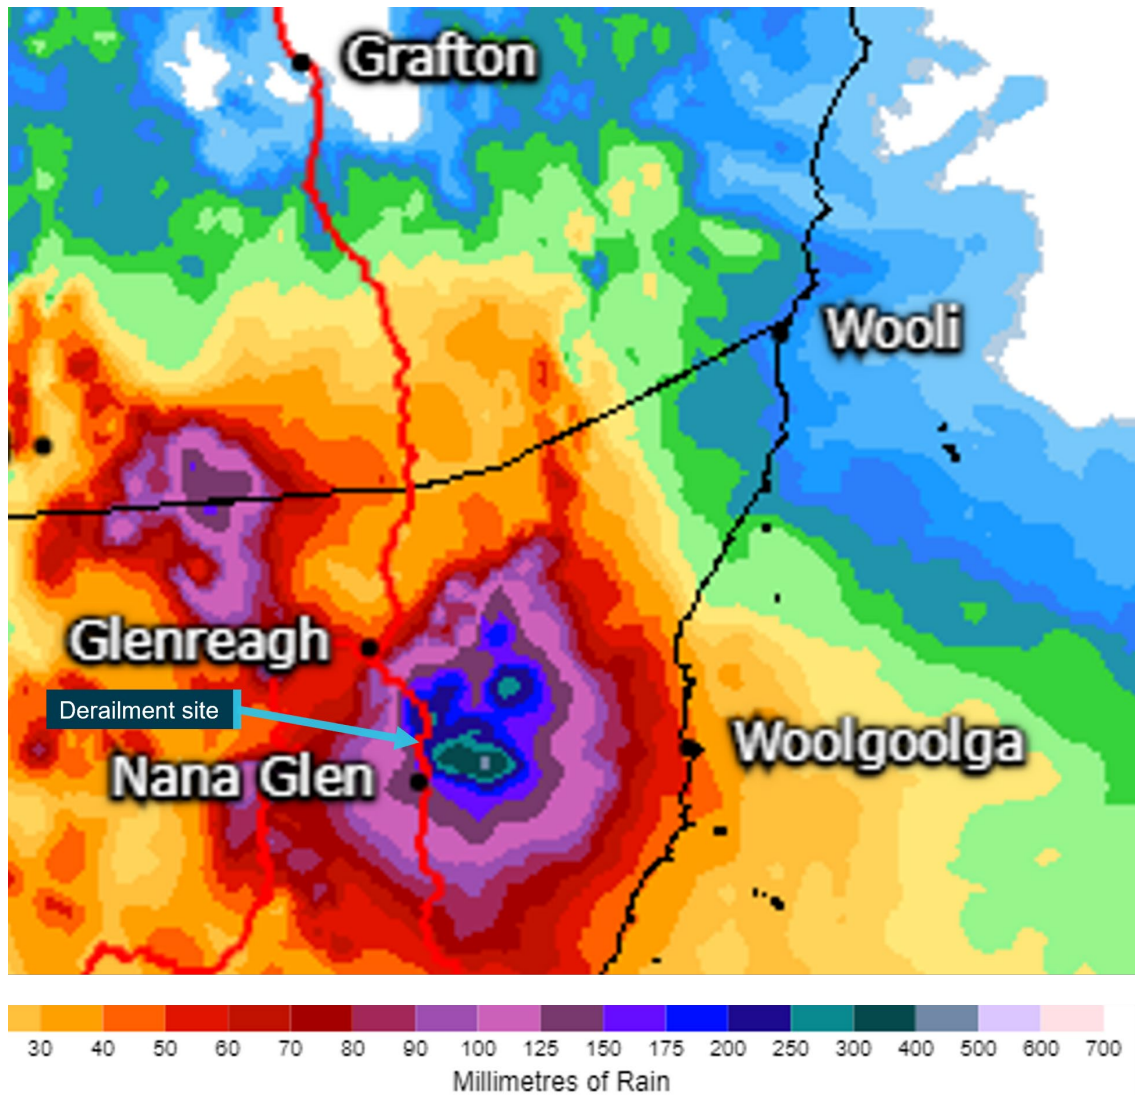
Figure 13: 6-hour rainfall accumulations to 0115 on 25 February 2021

Simulations undertaken by the EWN for the rainfall accumulations based on the Grafton radar in the 6-hours to 0115 on 25 February, suggested rainfall of between 200-300 mm may have fallen near the derailment site (Figure 13). Rainfall exceeding 300 mm may have fallen further east which was likely outside the catchment for Cowans Creek.

The simulation of the rainfall accumulations from the Grafton radar suggested that in 6-hours leading up to the derailment, rainfall of between 200-300 mm may have fallen near the derailment site (Figure 13). The 6-hour rainfall event may have been between 100-200 ARI (1% and 0.5% AEP) and possibly exceeded a 500 ARI (0.2% AEP) for that location (Table 11). The actual duration and intensity of the rainfall could not be determined, although, exceeded ARTC's threshold for black alerts and their infrastructure standards.

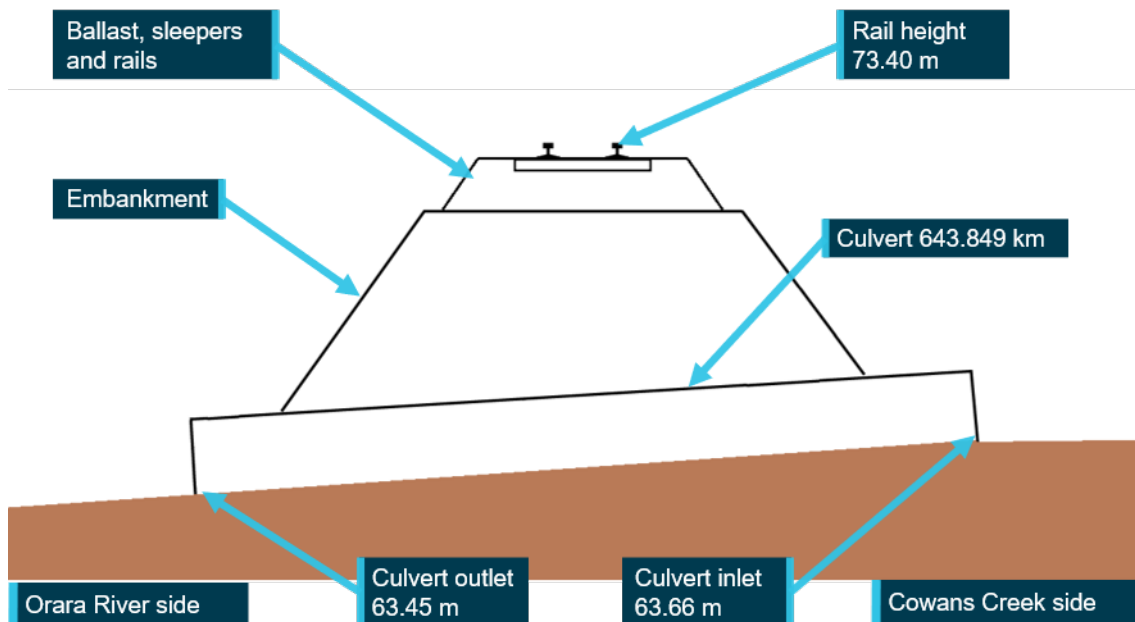
**Figure 17: Track drainage**

The culvert at 643.849 km was a steel reinforced concrete pipe and was 24 m long with a nominal diameter of 2 m (2020 mm x 1970 mm). The inlet elevation to the invert<sup>44</sup> was 63.66 m and the outlet invert was at 63.45 m (Figure 17).<sup>45</sup> The culvert invert was nominally 9.8 m below the top of the rail, which was at an elevation of 73.398 m. The inlet and outlet of the culvert had concrete headwalls and wingwalls (Figure 18 and Figure 19). The slope of the culvert was approximately 1.7 in 200 (1.7 m in 200 m). There were no records for when this culvert was installed.

Photographs taken on 28 February and 1 March 2021 showed that some debris had collected around the inlet and some small branches were near the inlet. These photographs showed that the culvert about the water line was not blocked. Some of the debris would likely have moved as the water levels receded.

Drawing depicting a cross section of the embankment at the derailment site through the culvert at 643.849 km. The elevations for the culvert inverts and rail heights are also noted. Not to scale. The elevations were in reference to the Australian Height Datum. Source: OTSI
