Clutch actuator lower bearing seizure and collision with terrain involving Robinson Helicopter Company R44, VH-KOV

near Nathan River Station, Northern Territory on 16 May 2022

ATSB Transport Safety Report

AO-2022-030

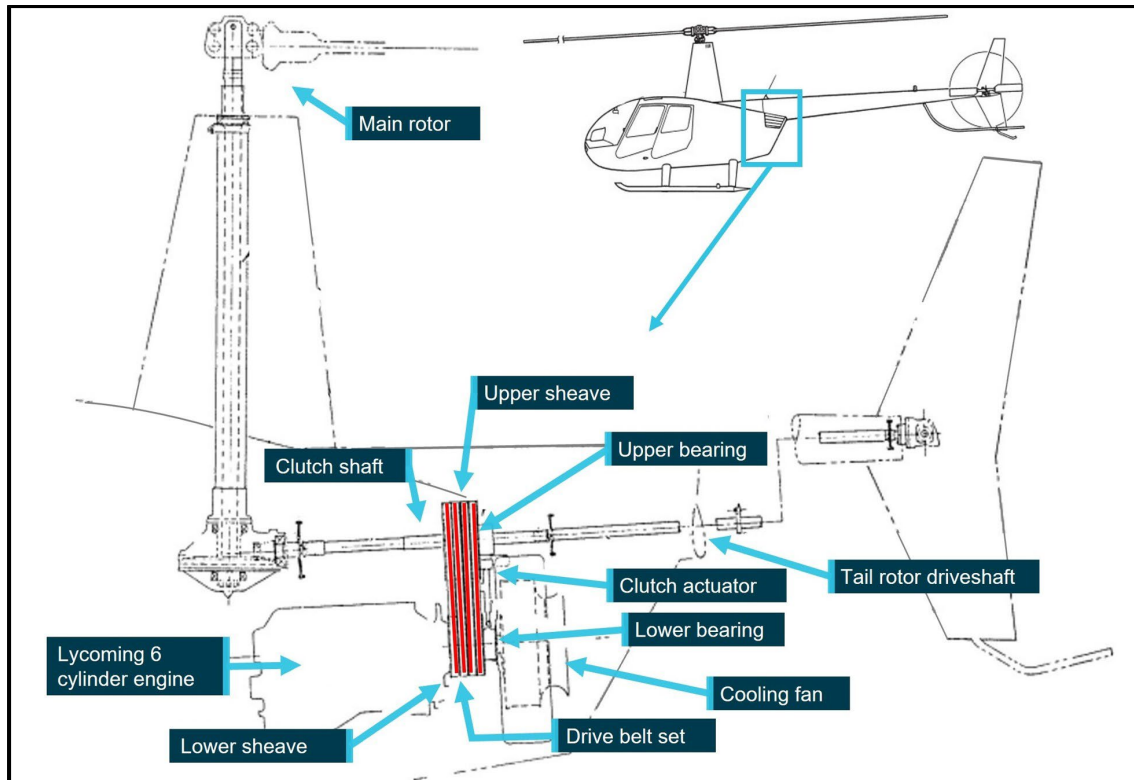
Figure 6: R44 drive system

A V-belt sheave is bolted directly to the engine output shaft (Figure 6). Rubber V-belts transmit power to the upper sheave, which contains an overrunning clutch. The upper sheave transmits engine power via a shaft both forward to the main rotor and aft to the tail rotor.

A bearing, connected to an electric clutch actuator, is mounted between a direct-drive fan wheel and the engine on the engine output shaft. The fan supplies cooling air to the cylinders and oil cooler via a fibreglass and aluminium shroud.
