# Fatal fall from the pilot ladder of *Formosabulk Clement*

5 nautical miles east of Caloundra, Queensland on 9 August 2021

**ATSB Transport Safety Report**

MO-2021-004

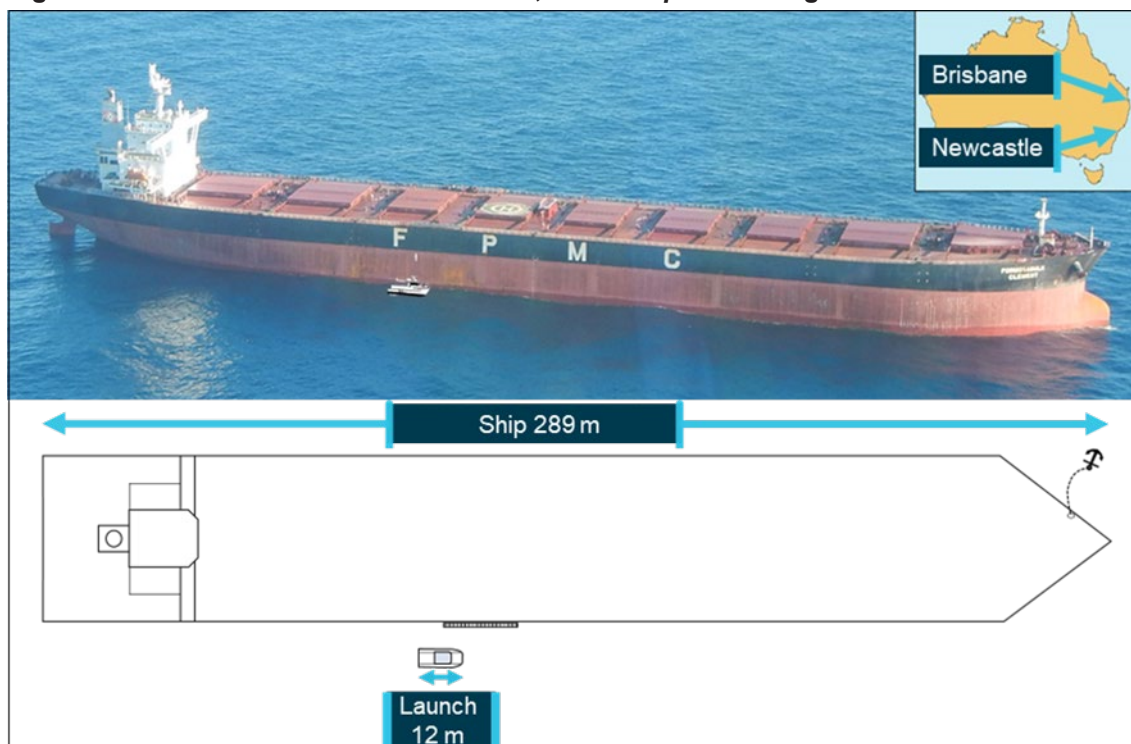
**Figure 1: *Formosabulk Clement* at anchor, PT Transporter alongside**

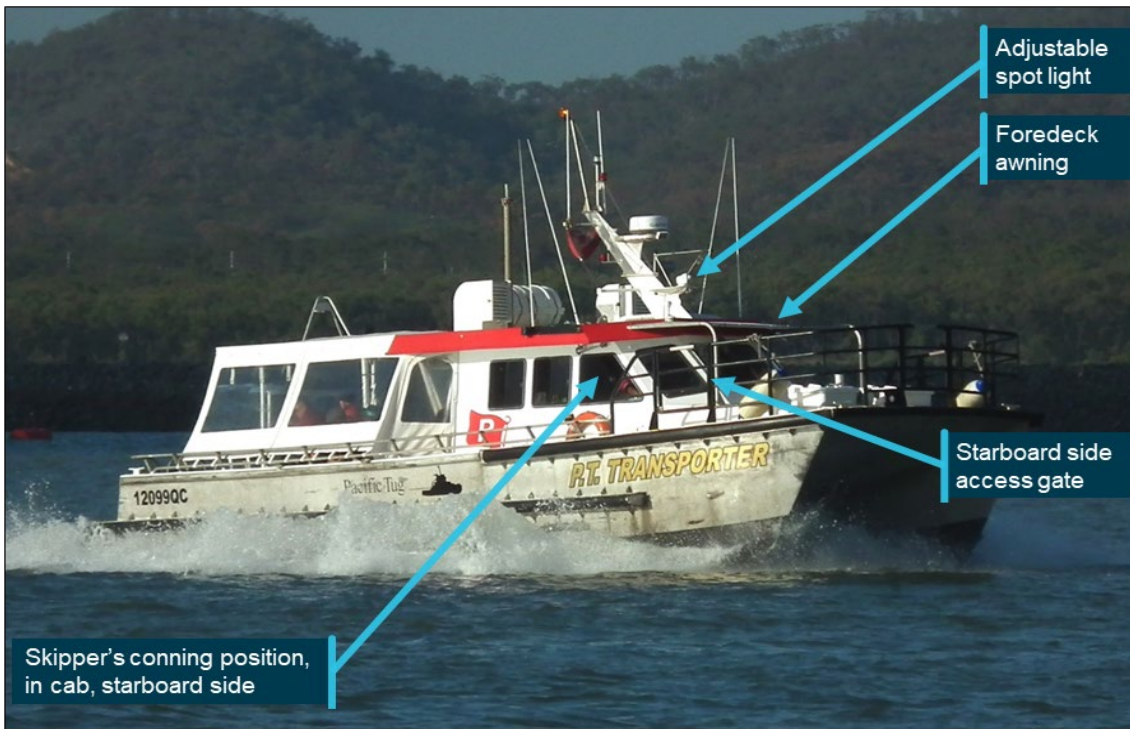
*PT Transporter* (Figure 6) was an aluminium catamaran, built in 1996 and refurbished in 2019 with machinery and fit out changes and upgrades, including main engines and generator. The vessel had a cruising speed of 20 knots and was 11.9 m long, with a breadth of 4.80 m and draught of

*PT Transporter* was in survey to class 1C,<sup>10</sup> certified to carry 2 crew and 23 passengers. It was designed, and predominantly used, for personnel transfer with the foredeck purpose-built for such. Since October 2019, *PT Transporter* had completed 51 personnel transfer operations, 39 of which were to outer anchorages.

**Figure 6: *PT Transporter***
