In-flight break-up, Robinson R44 Raven I helicopter, VH-NBY

3 km north of Broome Airport, Western Australia on 4 July 2020

ATSB Transport Safety Report

AO-2020-033

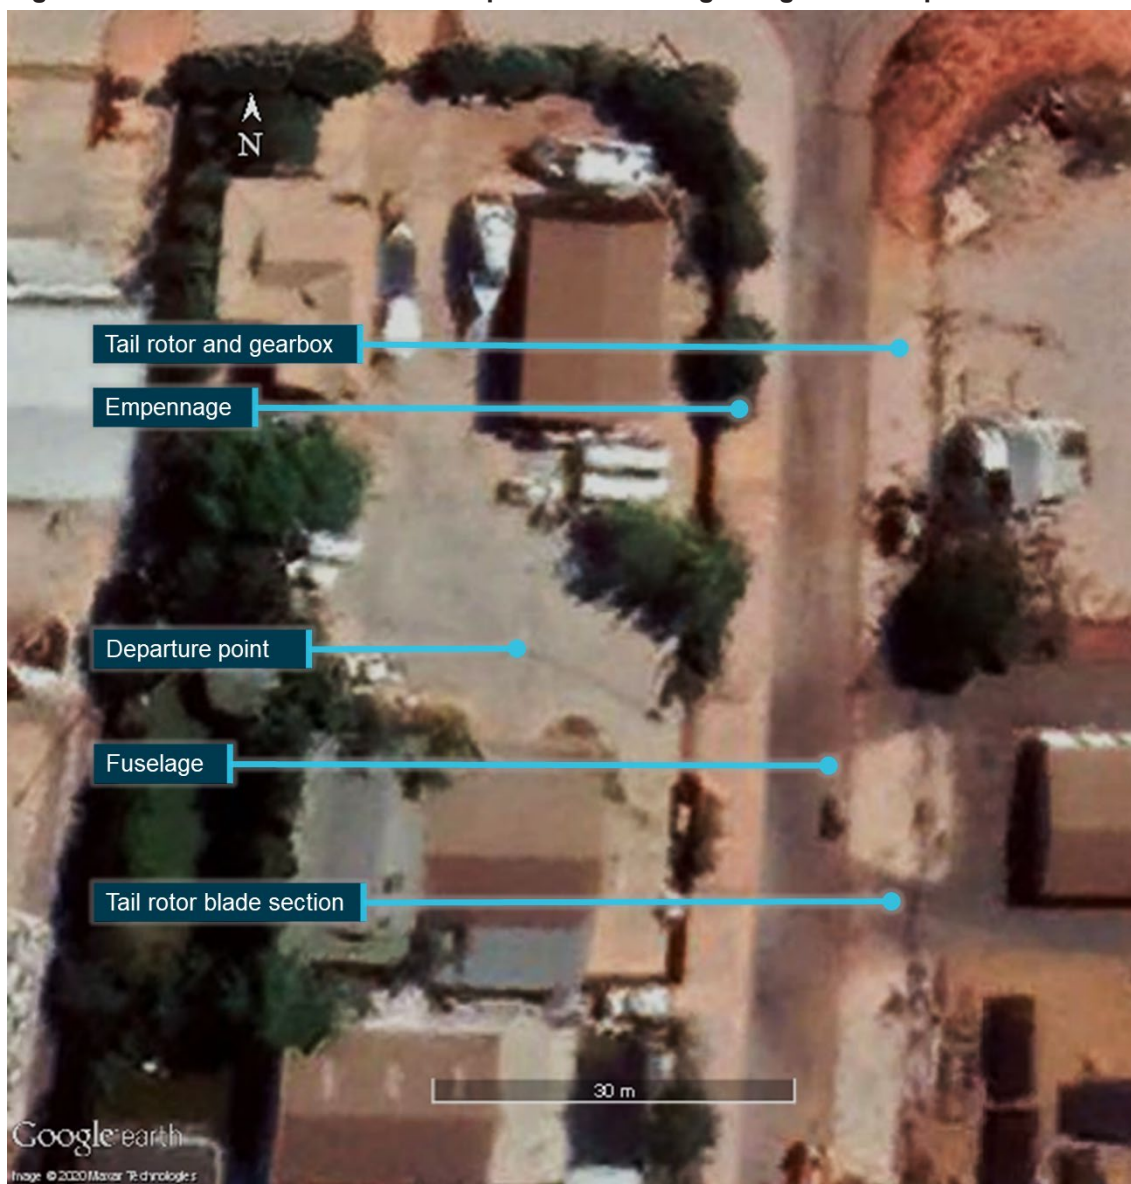
Figure 2: Location of aircraft and components following in-flight break-up

The helicopter continued climbing to about 75 ft while rotating twice to the right with increasing angular velocity, before rolling and descending rapidly toward the ground. The helicopter impacted heavily onto a road surface, about 30 m from the departure point (Figure 2). Calculations from a security camera recording showed that the duration from the first moment of the disturbance of the vertical fin to a total loss of control of the helicopter, was about 2.7 seconds.

The helicopter struck the road surface predominantly on its right side and in a nose-low attitude. The pilot, and a passenger, both seated on the right side of the helicopter were fatally injured. The front and rear left seat passengers were seriously injured. The helicopter was destroyed.

All components of the tail section of the helicopter were accounted for and recovered at the accident site. All fastener and assembly hardware was recovered. Most of the components and fragments were found between 0-36 m to the left of the intended track (Figure 2). There were 4 main wreckage areas comprising the fuselage, tail rotor blade tip, empennage, and tail rotor system, including the tail rotor gearbox (TRGB).

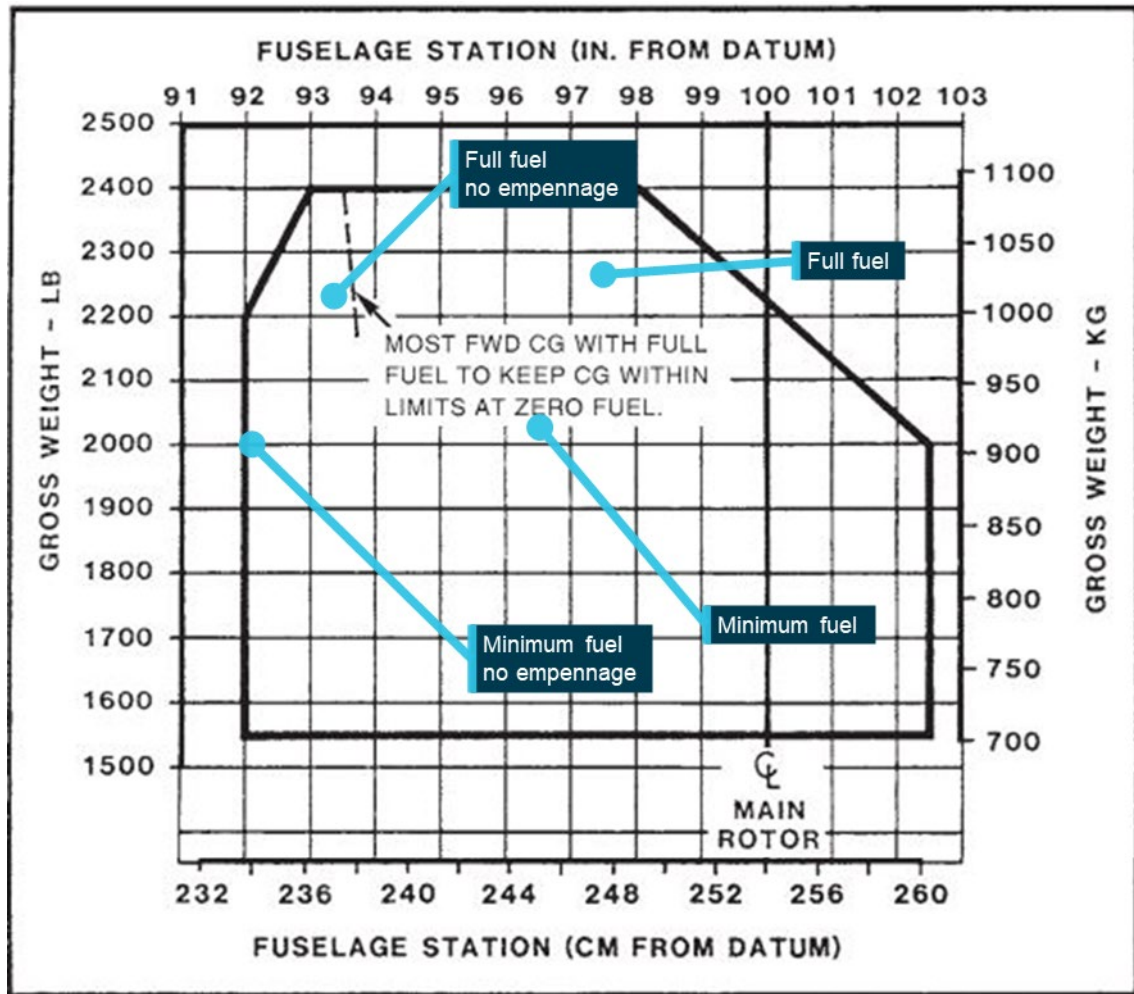
Figure 5: Centre of gravity calculations

The components lost in flight had a direct effect on controllability of the helicopter. Along with the obvious loss in primary yaw control, a significant change of centre of gravity occurred (Figure 5).

While there was a large shift forward in centre of gravity it is highly likely that VH-NBY's centre of gravity remained within limits following the in-flight break-up (Figure 5).

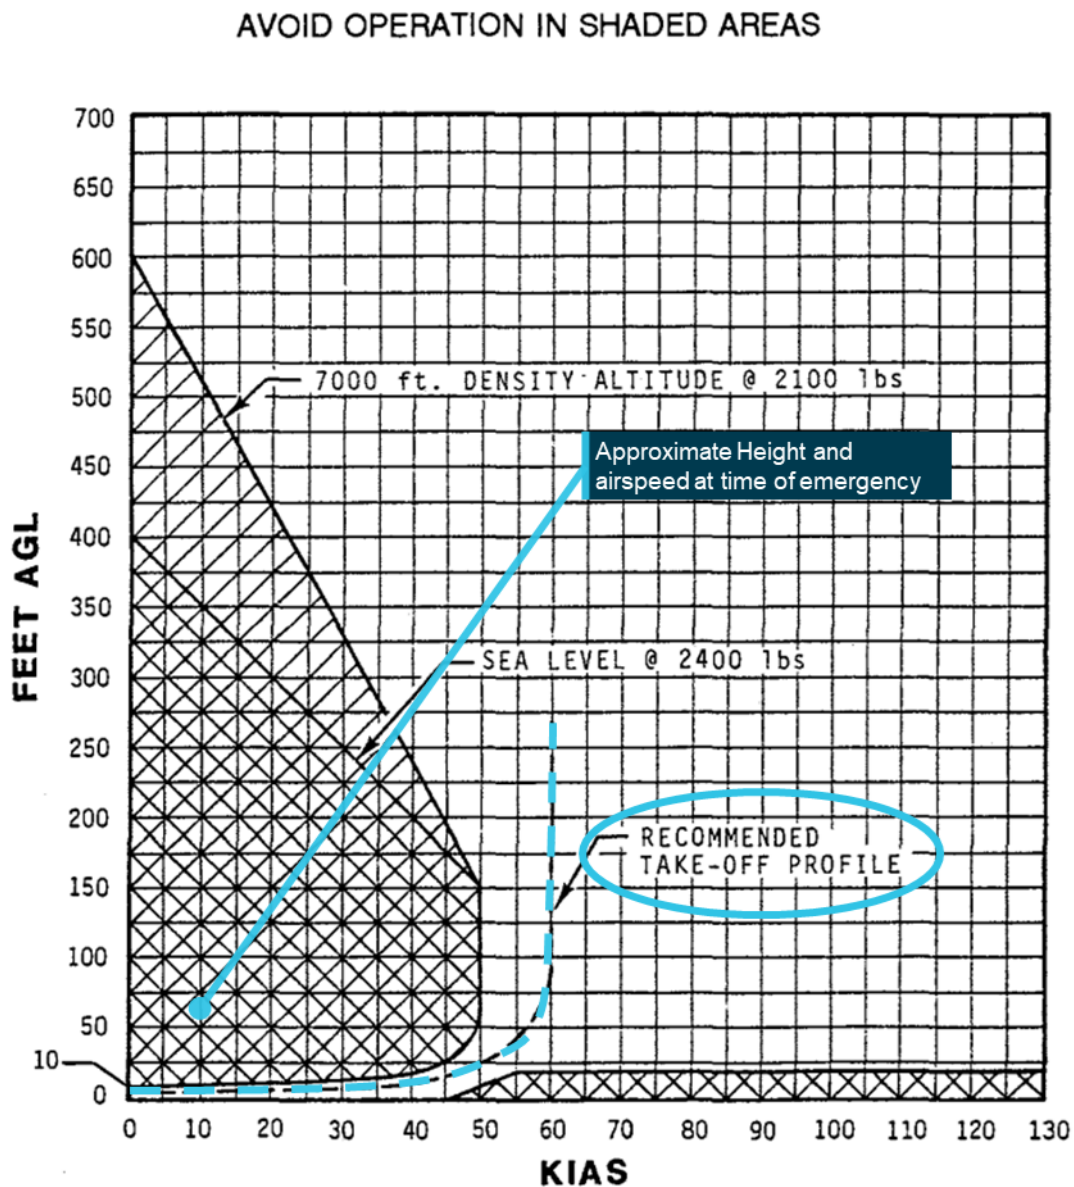
Figure 6: R44 Raven I height / velocity diagram

As shown in Figure 6, at the time the empennage and tail rotor system detached the helicopter was being operated within the R44 height/velocity diagrams 'avoid' area. In practice, this meant that there was probably insufficient total energy to be able to conduct the required power-off landing without damaging the helicopter.

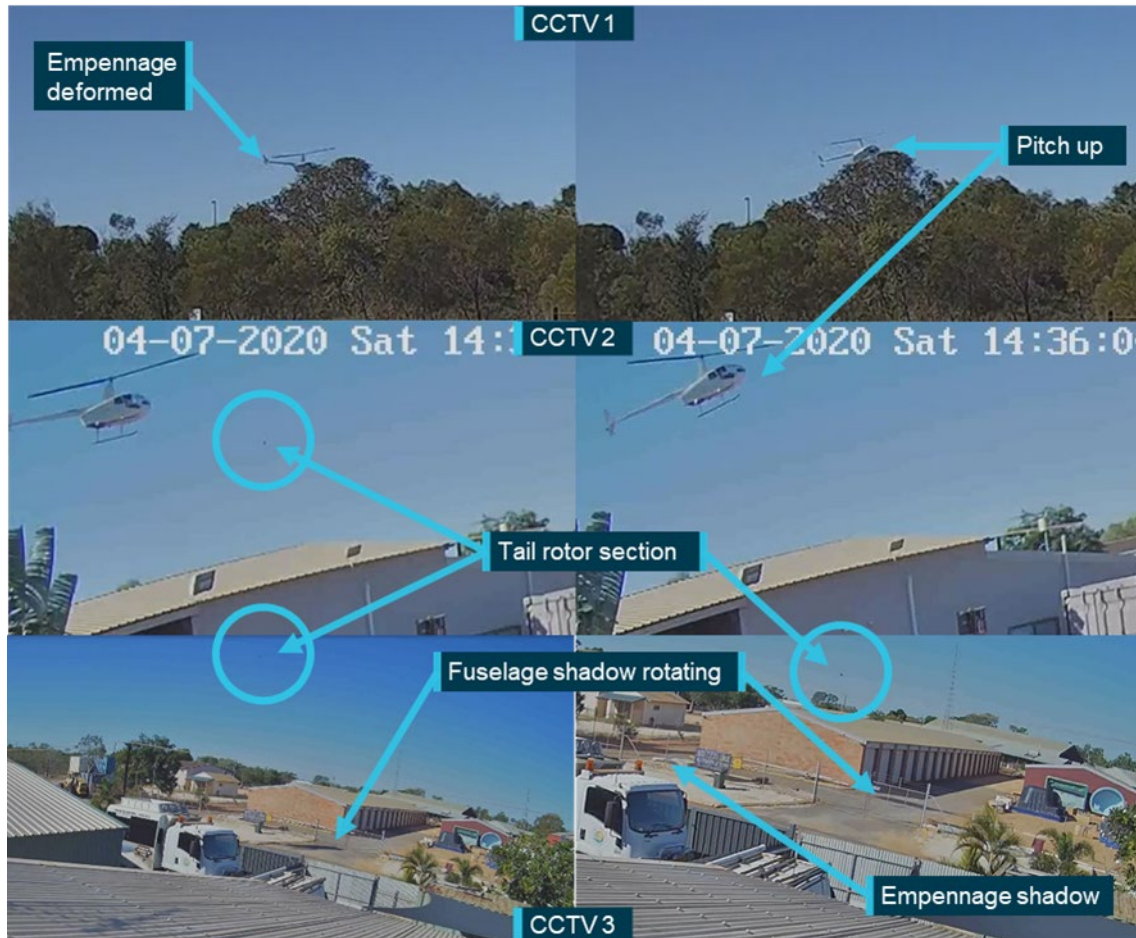
Figure 10: Continuity of the accident sequence on nearby security cameras (CCTV)

7.7	Helicopter continues climb and makes a second full right rotation.		Shadow shows second full rotation.
8.1	Helicopter continues to rotate. It rolls and descends before becoming inverted. The main rotor contacts the right skid and both separate.	Helicopter re-enters frame with 90° right roll before becoming inverted.	Helicopter re-enters frame with 90° right roll before becoming inverted, and impacting ground nose low on its right side.

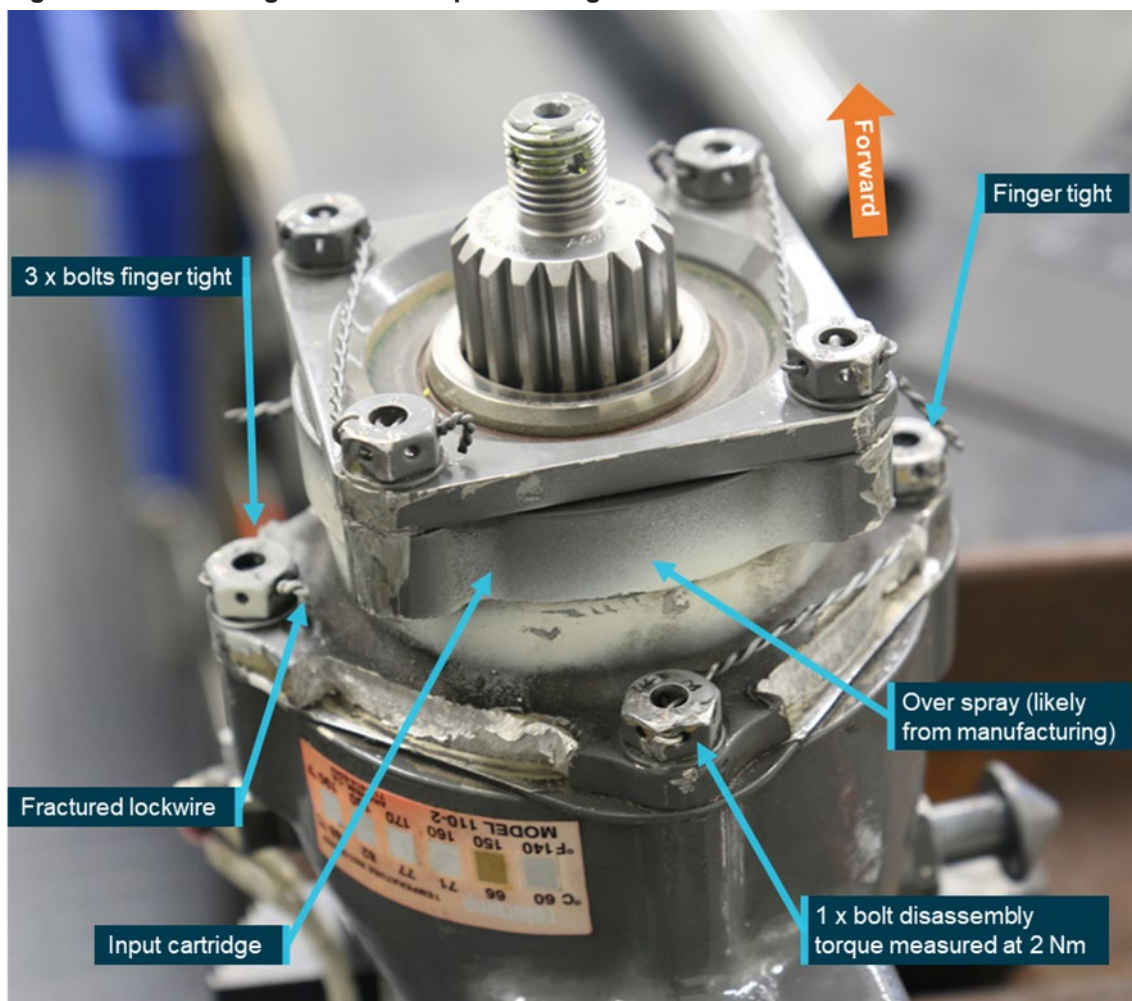
Figure 18: Tail rotor gearbox and input cartridge

The fastening torque of the bolts joining the input cartridge to the tail rotor gearbox casting was identified to be very low. Additionally, the adjoining lock wire that formed a secondary security to the keep the bolts tensioned and in place had been pulled away from the security hole on to the bolt head (Figure 18). The anodised surface at the interface of the input cartridge to the TRGB displayed no wear to the finished surfaces. The contact surfaces for each of the washers was examined and there was no evidence of significant fretting.

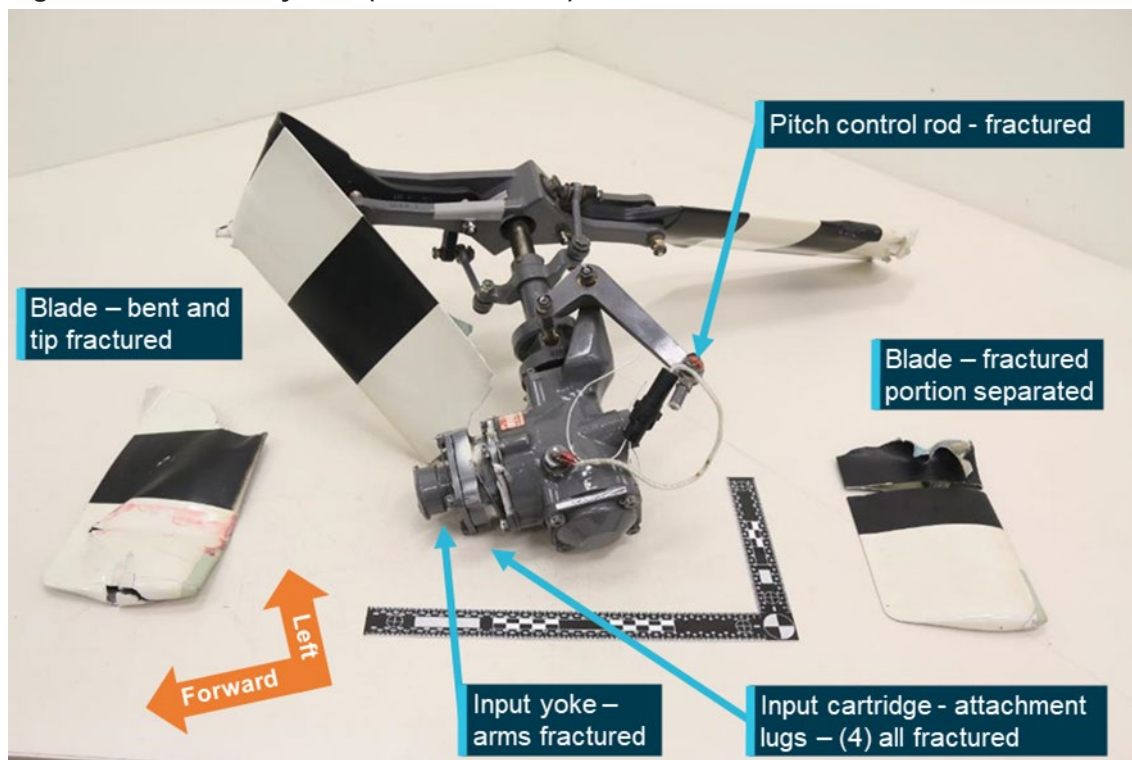
Figure 21: Tail rotor system (underside view)

The examination identified that one tail rotor blade had struck the underside of the tail cone (Figure 20), and tail rotor guard, and a prominent hole had been pierced through the bonded tip cap (Figure 21). The other blade had struck the lower vertical fin (Figure 22).

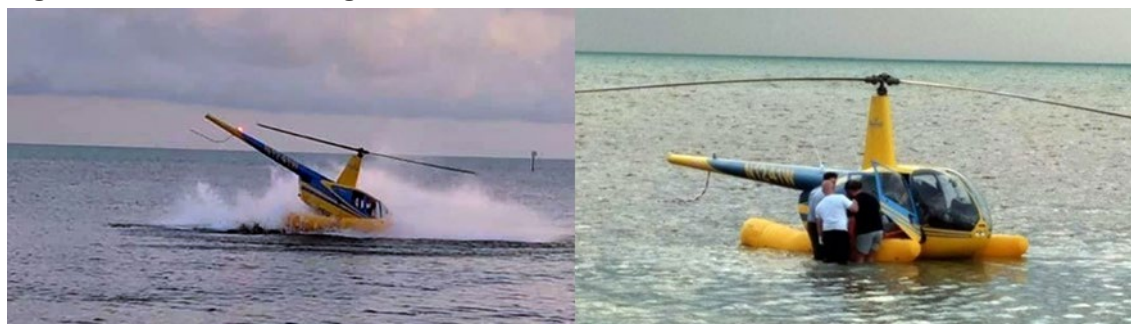
Figure 23: N1241W ditching and evacuation

The pilot of N1241W made a successful ditching following loss of empennage and TRGB (Figure 23). The 3 occupants sustained minor injuries. The NTSB found that 2 of the input cartridge attachment bolts were loose.

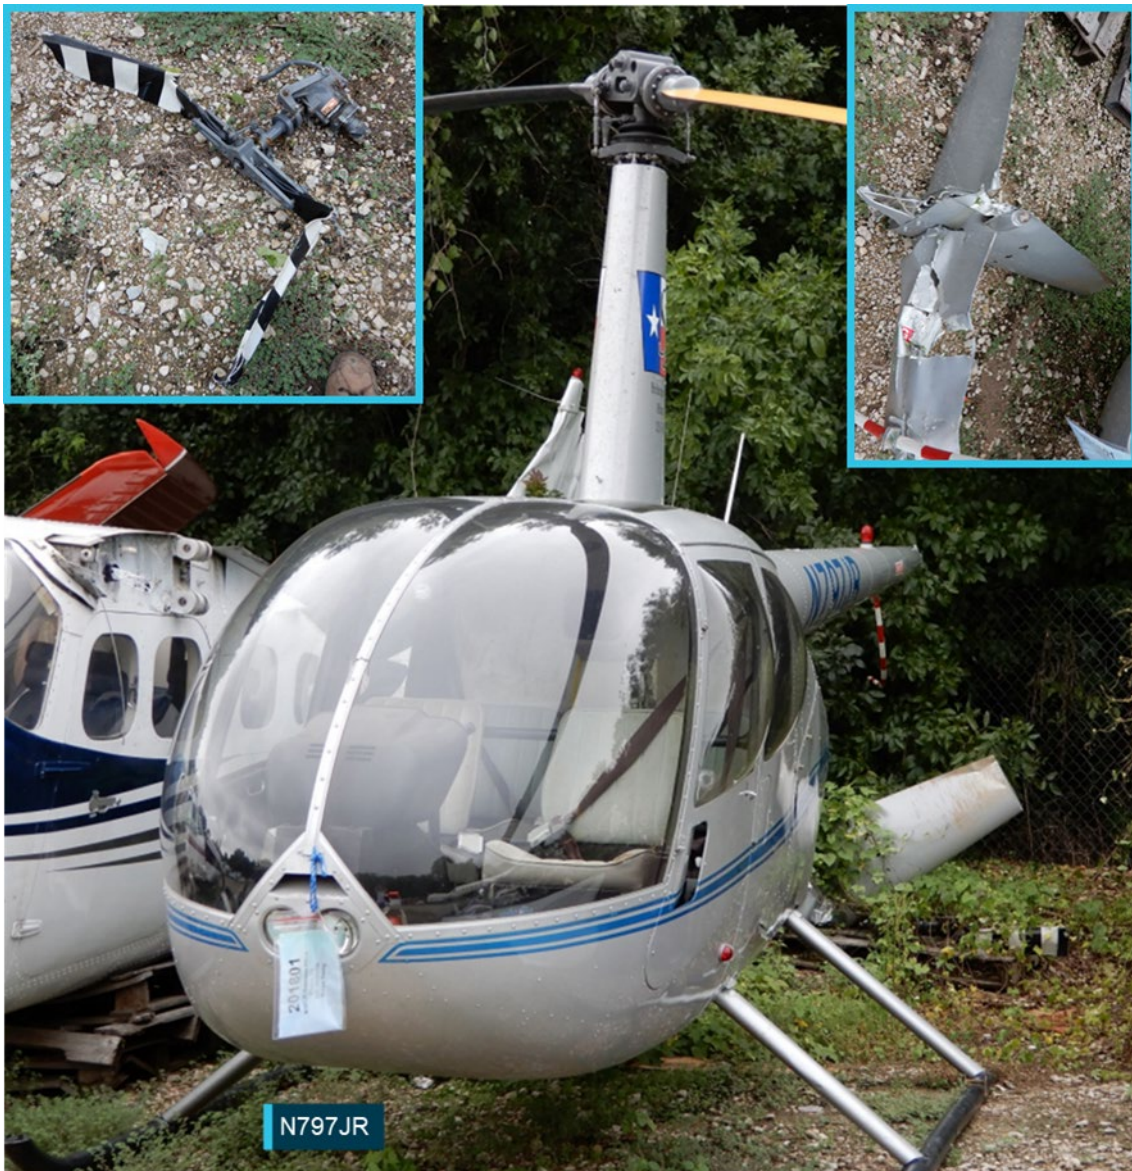
Figure 24: N797JR post in-flight break-up

Figure 24 shows R44 N797JR which experienced in-flight break-up similar to VH-NBY while hovering at a height of 50 ft (see the section titled *Previous occurrences*). The pilot reportedly followed the POH emergency procedure and, even though operating in the 'avoid' area of the height/velocity curve chart, the severity of the ground impact was cushioned by the energy remaining in the main rotor system, and the helicopter's skid gear. There was one person on board who had minor injuries.

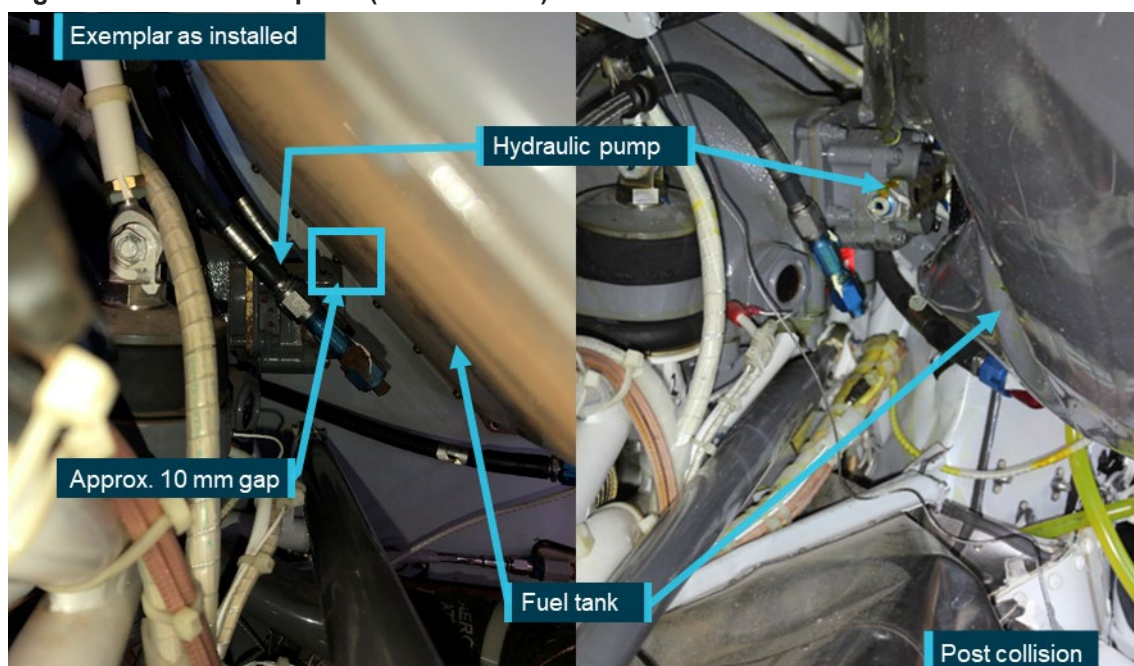
Figure 26: Fuel tank rupture (view forward)

The aluminium skin of the fuel tanks fitted to VH-NBY split at the riveted joints upon impact. The left tank ruptured, but the fuel bladder remained intact, retaining its fuel. The right tank ruptured and the bladder was punctured on impact by the hydraulic pump which was co-located with the main rotor gearbox (Figure 26).

The puncture allowed the release of fuel, but at a low rate (Figure 27). An unknown quantity of fuel leaked from the bladder and attending fire services contained the spill. About 30 L of fuel remained in the helicopter. Given the previously-observed rupturing of aluminium fuel tanks during significant impact, without the fuel bladders, the risk of a post-crash fire would probably have been significantly higher.

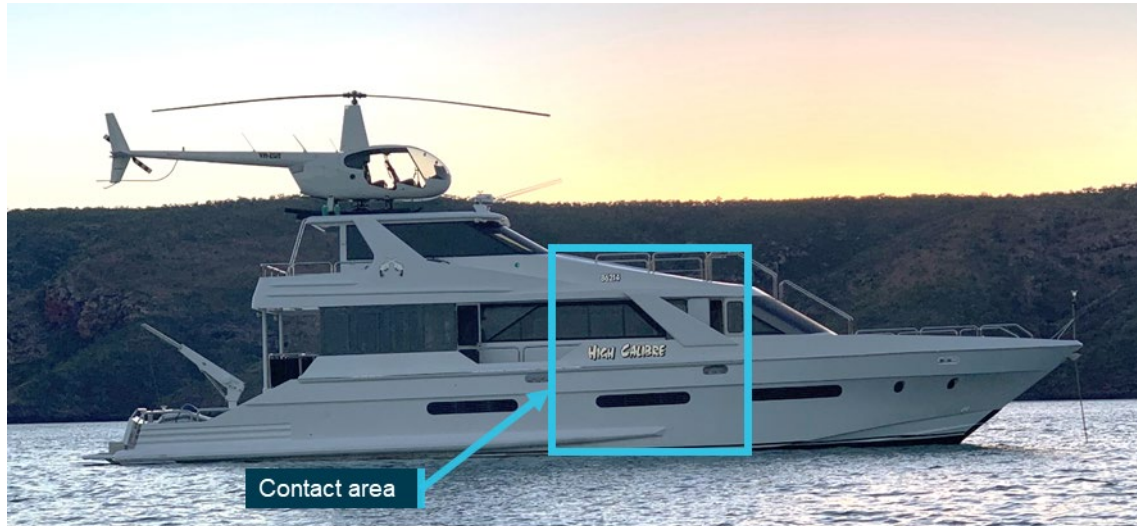
Figure 31: VH-ZGY on High Calibre

It is possible that control was lost due to the helicopter remaining tethered. Alternatively, if it had recently landed and was untethered, a mishandled departure may have initiated the roll over. The helicopter was not inspected and the actual cause of the rollover was not determined.

The front left occupant had serious injury, the owner sat front right, had severe bruising, and the rear right passenger had minor injuries. The helicopter was destroyed. The Civil Aviation Safety Authority confirmed the loss of VH-ZGY with an insurance agent, and the helicopter was not recovered. High Calibre had significant damage and the hull was penetrated above the water line. High Calibre was repaired in a remote location 11 days later.
