# Engine failure involving de Havilland Canada DHC-2 Beaver, VH-AAX

Moruya Airport, New South Wales, on 4 April 2022

Aviation Occurrence Investigation (Short)

AO-2022-025

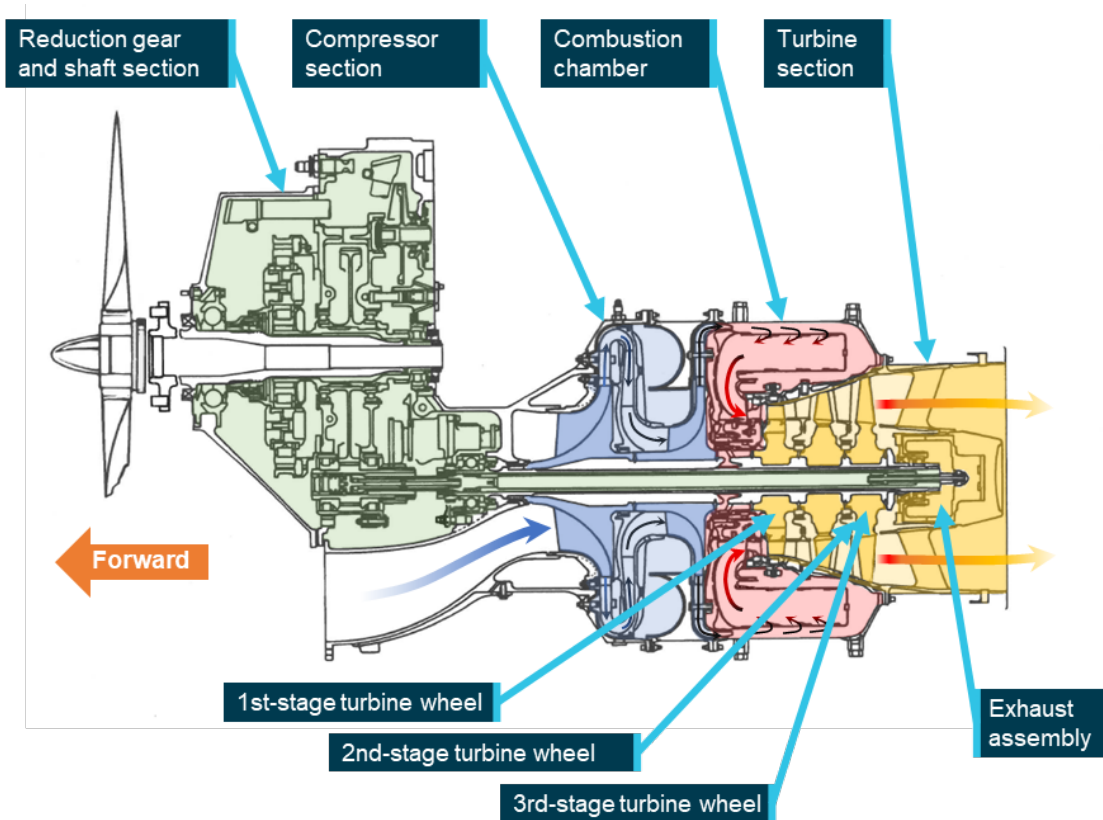
**Figure 4: Schematic of Honeywell TPE331-2-201A Engine**

The engine fitted to VH-AAX was a Honeywell International Inc (formerly AlliedSignal, Garrett, and AiResearch) model number TPE331-2-201A, turbo-propeller engine (Figure 4), serial number P90018C. It consisted of:

- a 2-stage centrifugal compressor
- an annular combustion chamber
- a 3-stage axial turbine
- a reduction gear and shaft section.

The turbine section contained the 1st, 2nd and 3rd-stage turbine wheels. The exhaust assembly was considered part of the turbine section.

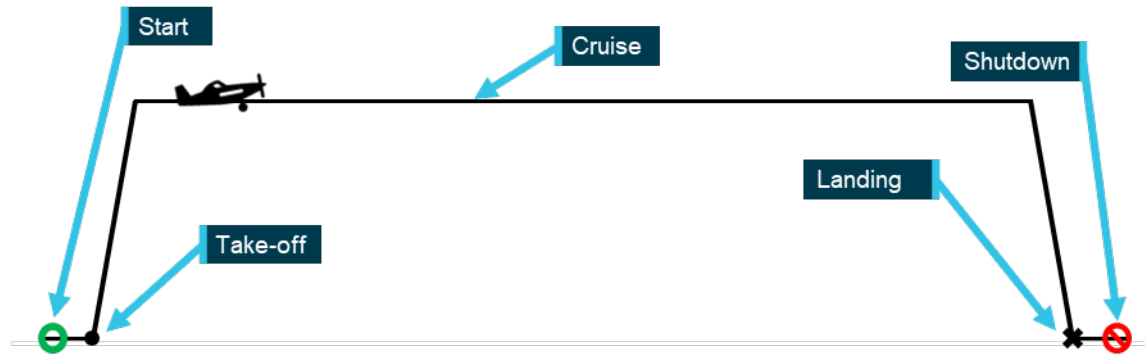
**Figure 8: Example of a passenger transport flight corresponding to a single engine cycle**

The previously established cycle counting and life limits for life-limited parts used in Honeywell TPE331 turboprop engines were based on a cycle that consisted of an engine start, aircraft take-off, cruise, landing, and engine shutdown (Figure 8). This is typical of a passenger transport flight. Applying this, an engine component such as a turbine wheel, would accrue a single cycle for each engine start/shutdown, irrespective of how many landings occurred.

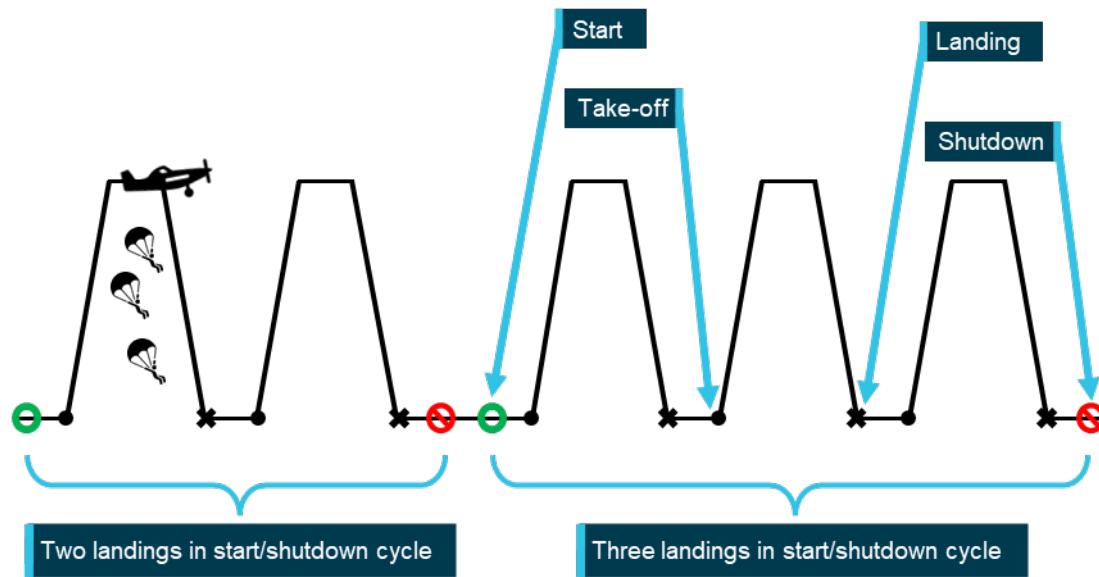
**Figure 9: Example of a special-use operation requiring an equivalent cycle calculation**

The AD required implementation of a new flight cycle counting method, which involved tracking ‘equivalent cycles’ for turbine wheels in aircraft undertaking special-use operations (Figure 9). An equivalent cycle incorporated a damage fraction factor for each additional landing that occurred with no engine shutdown followed by a take-off. This was in addition to the cycle for one landing associated with the start/shutdown as shown in Figure 8. Total equivalent cycles were the sum of equivalent cycles for all operational flights.

Note: Schematic showing hypothetical day of operation for an aircraft used for 'special-use' operations. This example shows a total of 2 shutdowns and 5 landings.  
Source: ATSB
