# Fuel exhaustion and collision with terrain involving Robinson R44 II, VH-IDW

King River, Northern Territory on 28 February 2022

ATSB Transport Safety Report Aviation Occurrence Investigation (Systemic) AO-2022-009 Final – 22 November 2023 Cover photo: Dallas Presser

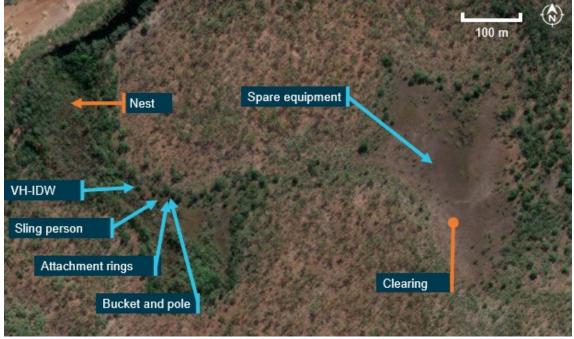
Figure 4: Accident trail

Based on photos and reports from those who attended the site on the accident day, the egg collector's bucket and pole were the first items in the accident trail (Figure 4). The pole was vertical with one end embedded in the ground. About 4 m beyond the pole, the long line attachment rings were found, also embedded in wet ground, with the long line loosely coiled over about 8 m. The egg collector was found wearing a harness, which was intact, firmly secured and attached to the long line, and their helmet was on the ground nearby. The long line was not connected to the helicopter.

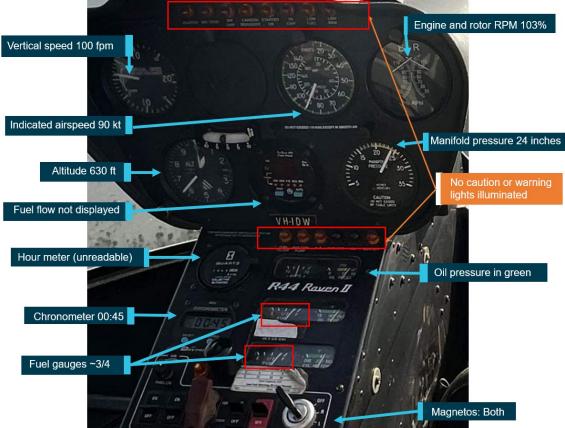
Figure 10: Cut-out of in-flight photo taken at 0743 showing cockpit indications

A georeferenced in-flight photo was taken at 0743 on the accident morning, 111 km beyond Noonamah and 94 km prior to the Mount Borradaile refuelling stop, on a direct track between the 2 locations (Figure 10). The photo showed:

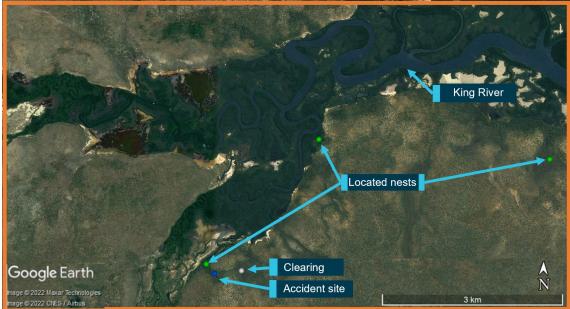
Figure 12: Inset from Figure 11 showing nests in the vicinity of the accident site with the status of 'located' on the Crocpad data

The accident pilot reported that one of the nests in the vicinity of the accident site could be collected on foot (without slinging). It was not known whether the crew of VH-IDW visited that nest before slinging towards the target nest where the accident occurred. However, the first person to attend the accident site reported no eggs had been collected and there was no indication any of the nests in the area had been visited.

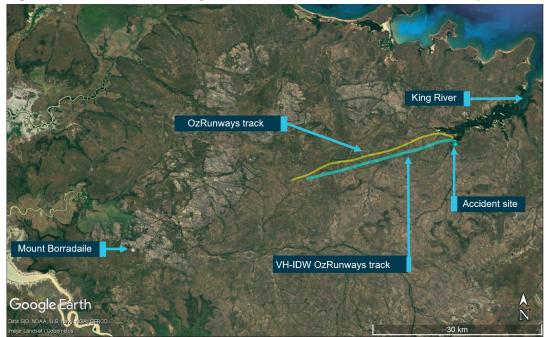
Figure 13: Recorded OzRunways tracks of VH-IDW and another R44 helicopter

OzRunways flight path data was obtained for 2 of the R44 helicopters, including VH-IDW. The data contained tracks commencing about halfway between Mount Borradaile and the King River, and ceasing near the clearing where VH-IDW and its crew were last seen prior to the accident (Figure 13). The data for VH-IDW was recorded on the egg collector's iPhone from 0841:28 to 0850:13 local time and uploaded to the OzRunways server. The data covered about 15 NM, equating to a ground speed of about 100 kt. The other track was from 0840:22 to 0850:15, indicating the 2 helicopters were operating in company.
