Level crossing collision between passenger train E820 and road vehicle

Wynnum West, Queensland, on 26 February 2021

ATSB Transport Safety Report

RO-2021-005

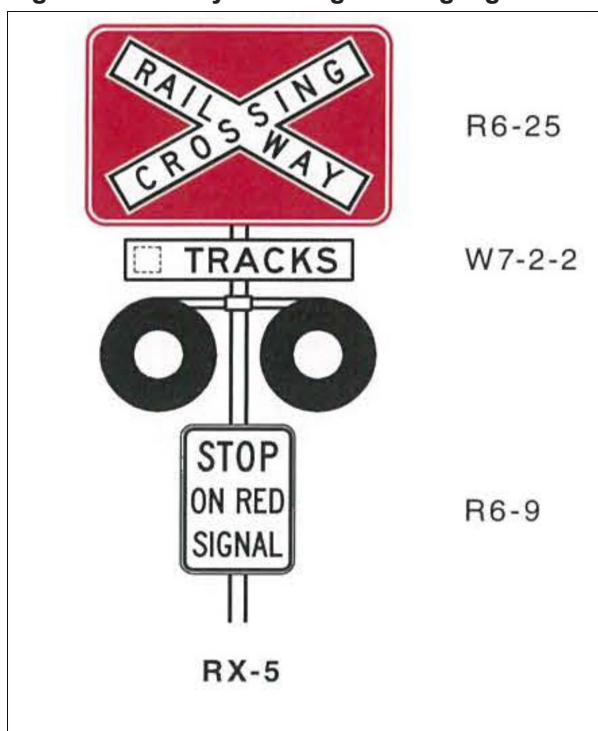
Figure 4: Railway crossing flashing signal assembly (RX-5)

Post-accident functionality testing and an on-site observation conducted by QR, which included the warning devices at the level crossing, identified the flashing signals of the assembly were operating correctly.

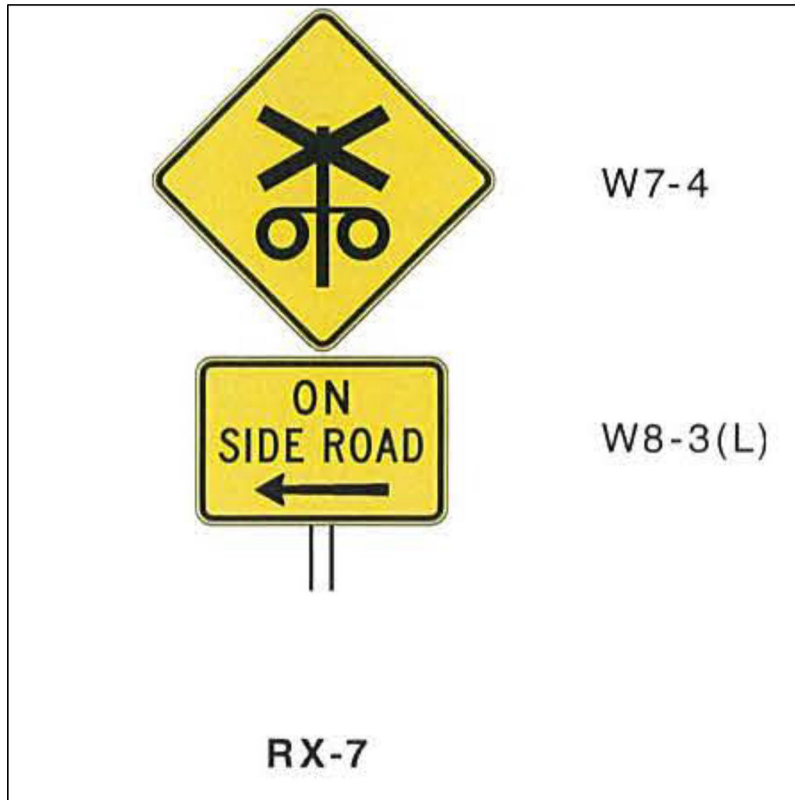
Figure 5: Railway crossing flashing signals ahead on side road assembly (RX-7)

An inspection of road signage, conducted by QR on 3 March 2021, identified an RX-7 assembly on the left side of Lindum Road about 80 m from the intersection, however, the W8-3 sign was missing from the assembly. It could not be determined if the W8-3 sign was in place at the time of the accident.
