# VFR into IMC and controlled flight into terrain involving Cessna R182, VH-EHM

36 km north-west of Archerfield Airport, Queensland on 29 August 2022

## ATSB Transport Safety Report

AO-2022-041

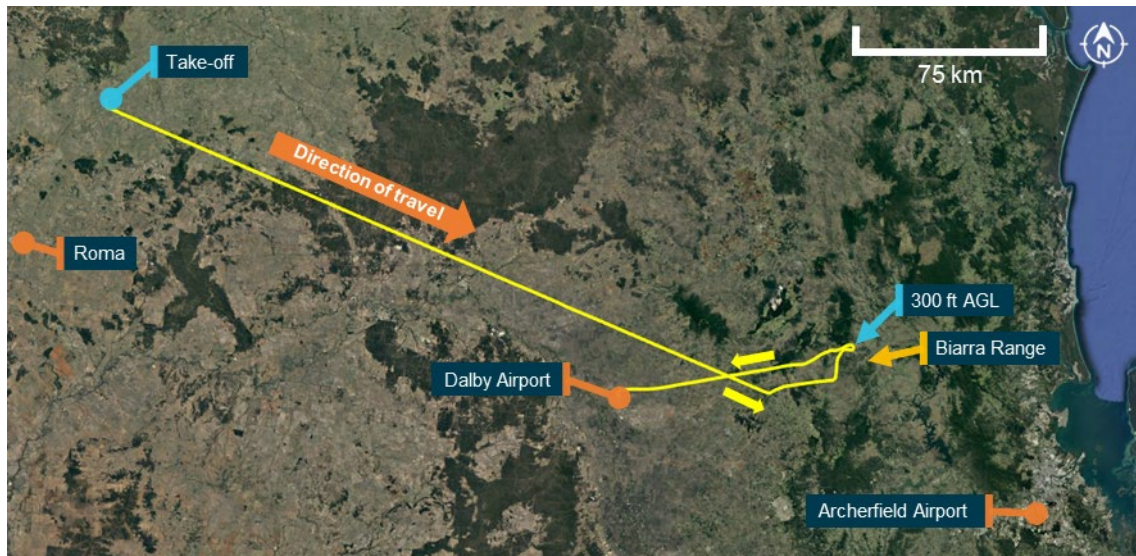
**Figure 1: Flight to Dalby Airport**

The following day, VH-EHM departed Lighthouse at 0715 local time with the pilot, 2 passengers, and pet dog, for an air transport<sup>1</sup> flight under the visual flight rules (VFR)<sup>2</sup> back to Archerfield (Figure 1). Recorded flight data showed the aircraft was initially established on a direct south-easterly track towards Archerfield at cruise altitudes between 3,400 ft and 3,900 ft above mean sea level (AMSL).<sup>3</sup> The en route weather forecast valid at the time of departure indicated low cloud, rain, fog and associated reduced visibility (see the section titled *Meteorological information*).

At about 0850, the pilot was contacted by a person via mobile phone. During the conversation, the pilot reported some weather on the range and their intention to refuel at Dalby before attempting to find another way to Archerfield. At 0901, the aircraft landed at Dalby and was refuelled with about 263 L of fuel.

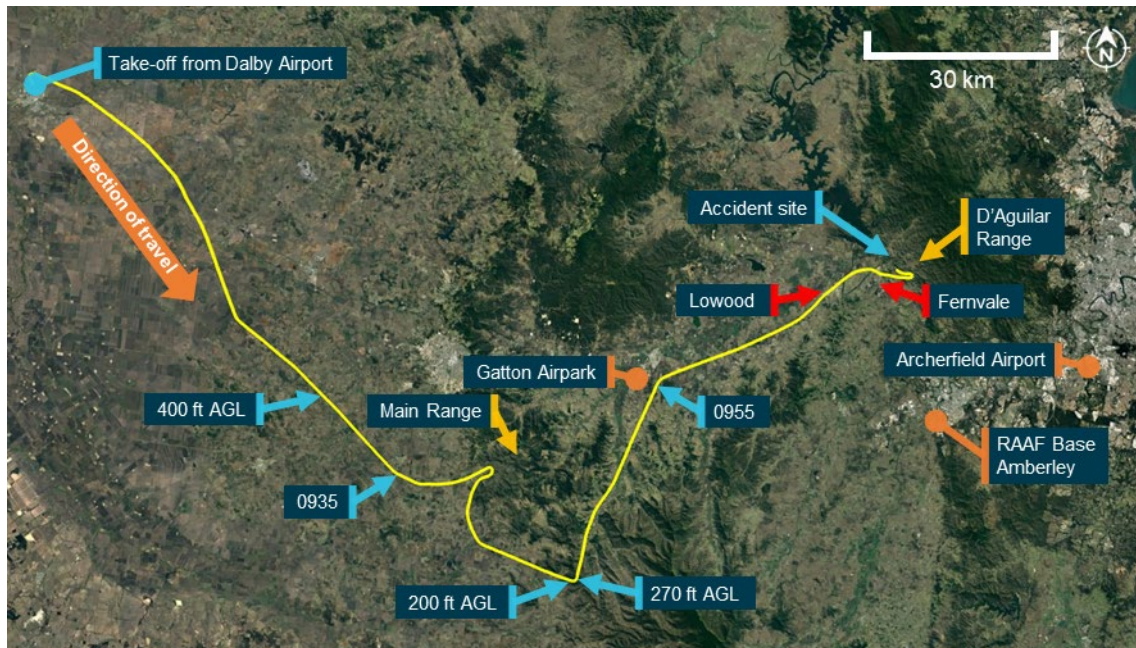
**Figure 2: Accident flight**

(Figure 2). At 0935, the pilot turned left towards Main Range, and about 8 km later, completed a 180° turn between 300–500 ft AGL before tracking south-east and climbing to about 2,500 ft (1,000 ft AGL).

At 0946, the aircraft passed over a mountain ridge at about 2,800 ft (200 ft AGL) before conducting a 90° left turn over another ridge at about 2,900 ft (270 ft AGL). VH-EHM then tracked to the north-east, and descended down the range to an altitude of about 1,200 ft (700 ft AGL).

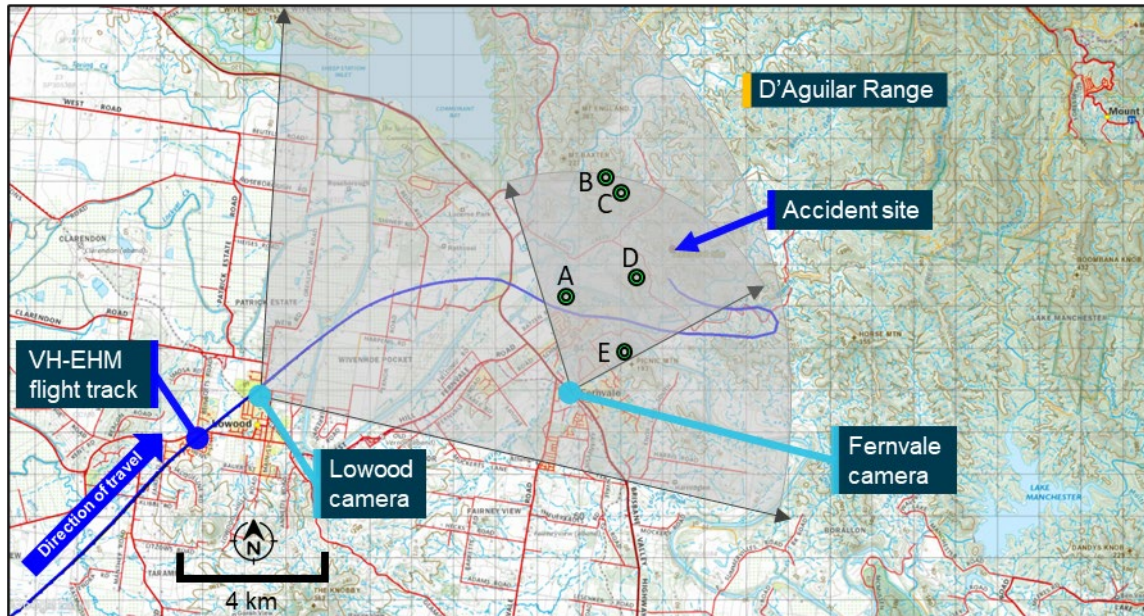
**Figure 8: Map showing camera field of views, identifiable points (A to E), and flight track**

Surveillance video cameras from Lowood and Fernvale provided information on the weather around the time of the accident. The field of view of each camera was determined (Figure 8), alongside identifiable mountain peaks (labels A to E).

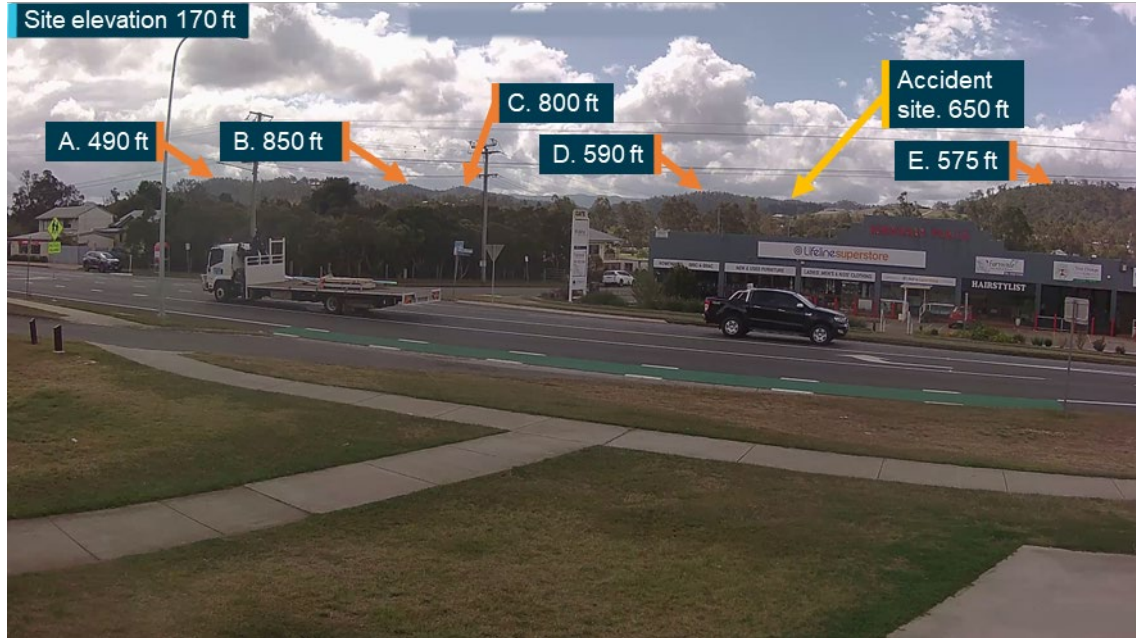
**Figure 10: Image from Fernvale showing the D'Aguilar Range in clear conditions**

Another surveillance video camera from Fernvale, located about 4.2 km south-west of the accident site, provided video observations of the weather conditions surrounding the accident site. An exemplar image from the video is provided to show identifiable peaks of the D'Aguilar Range and their elevations in clear conditions (Figure 10).

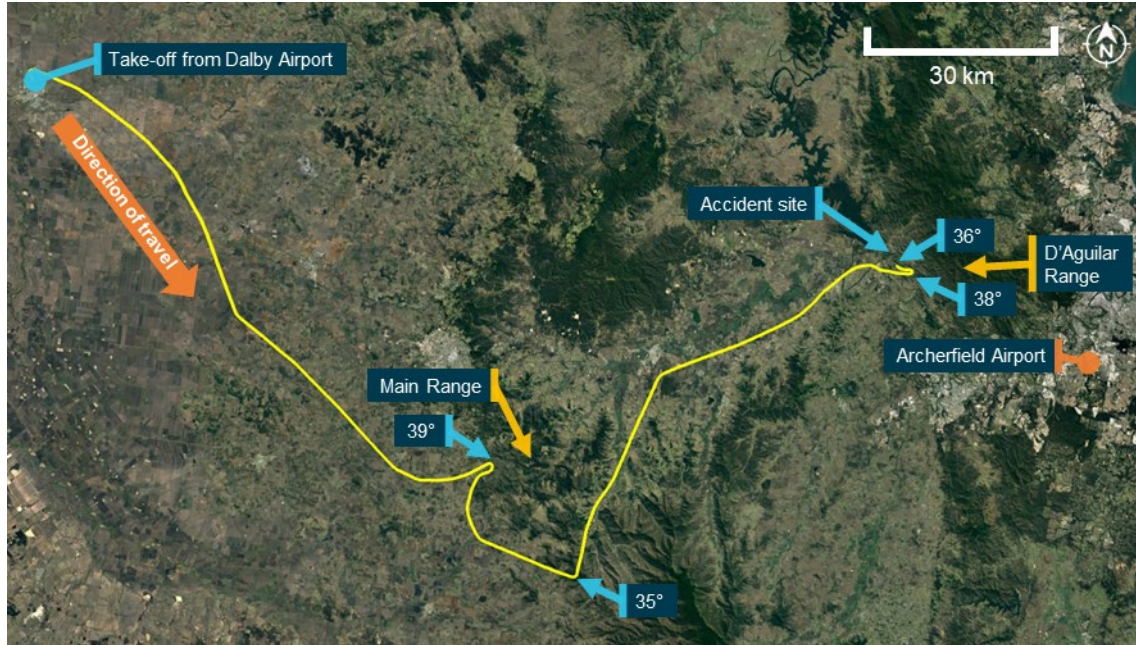
**Figure 12: Significant turns during flight**

- The aircraft made 4 significant turns during the accident flight including 2 course reversals. Based on flight data, the 2 turns around the Main Range (including a 180° course reversal) had estimated average bank angles of 35° and 39°. The 2 turns near the D'Aguilar Range (including the turn leading up to the accident) averaged 38° and 36° indicating they were made in the course of controlled flight similar to the previous turns (Figure 12).

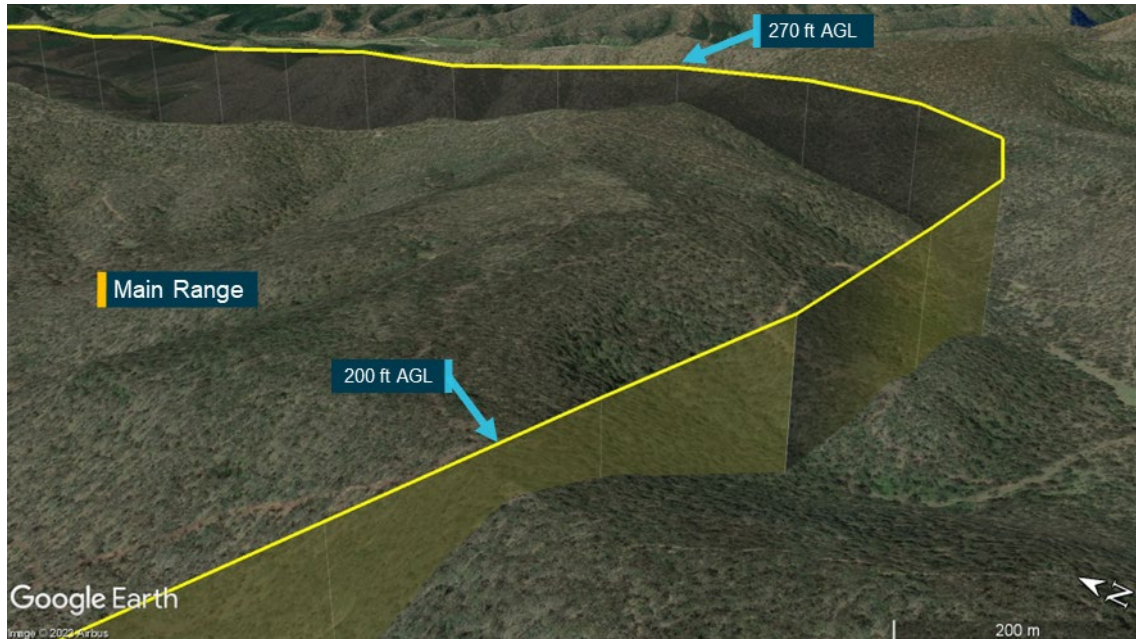
**Figure 13: Low-level flight over Main Range**

- The aircraft was flown below 500 ft AGL<sup>29</sup> on several occasions during the accident flight, with the lowest being about 200 ft AGL (Figure 13). Since the terrain elevation data did not account for vegetation or structures, it was likely that there were lower vertical clearances during the flight.
