Mid-air collision involving SIAI Marchetti S-211s, VH-DZJ and VH-DQJ

25 km west of Tyabb Airport, Victoria, on 19 November 2023

ATSB Transport Safety Report

Aviation Occurrence Investigation AO-2023-057 Preliminary – 17 January 2024 Released in accordance with section 25 of the Transport Safety Investigation Act 2003

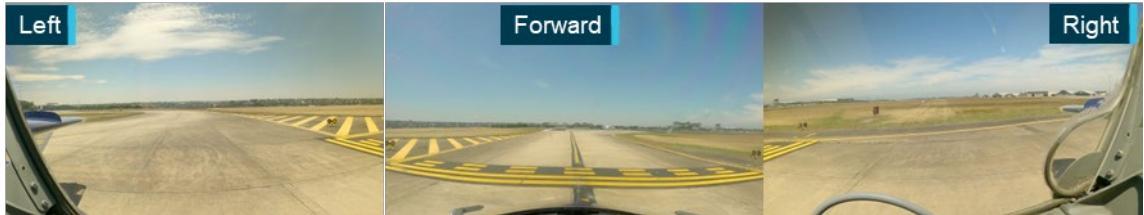
Figure 8: The recorded views of the cameras fitted to VH-DQJ

There were 4 cameras fitted to Viper 1, of which 3 recorded video and audio during the flight (Figure 8), including the collision. The cameras were mounted on each side of the front seat headrest, looking left and right, on the glareshield looking forward and one mounted on the instrument panel facing the control column. The camera facing the control column stopped recording before departure while the cameras facing forward and left stopped filming during the return flight to Essendon. The right facing camera stopped filming after the flight as the crew exited the aircraft.
