Collision with terrain involving Cessna 172, VH-JUA

1 km north-east of Murwillumbah, New South Wales on 15 October 2023

AO-2023-048

Final – 14 February 2024

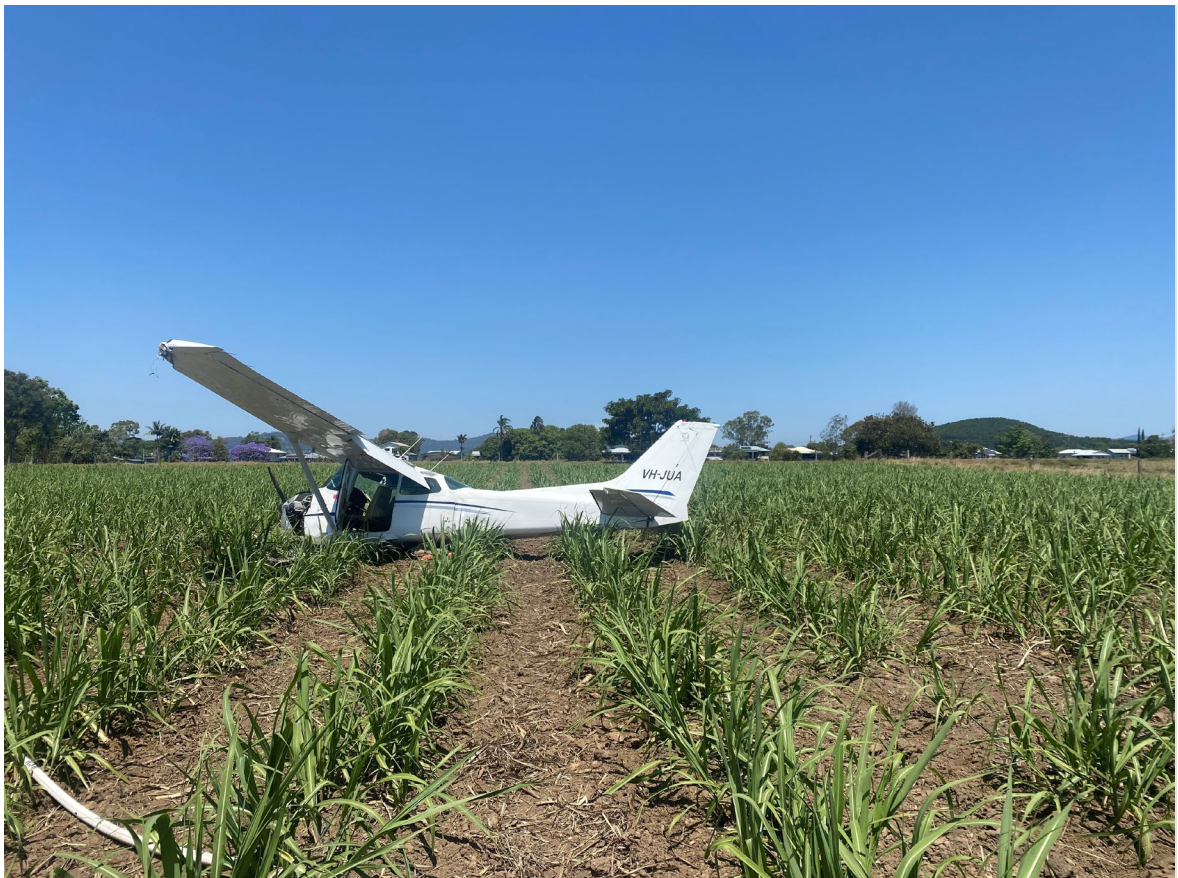
Cover photo: Photo courtesy of NSW Police.

During the final approach, the pilot estimated that the aircraft was too high for a landing and elected to conduct a go-around. During the go-around, the aircraft did not climb as expected resulting in the pilot conducting a forced landing about 1km north-east of the airport. The aircraft was substantially damaged and the pilot sustained minor injuries.
