Fuel starvation and collision with water involving Rockwell International 114, VH-WMM

1 km north of Redcliffe aircraft landing area, Queensland, on 19 December 2021

ATSB Transport Safety Report

AO-2021-053

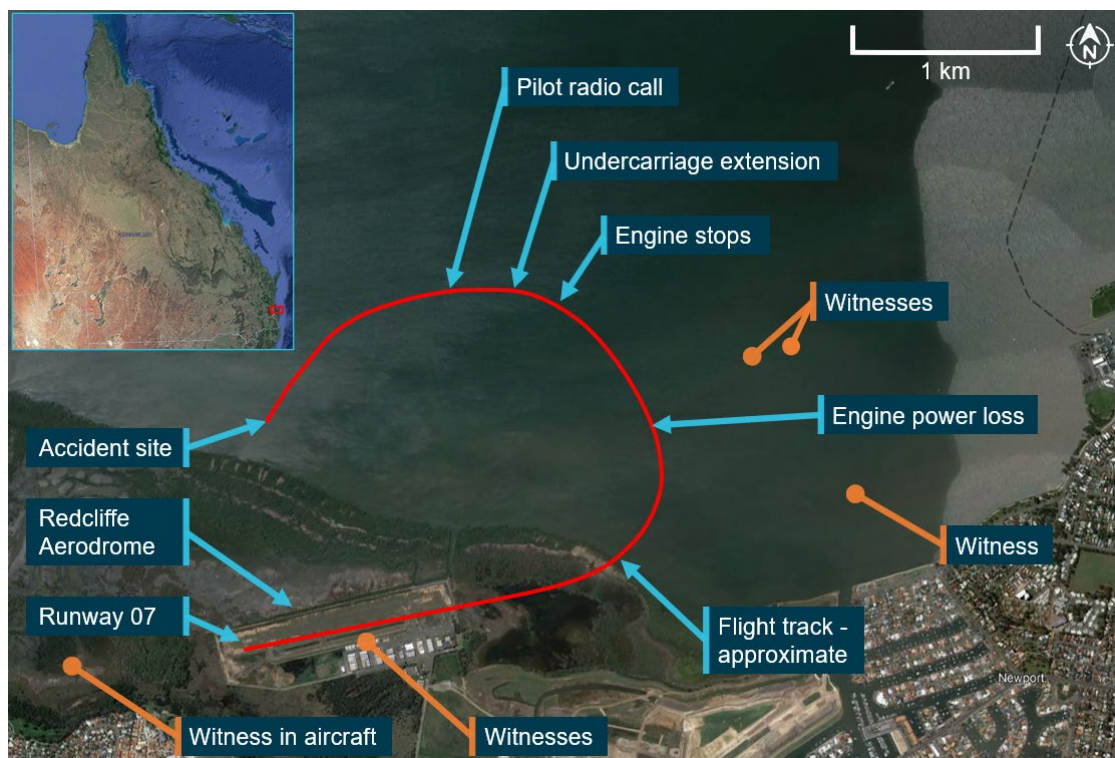
Figure 1: Redcliffe aircraft landing area and VH-WMM approximate flight path and accident site

A passenger video (see [Appendix - Sequence of events](#)) was recovered from a mobile phone which showed portions of the taxi, before take-off checks, and the accident flight. Several witnesses at the airfield, in boats near the airfield, and in other aircraft also observed the flight of VH-WMM (Figure 1).
