# Drive shaft failure and loss of control involving Garlick Helicopters UH-1H, VH-UHX

36 km north of Launceston, Tasmania on 14 February 2022

ATSB Transport Safety Report Aviation Occurrence Investigation (Defined) AO-2022-006 Final – 12 March 2024 Cover photo: Jamie Davis

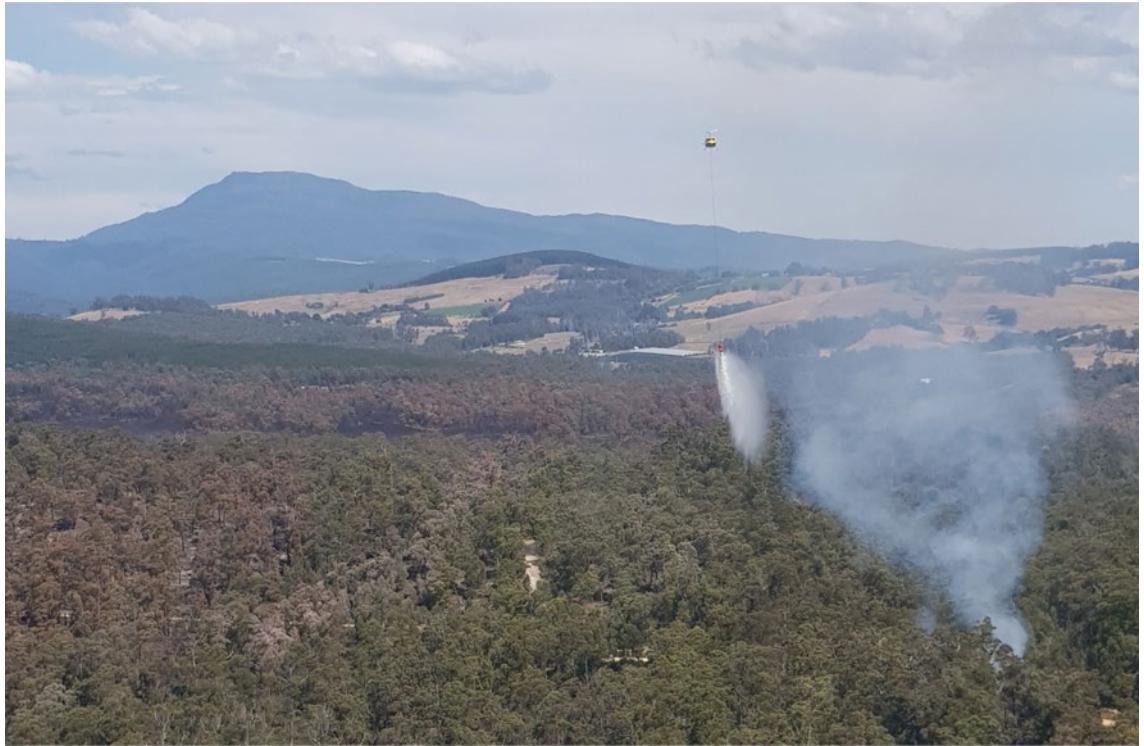
Figure 3: VH-UHX releasing the underslung bucket contents at a considerable height and distance away from the spot fire (smoke plume)

Personnel onboard the air attack supervising helicopter (Firebird 460) captured several images and a short video of VH-UHX approaching the designated spot fire. One of the images showed the early release of water from the underslung bucket (Figure 3). The video file recorded by another passenger commenced in the moments after the water had been released and showed VH-UHX in a left turn (Figure 4). The video did not capture the yawing movement reported by the pilot-witness at the TFS staging area.

The image was captured by a witness onboard Firebird 460. Metadata identified that the image had been captured at timestamp 1514:42 Source: Rod Sweetnam

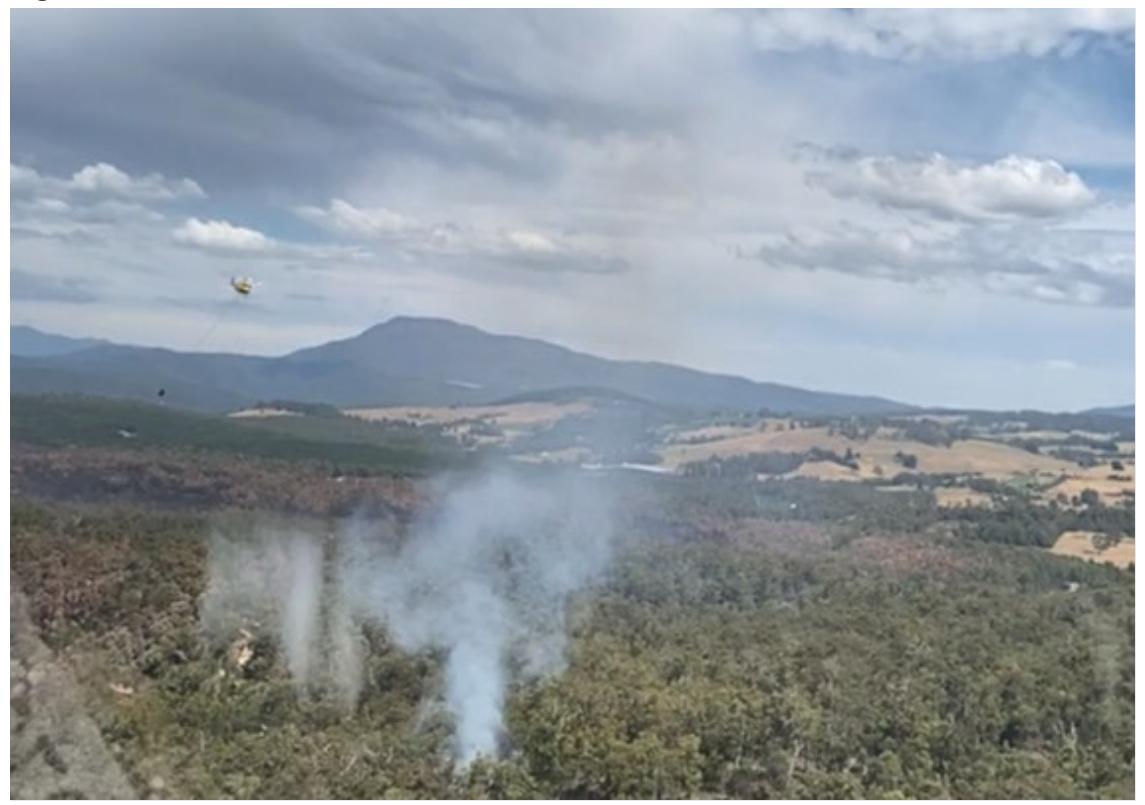
Figure 4: VH-UHX in a left turn moments after the water release

This image is cropped from a video file captured by TFS personnel within Firebird 460 and shows the empty underslung bucket trailing VH-UHX Source: Tasmania Fire Service, modified by ATSB

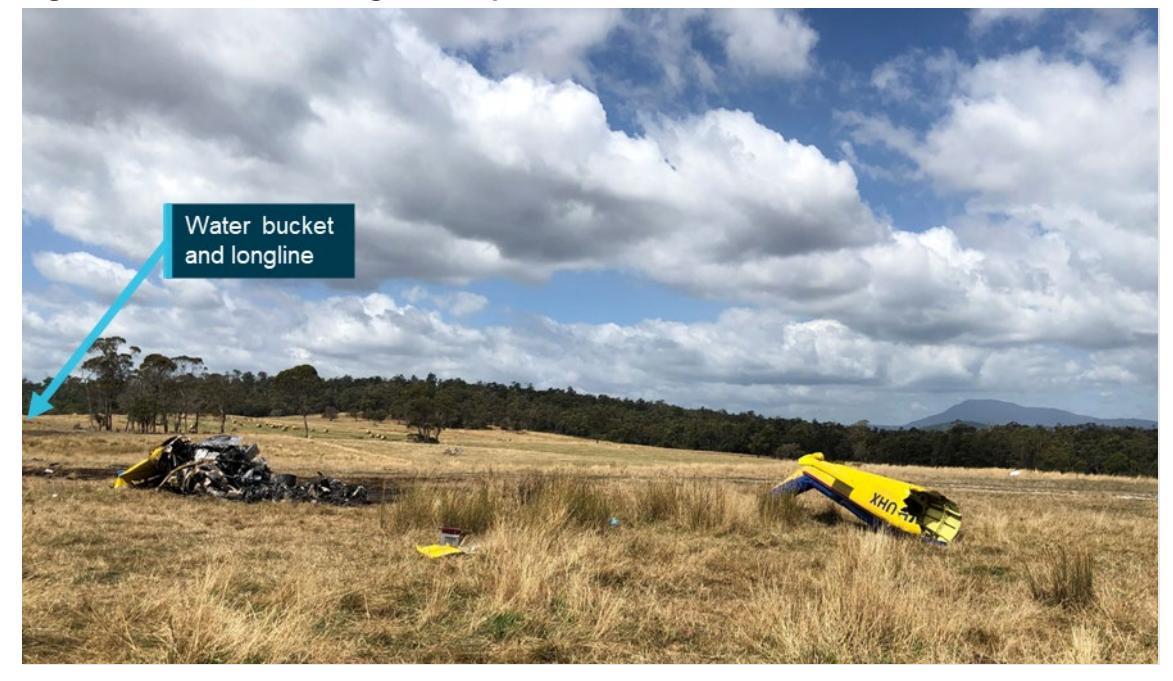
Figure 5: View of the fuselage and separated tail section at the accident site

The helicopter wreckage was located in a grassy paddock near Pipers Brook Road, about 2.6 km north of the TFS staging area. The helicopter had been destroyed from ground impact forces and the subsequent fuel-fed fire (Figure 5). A survey of the accident site showed the wreckage to be orientated in a westerly direction (Figure 6).

The Lebrina fireground was located beyond the foreground tree line at the perimeter of the paddock. The upper wire cutter guide, longline and water bucket were located further back toward the tree line. Source: ATSB

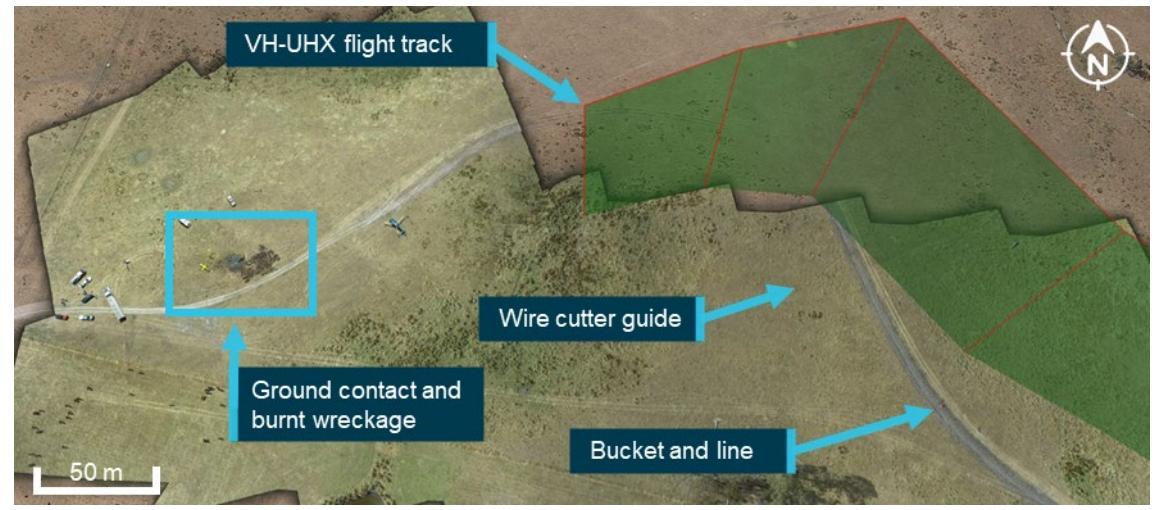
Figure 7: Accident site showing the flight track of VH-UHX (red/green shaded area) and items that had liberated from the helicopter

The furthest items from the accident site were the tip from the upper wire cutter guide (located 220 m from the wreckage) and the underslung water bucket that remained attached to its longline (located 300 m from the wreckage) (Figure 7). Deformation to the fractured wire cutter guide was consistent with it being struck and projected by a main rotor blade.

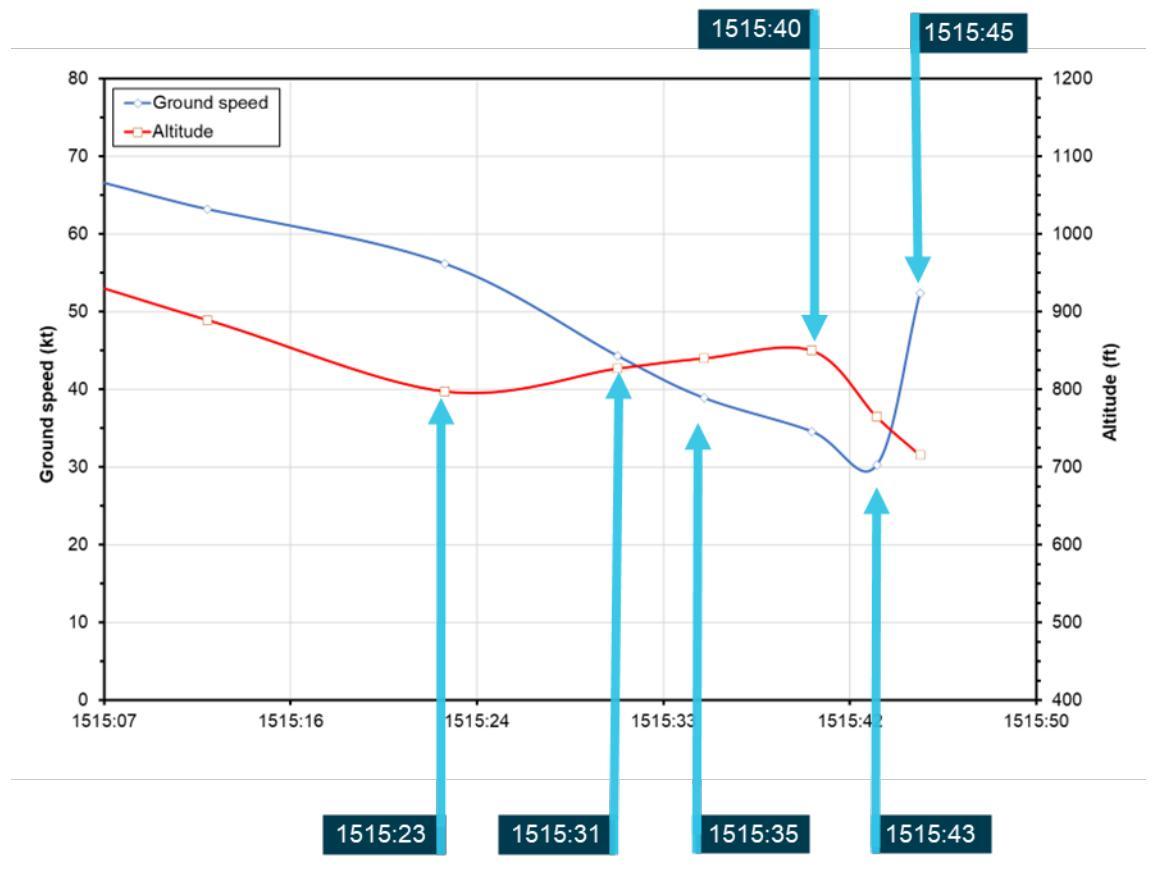
Figure 13: Presentation of the final GPS data points from the accident flight plotting altitude and ground speed against local time

The final 2 data points (Figure 13) indicated that VH-UHX descended at a mean rate between 1,500 and 1,700 feet per minute, consistent with autorotation. Calculations indicated that the descent commenced at approximately 430 ft above the terrain. During this time, the horizontal ground speed component of the helicopter initially reduced to about 30 kt before increasing to about 50 kt. The final data point from the onboard GPS was recorded at 1515:45. The final data point from the Tracplus was transmitted at 1515:58 and was likely a post-collision system shutdown.

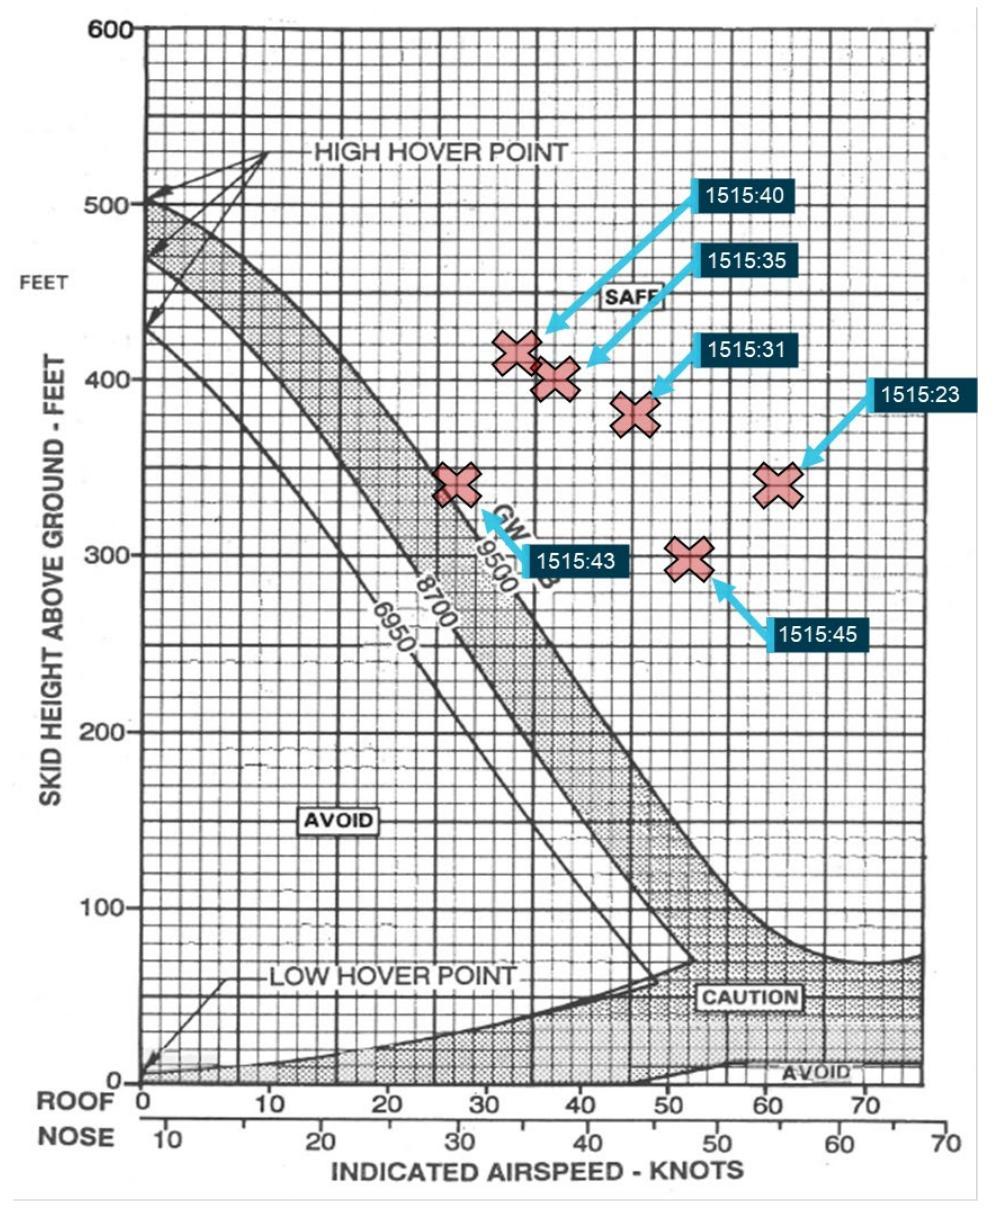
Figure 14: Data points from the onboard GPS noting time, airspeed (calculated) and height are overlaid on the UH-1H height-velocity helicopter performance diagram

The ATSB evaluated the likelihood that VH-UHX should have been able to complete a safe landing after an engine failure. Figure 14 and Figure 15 show the recorded heights and speeds of the last 6 data points from the flight path data. This shows that for this phase of the flight, the helicopter was outside the avoid area of the height-velocity curve, indicating that an autorotative glide should have been possible with the nominal helicopter rotor rpm.

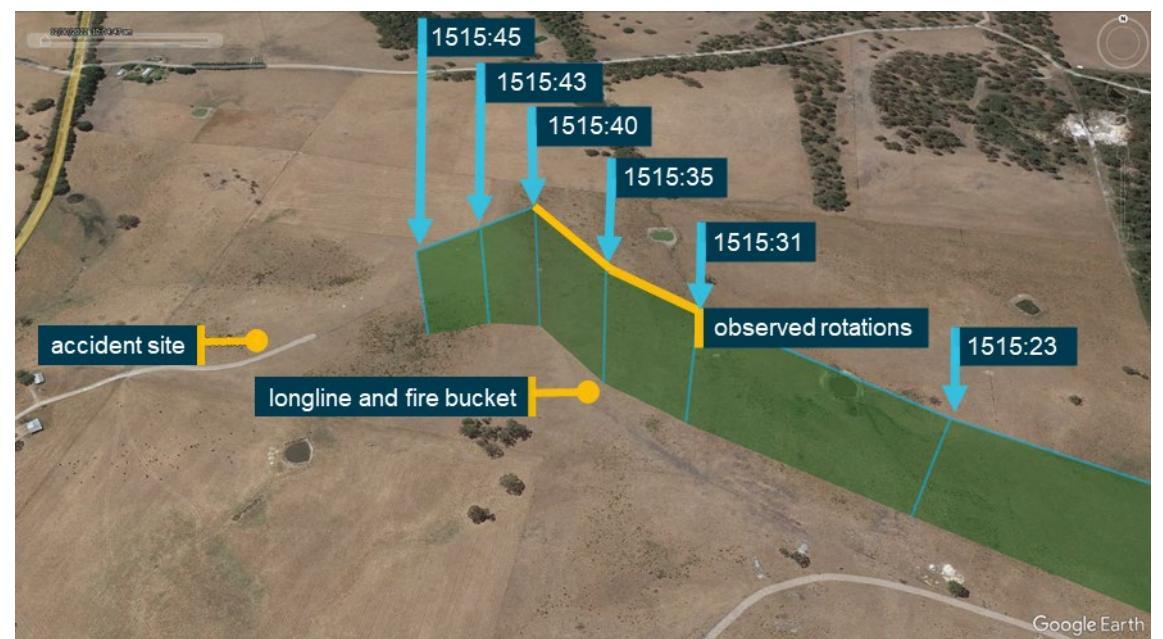
Figure 15: The final data points from Figure 14 are overlaid against the final track of the helicopter

The approximate position of the yawing (rotations), the longline and fire bucket, and the accident site are also shown. Source: Google Earth, annotated by the ATSB
