# Loss of control and collision with terrain involving Cirrus SR22, VH-XGR

Bankstown Airport, New South Wales on 17 March 2023

## **ATSB Transport Safety Report**

AO-2023-011

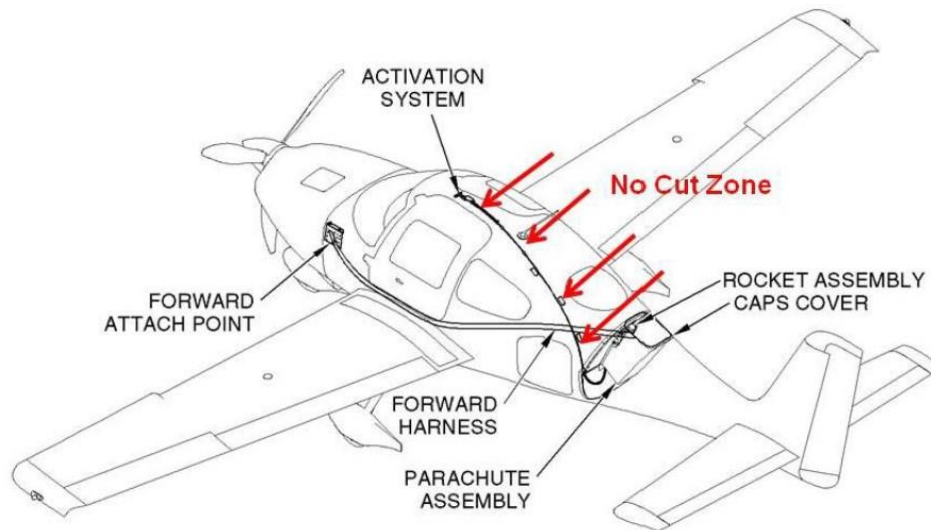
**Figure 5: Diagram extracted from Cirrus 1<sup>st</sup> Responder Information Manual - Activation handle and cable hazards**

Of particular concern is the activation cable routed through the cabin roof that can be altered or stretched during an accident sequence and/or rescue and recovery. This can occur with the activation handle safety pin inserted. On a diagram of the aircraft, the cable route and parachute compartment were identified as a do not cut zone (Figure 5).

**Use caution when using prying or using cutting tools near the activation cable!**

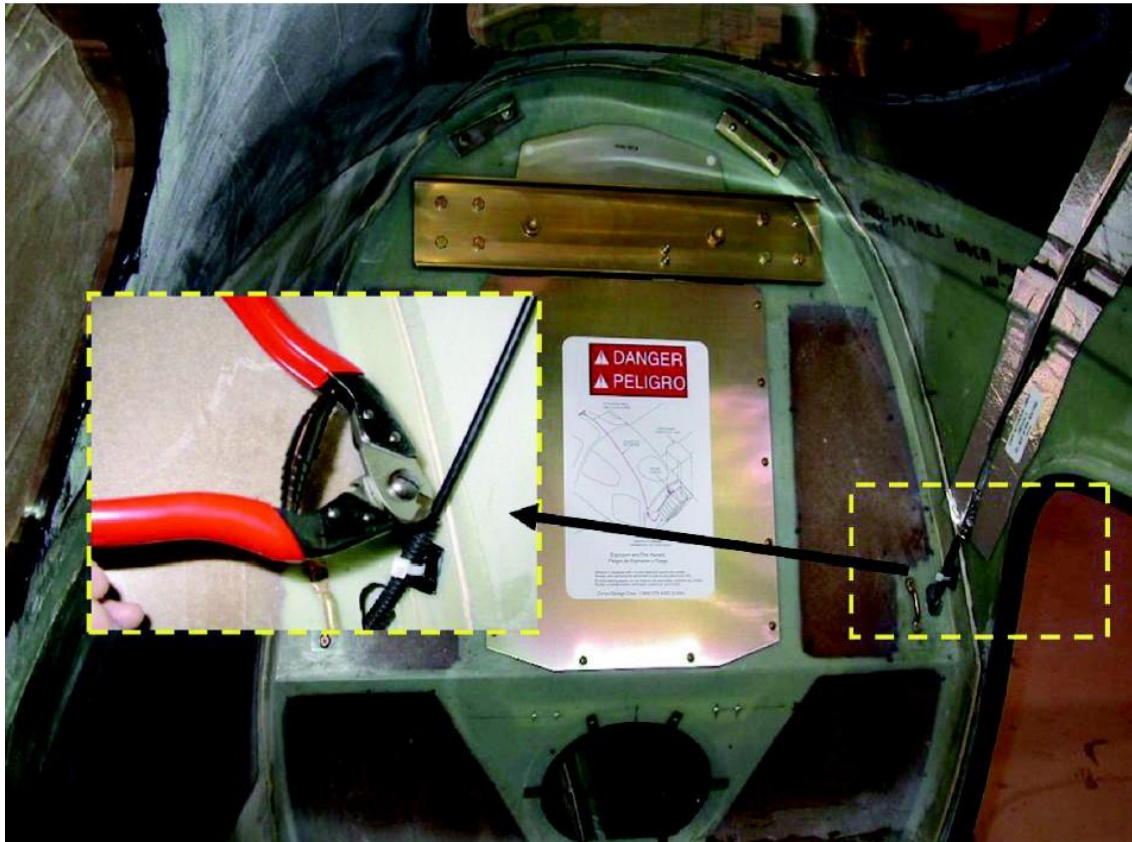
**Figure 6: Image extracted from Cirrus 1<sup>st</sup> Responder Information Manual showing rear cabin (looking rearward; carpeting and panels removed), warning placard, and cable cutting location**

For an intact aircraft, CAPS can be secured by inserting a safety pin into the activation handle and handle holder. If an aircraft is not intact, CAPS should be disabled by cutting the activation cable as close to the igniter assembly as practicable (Figure 6). This is a temporary measure that decreases the risk of inadvertent ignition substantially enough to proceed with rescue efforts. Additionally, for an electrically fired system, aircraft batteries can be disconnected, and the igniter wires shunted.
