ATSB TRANSPORT SAFETY INVESTIGATION REPORT

Additional Analysis of Left Engine Failure VH-LQH

6 March 2006

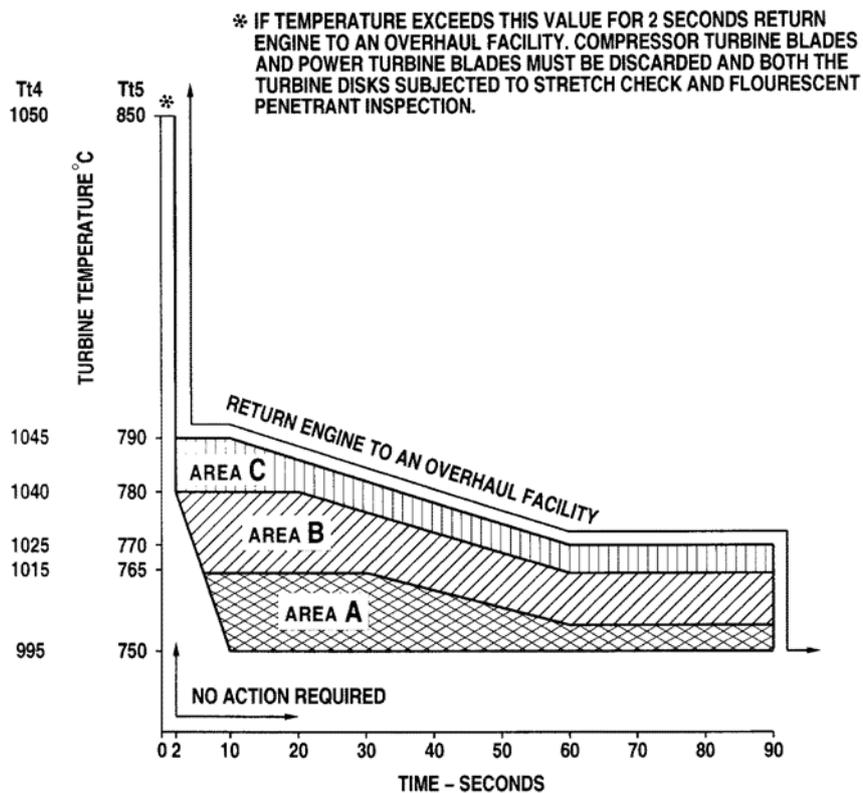
Overtemperature Limits (All Conditions except Starting)
 Figure 2-6-3

- AREA A** 1. DETERMINE AND CORRECT CAUSE OF OVERTEMPERATURE.
 2. VISUAL INSPECTION THROUGH EXHAUST PORTS OF POWER TURBINE BLADES AND EXHAUST DUCT TURNING VANES (IF FITTED).
 3. RECORD IN ENGINE LOG BOOK.
- AREA B** 1. PERFORM HOT SECTION INSPECTION.
- AREA C** 1. PERFORM HOT SECTION INSPECTION.
 2. RETURN COMPRESSOR TURBINE DISK AND BLADE ASSEMBLY TO AN OVERHAUL FACILITY FOR STRETCH CHECK AND FLOURESCENT PENETRANT INSPECTION.

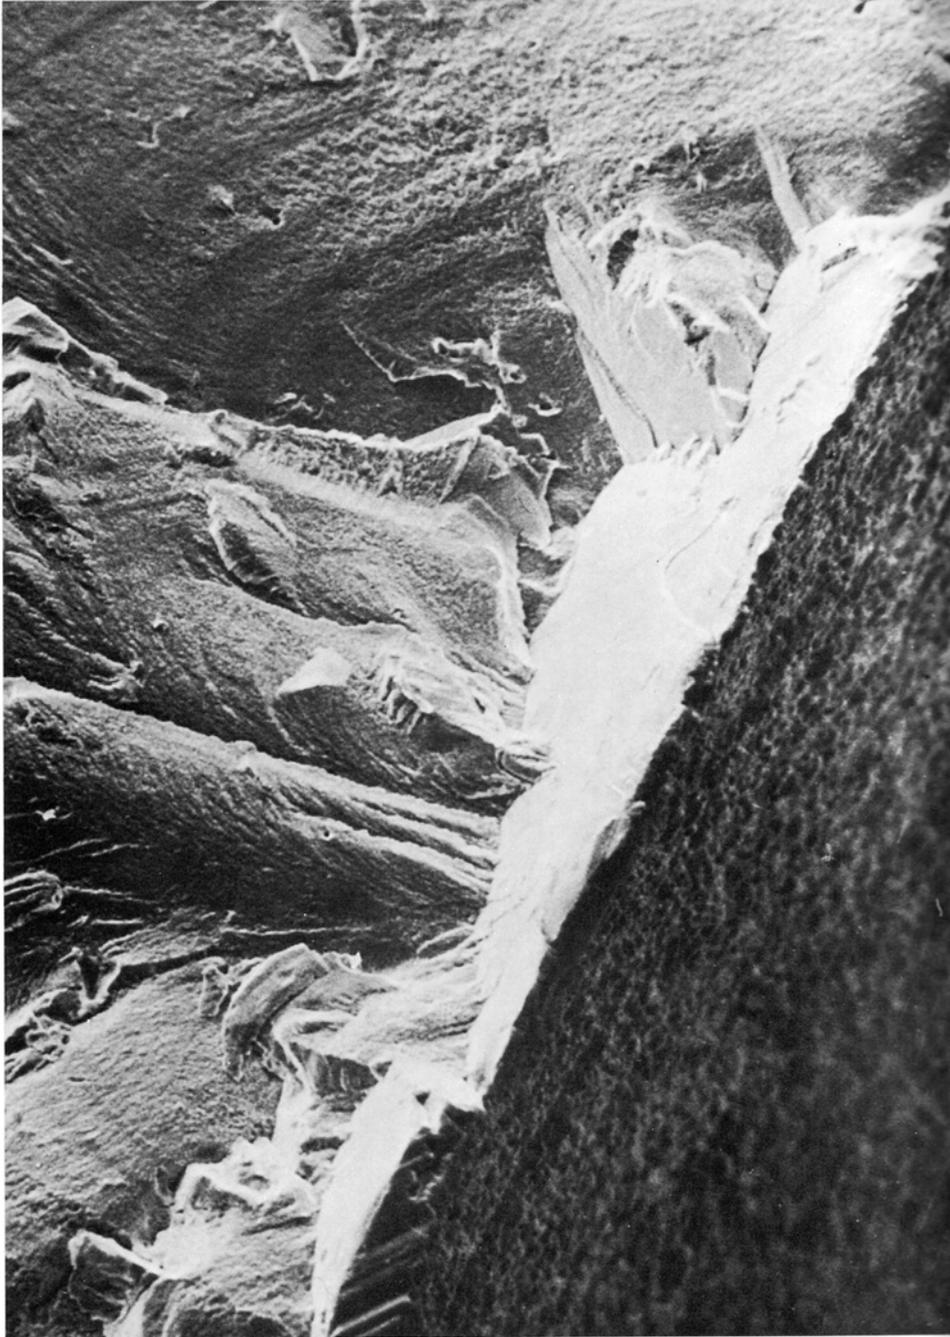
111

111. The fatigue fracture of a nickel alloy turbine blade commenced on the obliquely inclined flat surfaces (Stage I) and subsequently propagated as a transcrystalline fatigue crack (Stage II) (shown at the left-hand side of the picture). (260:1)

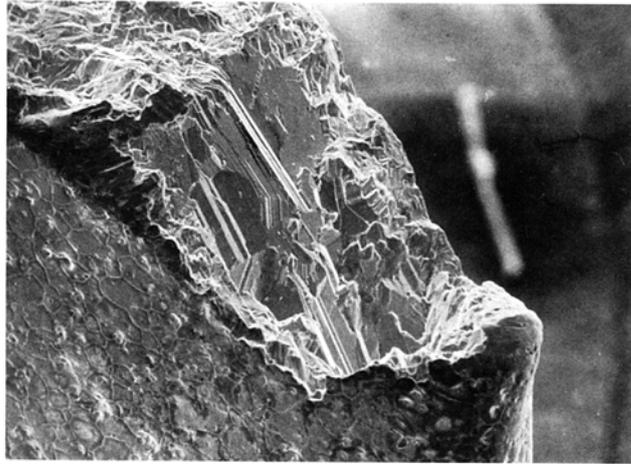
112

112. Hot gas corrosion and fatigue fracture in a nickel-based alloy turbine blade (Nimonic 105). The hot gases attacked the whole surface, but particularly the grain boundaries. This led to the formation of a fatigue crack whose initiation region showed the cleavage-like facets which typically form in nickel-based alloys (Stage I propagation). The continued transcrystalline fracture propagation is no longer crystallographically oriented. (120:1)

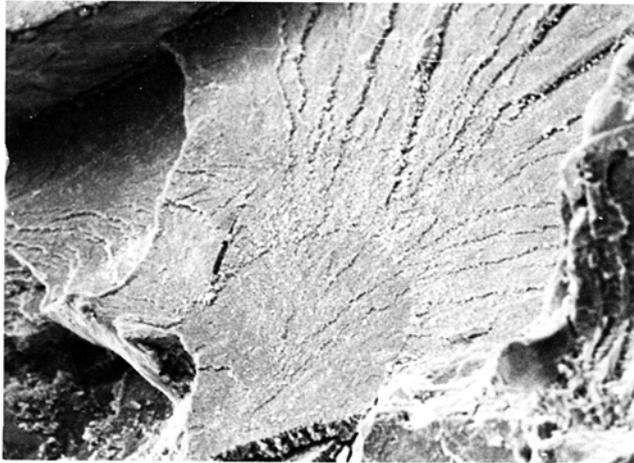
113

113. A fatigue fracture which occurred in a nickel-based alloy operating at high temperature: Stage I of fatigue fracture. (280:1)

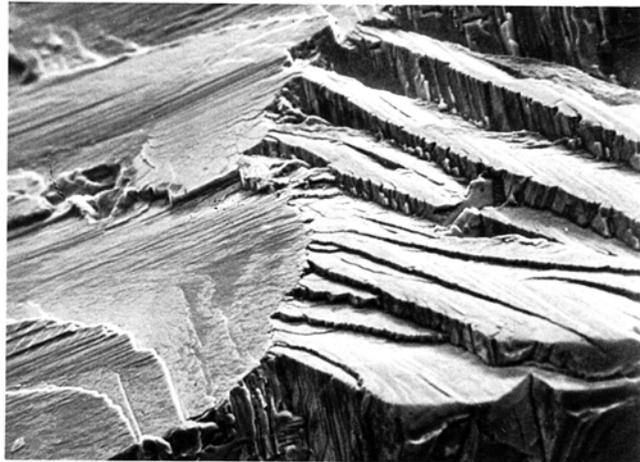
114

114. Cleavage-like, crystallographically oriented fatigue fracture in a laboratory tested specimen of a nickel-based casting alloy (Nimocast 713V). The test was carried out at high temperatures under conditions of pulsating tensile fatigue testing (0 to 0.2kN/mm²) Stage I of fatigue fracture, showing the typical fracture surface found in nickel-based alloys. (525:1)

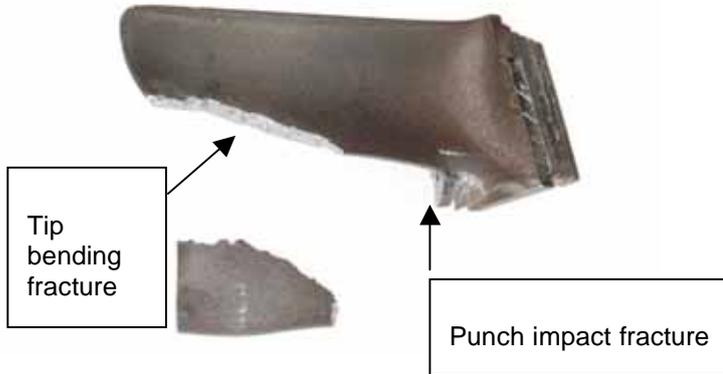
Tip bending fracture features

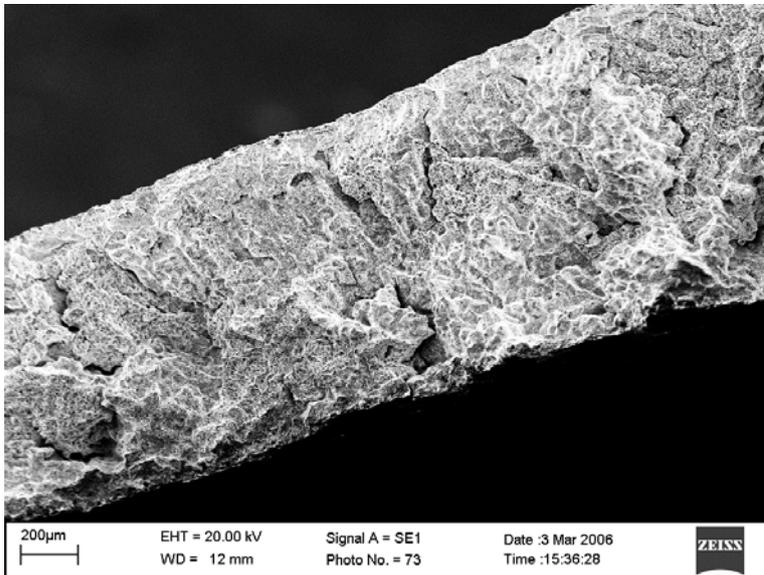
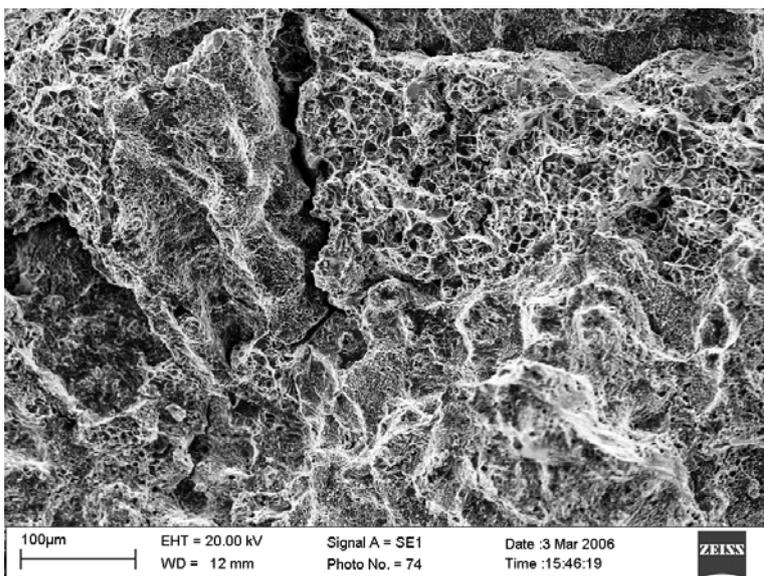
Punch impact fracture
