# In-flight break-up involving Robinson R22 Beta II, VH-RAS

13 km south-west of Koorda, Western Australia, on 2 October 2022

## **ATSB Transport Safety Report**

AO-2022-045

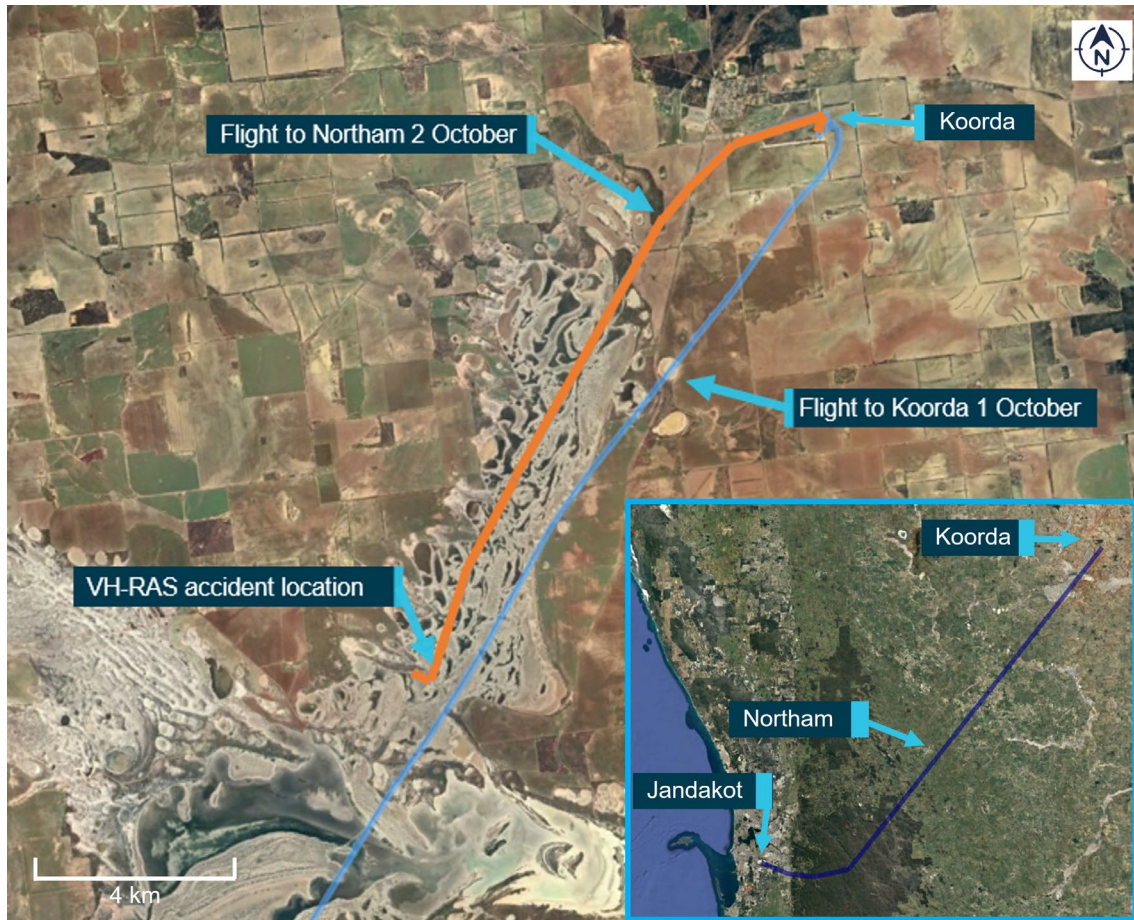
**Figure 1: Flight from Jandakot to Koorda and from Koorda on the morning of the accident**

When VH-RAS did not arrive at Jandakot as expected, and after confirming it had not landed at Northam, the helicopter was reported as overdue at about 1500 and a search was commenced. The search was coordinated by the Australian Maritime Safety Authority's Joint Rescue Coordination Centre. The wreckage was subsequently located at about 1600 on a dry salt flat in the Cowcowing Lakes region, about 13 km south-west of Koorda (Figure 1). The helicopter was destroyed, and both occupants were fatally injured.

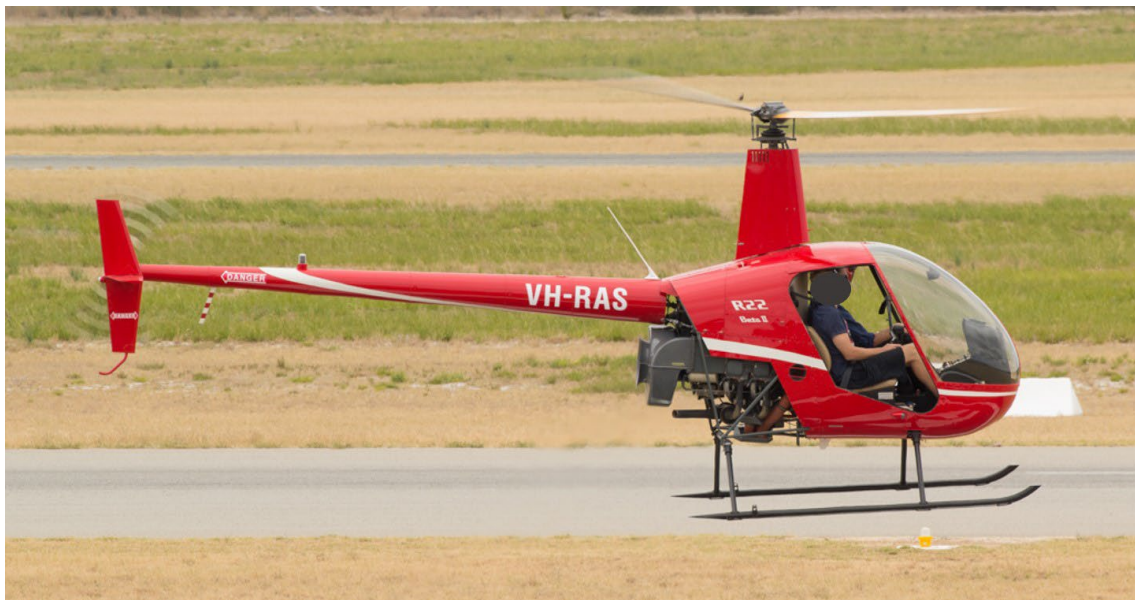
**Figure 2: VH-RAS**

VH-RAS (Figure 2) was a 2-seat Robinson Helicopter Company (RHC) R22 Beta II helicopter, serial number 4617, powered by a Textron Lycoming O-360-J2A, 4-cylinder carburetted piston engine. It was manufactured in the United States in 2013 and first registered in Australia the same year. It was purchased by the pilot in 2016 and had been maintained by the same maintenance organisation since that time. The helicopter was to undergo a periodic inspection every 100 hours or 12 months, whichever came first. The last periodic inspection had been completed in November 2021, with the current maintenance release issued at that time. At the time of the accident, the helicopter had accrued about 13 hours since the periodic inspection and 2,080 hours total time-in-service.

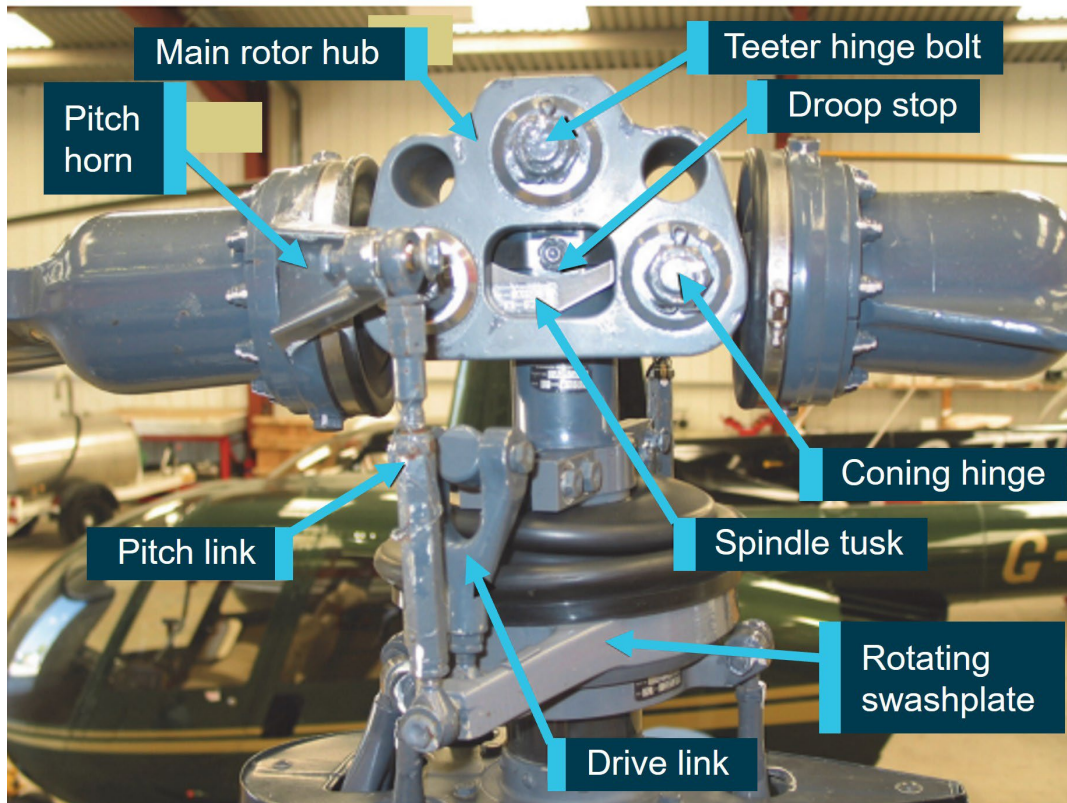
**Figure 3: R22 main rotor head assembly**

The 2-blade main rotor assembly is a semi-rigid rotor head, otherwise known as a teetering rotor head (Figure 3). Bolts secure the rotor blades to the main rotor hub at the coning hinges.<sup>7</sup> The teetering head allows the rotor disk to take up an attitude appropriate to the flight condition, with the coning hinges allowing the blades to achieve the optimum coning angle appropriate for the flight and loading conditions. This design permits a lighter blade structure than would otherwise be required.

to teeter and flap around its designed flight axis via the teeter hinge, while polyurethane teeter stops limit the degree of teetering to protect the mast from direct contact with the main rotor blades. The main rotor system is also fitted with pitch change links, which connect the swashplate to the pitch horn and transmit the flight control inputs to the main rotor blades.

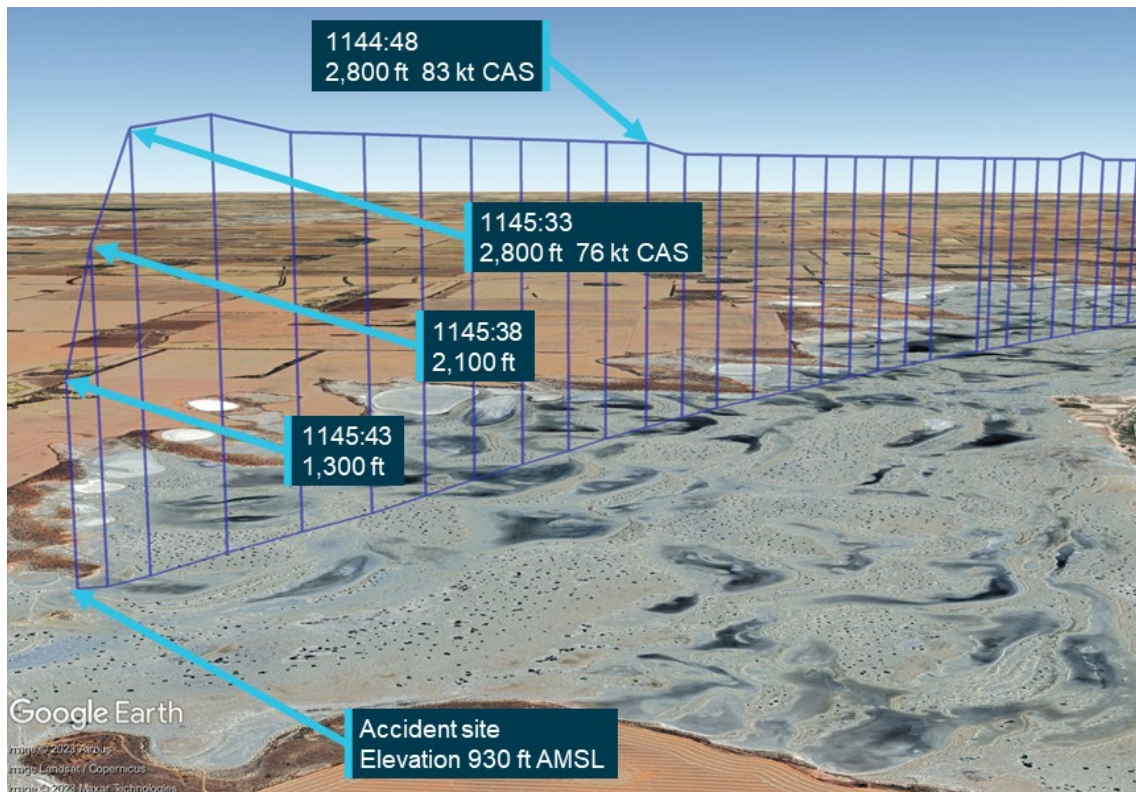
**Figure 6: iPhone track data, truncated altitude, and estimated airspeed for VH-RAS during last the 2 minutes of flight**

Data transmitted by the iPhone (blue) and data from the handheld GPS (green) is depicted in Figure 5 and Figure 6.
