Mid-air collision involving SIAI-Marchetti S-211s, VH-DZJ and VH-DQJ

25 km west of Tyabb Airport, Victoria on 19 November 2023

ATSB Transport Safety Report

AO-2023-057

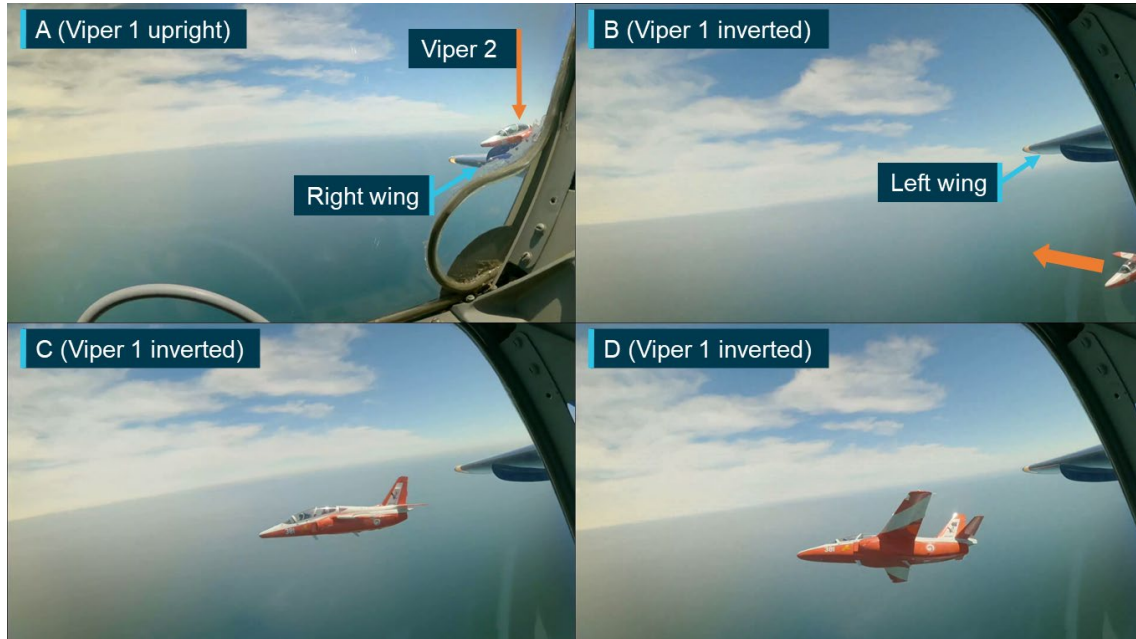
Figure 2: Recorded images from Viper 1 of first manoeuvre

The crews completed the brief and, at 1324 local time, the aircraft departed Essendon towards Port Phillip Bay. About 6 minutes later, while the aircraft were operating at about 3,000 ft above mean sea level and at a speed of about 200 kt, the crews began manoeuvring for the planned sequence. Viper 2 moved rearward (panel A in Figure 2) and Viper 1 rolled inverted (panel B in Figure 2). From a low right echelon position, Viper 2 then moved forward and climbed toward the line abreast position while also moving laterally closer to Viper 1 (panel C in Figure 2). The rate of closure between the aircraft increased and before Viper 2 could stabilise in the line abreast position, the pilot banked away and moved out of the formation (panel D in Figure 2). Viper 1 then rolled upright.
