Loss of control and collision with terrain involving Beechcraft E55, VH-OMD

Cowra Airport, New South Wales on 11 April 2024

ATSB Transport Safety Report

AO-2024-011

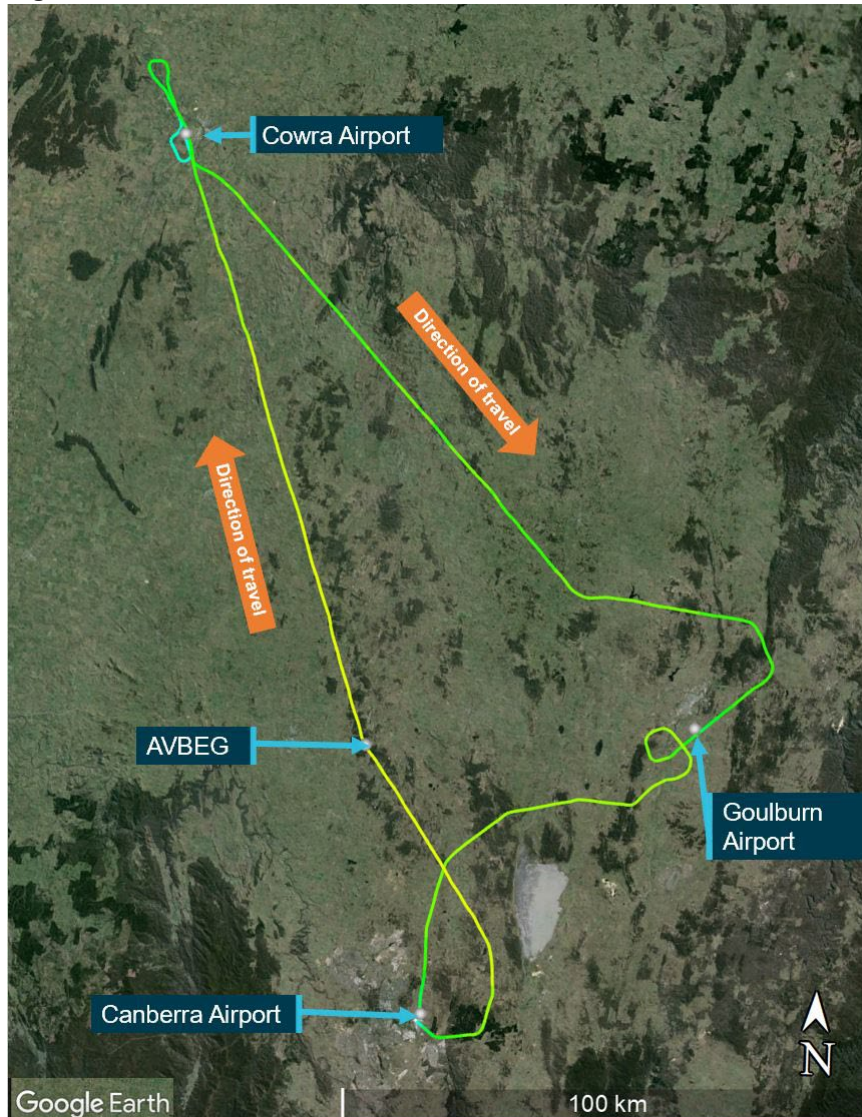
Figure 1: VH-OMD track from Cowra to Goulburn, Canberra and return via AVBEG

OzRunways³ flight path data showed that the aircraft departed Cowra Airport at 1156 local time. En route to Canberra, the student conducted an instrument approach⁴ to Goulburn Airport, NSW, but did not land there. The student then conducted an instrument approach to Canberra, landed and taxied to the general aviation apron. After a short break, and without shutting down the engines, the aircraft departed Canberra Airport at 1323 via a standard instrument departure. The aircraft climbed to 10,000 ft above mean sea level (AMSL), tracked via waypoint AVBEG and commenced a descent when 35 NM from Cowra (**Figure 1**).

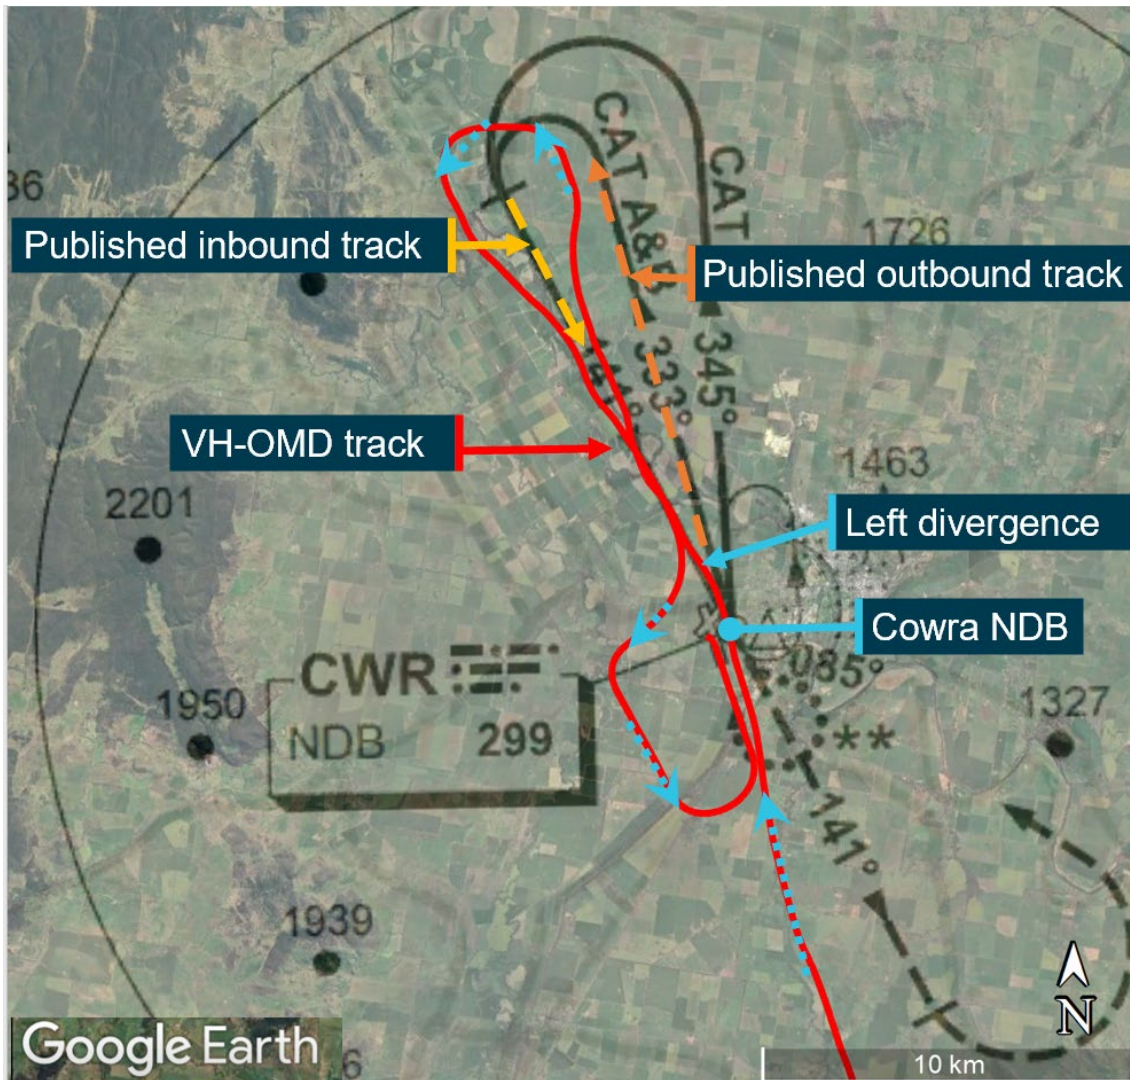
Figure 2: VH-OMD track overlaid on published Cowra NDB approach

the published outbound track, and tracked outbound on the published inbound track for about 2 minutes, before starting to correct to the right (Figure 2).

About 4 minutes after passing over the NDB, the aircraft commenced a left inbound turn and was established within the required 5° tolerance of the published inbound track about 5 NM from the threshold of runway 15.

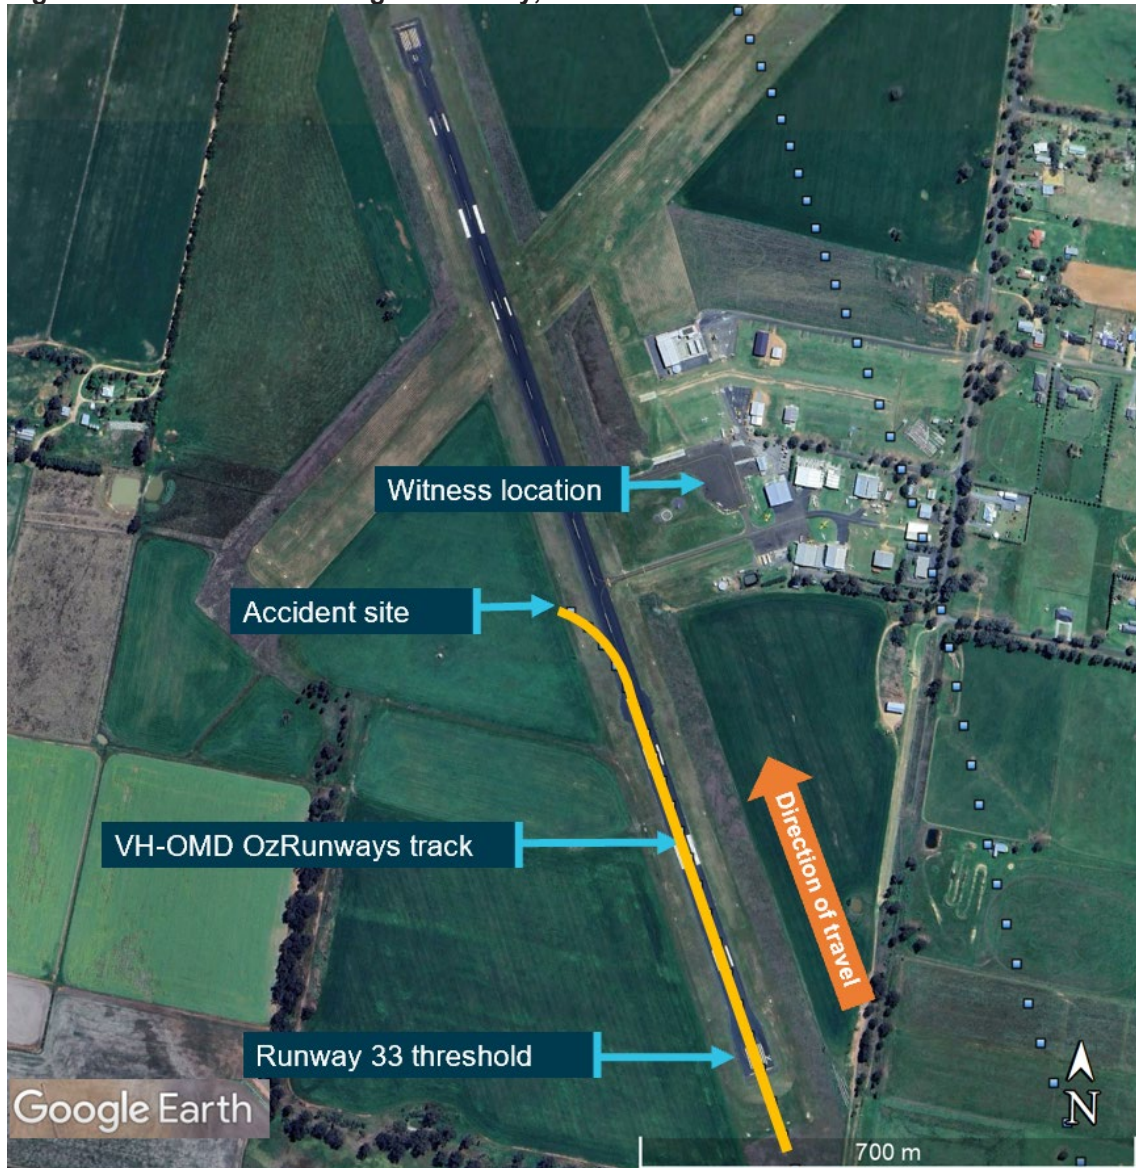
Figure 3: VH-OMD track along the runway, accident site and witness location

OzRunways data showed that the aircraft started to deviate left of the runway centreline at 1416:14 at 69 kt ground speed, but there was insufficient recorded information to determine whether or not it touched down prior to that occurring. The instructor reported taking control of the aircraft from the student and verifying that both throttle levers were fully forward. Assessing that the yaw was due to left rudder input by the student, the instructor called for the student to let go of the controls and applied right rudder, but was unsuccessful in regaining control of the aircraft. A witness facing away from the runway heard what they assessed as one engine power up and turned to see the aircraft 10–20 ft above the runway, pitched 10–12° nose-up, and in a rapid left roll (Figure 3).

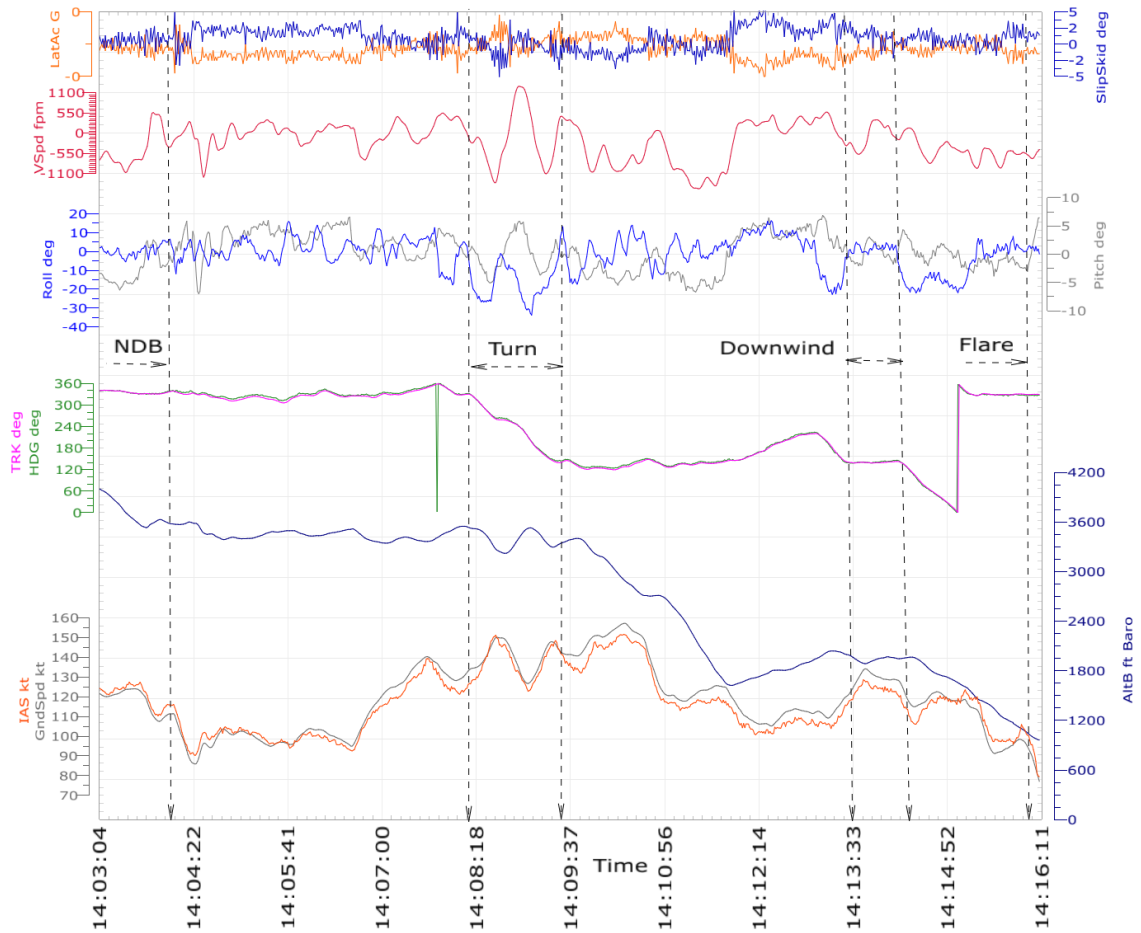
Figure 6: Selected parameters from the Garmin electronic flight instrument

OzRunways¹⁵ data from the student's electronic flight bag application contained aircraft track, altitude and ground speed. The ATSB also obtained flight data from the aircraft's Garmin electronic flight instrument (EFI), which included 40 data parameters. Figure 6 shows key parameters from the EFI data, with the following observations.
