# Collision with terrain involving Oficinas Gerais de Material Aeronautico DHC-1 MK 22 Chipmunk, VH-POR

Jandakot Airport, Western Australia on 26 April 2024

## **ATSB Transport Safety Report**

AO-2024-013

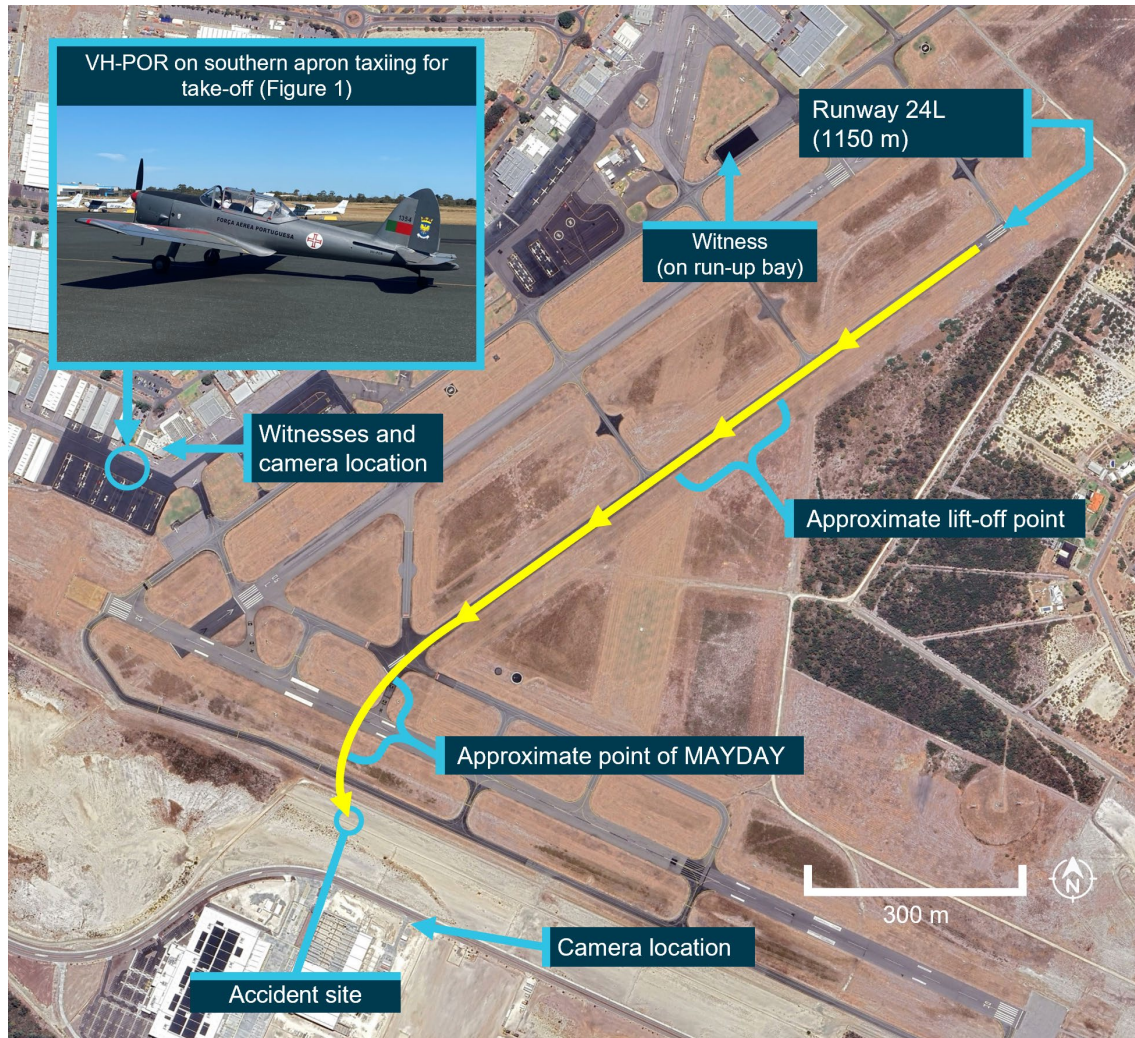
**Figure 2: Approximate flight path**

The pilot continued to taxi to the end of runway 24L and at 1313 was given clearance to take off. Camera footage recorded the aircraft commencing its take-off roll and becoming airborne about halfway along the runway's length (Figure 2).

One witness, located at the run-up bay, recalled seeing something 'flapping' on the aircraft during the take-off. This witness, and witnesses in a nearby building looking through a window, observed the aircraft turn to the left at low height near the end of runway 24L. There were no reports of an abnormal engine sound. At 1314:24, the pilot made a radio call stating 'papa oscar romeo papa oscar romeo MAYDAY MAYDAY MAYDAY'.<sup>2</sup>

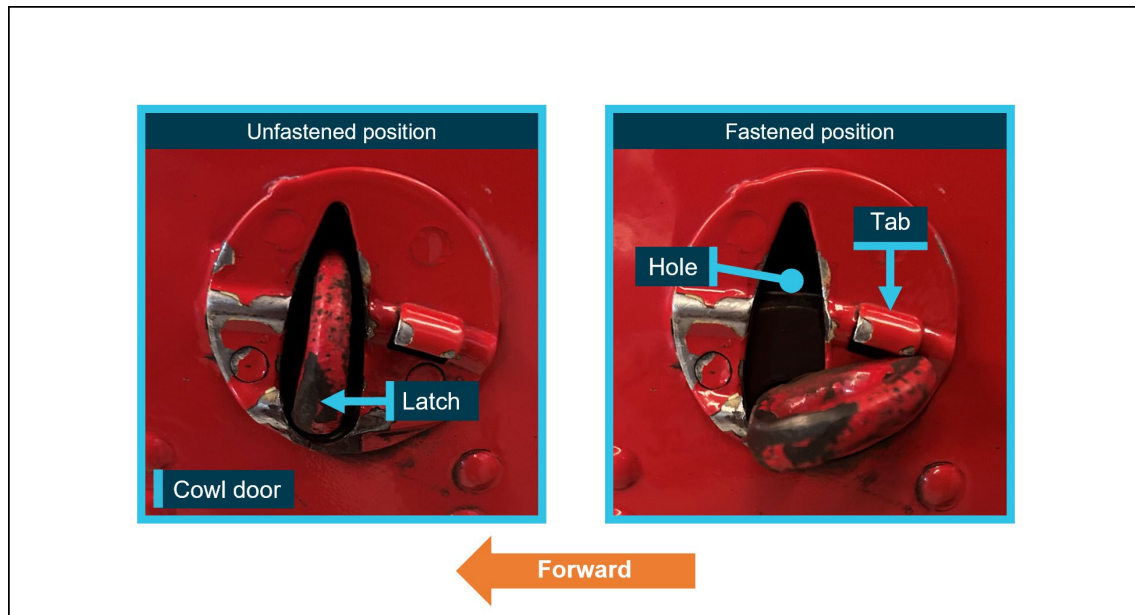
**Figure 4: DHC-1 Chipmunk cowl latch detail (exemplar aircraft, left side shown)**

Access to the engine is via a cowling door on either side. The cowl doors are hinged at the top and fastened by 2 latches at the bottom of each cowl. The latches are attached to the lower engine cowl and when in the vertical position pass through holes on the cowling doors (Figure 4, left). To fasten the cowl, the latches are pulled outboard, further compressing a pre-compressed spring, and turned aft (1/4 turn) to the horizontal position. Releasing the latch then fastens the cowl. The latches are held in place by the spring and prevented from unfastening by a tab (Figure 4, right). There was no evidence of pre-impact damage to the engine cowl latches fitted to VH-POR (see *Wreckage and impact information*).

Damage to the engine cowl latches was indicative of the latches being correctly fastened on the right side but unfastened on the left at the time of impact. The engine cowls and latches were otherwise undamaged.

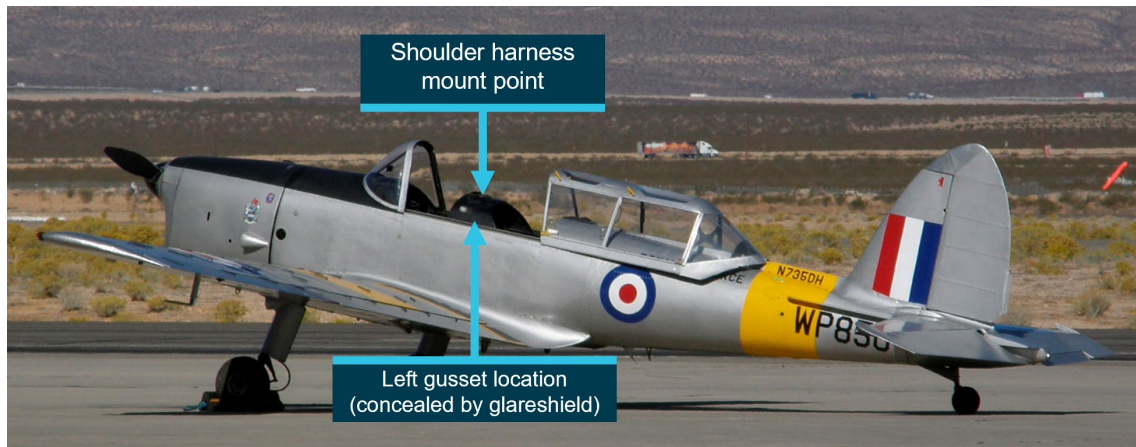
**Figure 5: DHC-1 Chipmunk cockpit showing gusset and shoulder harness locations (exemplar aircraft)**

The upper structure between the front and rear cockpits of the DHC-1 Chipmunk, corresponding to the attach point for the front cockpit shoulder harness, had 2 mountings, called gussets (Figure 5 and Figure 6).

The ATSB found that on impact the upper structure between the front and rear cockpits, corresponding to the attach point for the front cockpit shoulder harness, was torn away from its mountings (Figure 7). All 12 rivets (6 per side) that attached the structure to the mountings had sheared.
