Midair collision involving Eurocopter EC130 B4, VH-XH9, and Eurocopter EC130 B4, VH-XKQ

Main Beach, Gold Coast, Queensland, on 2 January 2023

ATSB Transport Safety Report

AO-2023-001

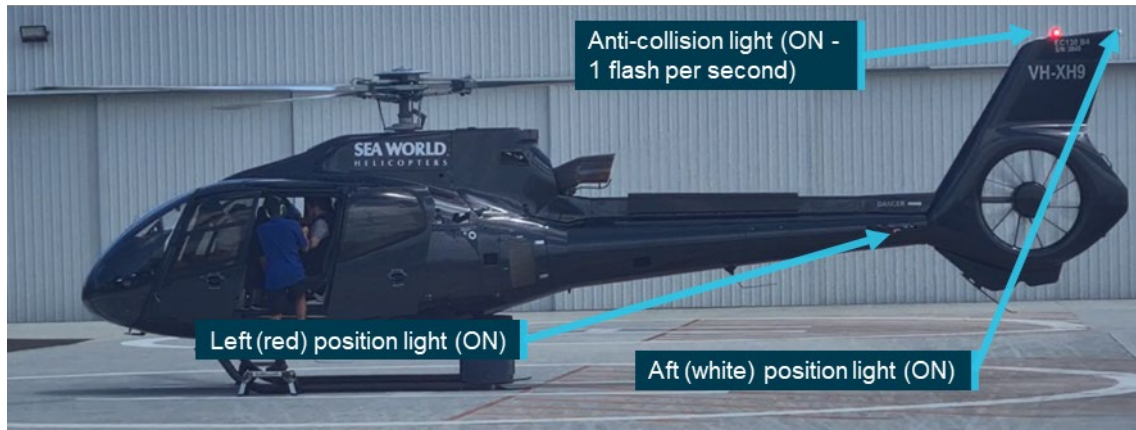
Figure 7: XH9 lighting configuration

Both XKQ and XH9 were fitted with LED left (red), right (green) and rear (white) position lights. Video footage of both helicopters prior to, and during, the accident flight confirmed that the position lights on XH9 were switched on (Figure 7). The video footage also confirmed that the left and right position lights of XKQ were switched on (Figure 8). Video footage could not confirm that XKQ's rear position light was active, likely due to the background luminosity and the distance of the camera from the light. However, all 3 lights were activated with one switch, so it was almost certainly on.

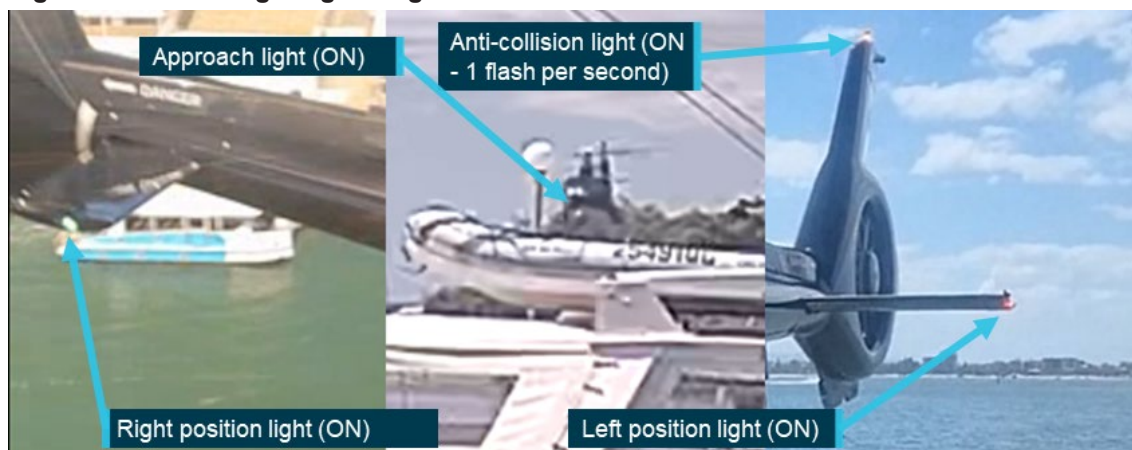
Figure 8: VH-XKQ lighting configuration

systems use. CCTV recording of XKQ departing the park pad (Figure 8 centre panel) showed the approach light steady on, consistent with the approach light being switched to ON.

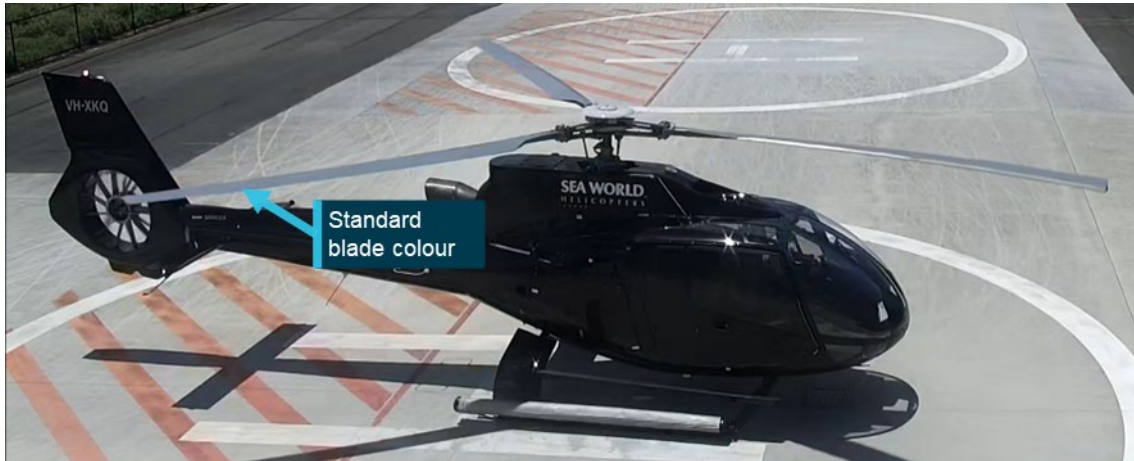
Figure 12: XKQ at the operator's heliport showing standard visibility blades

The top surface of the main rotor blades of XKQ, as shown in Figure 12, were not coated with a high-visibility paint scheme nor were they required to be.

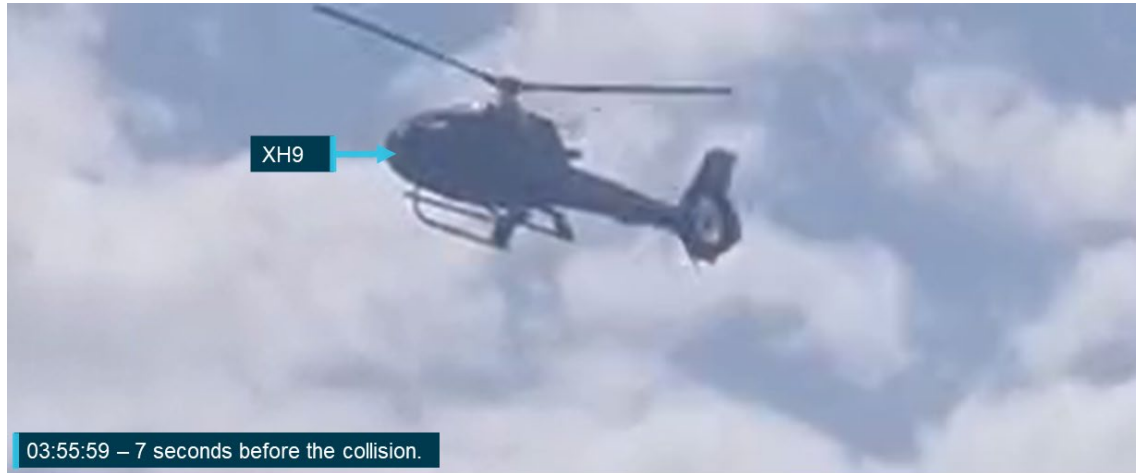
Figure 14: Footage from onboard XKQ showing the relative contrast between XH9 and its background

Video footage taken by passengers on board each helicopter captured the approach of the other helicopter (see *Passenger cameras*) and the background against which it would have been sighted. Footage from on board XKQ showed the dark grey body colour of XH9 contrasted against the blue sky and white clouds. Figure 14 shows XH9 against this background 7 seconds before the collision.

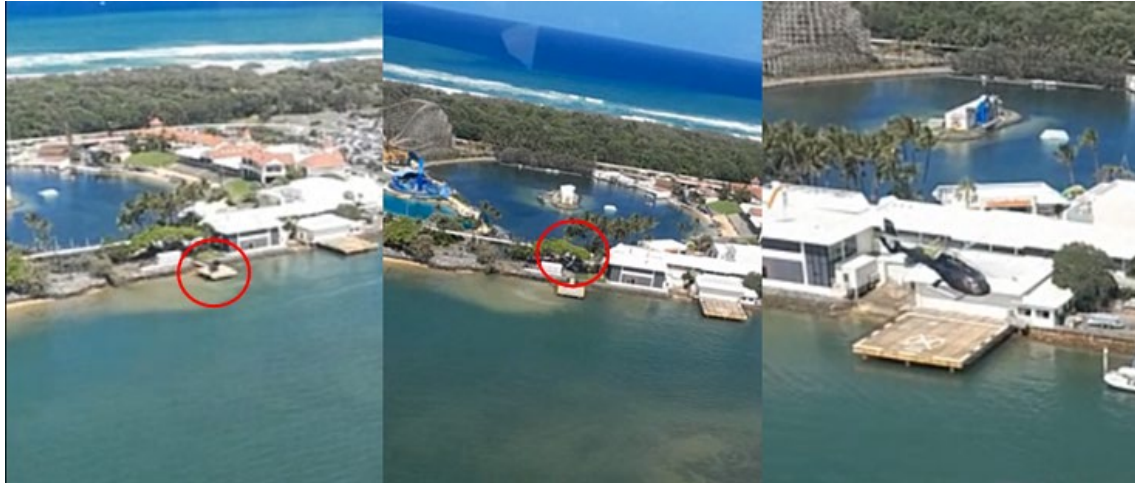
Figure 15: VH-XKQ as captured from the rear seats of VH-XH9

Video from XH9 showed XKQ before take-off through to the collision. The footage showed the black body of XKQ contrasting with 3 distinct backgrounds.

Figure 15 shows XKQ contrasting with these 3 elements. Note that the upper surface of the plainly painted main rotor blades is not visible in any of the images.

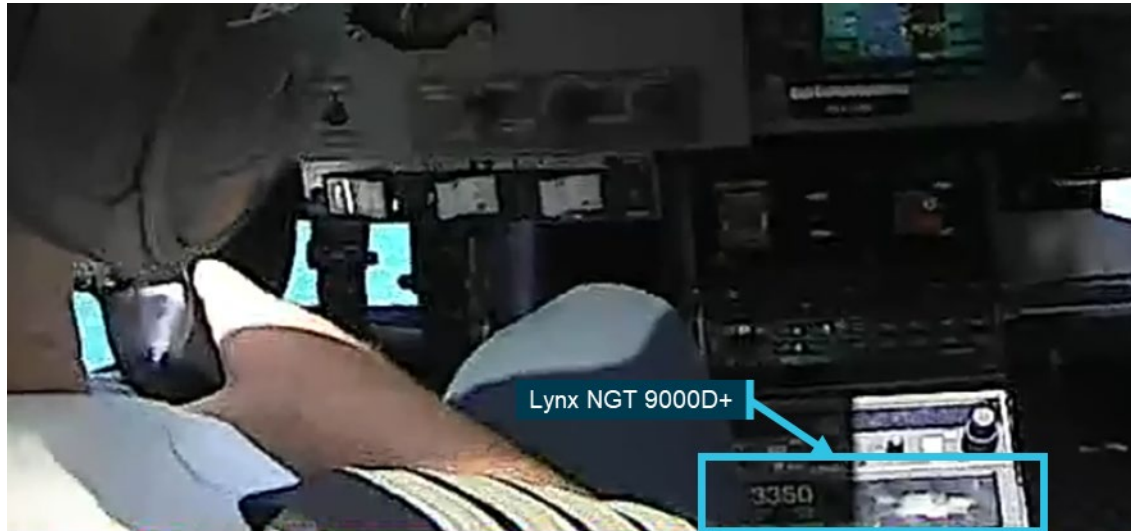
Figure 17: Location of L3 Lynx NGT 9000D+ in VH-XH9

The pilot of XH9 did not recall a visual display of traffic being available in XH9. Footage of previous flights in XH9 indicated the Lynx NGT displayed active traffic. However, the position of the transponder on the aircraft’s instrument console was consistent with the normal location of a transponder, which as a device pilots seldom refer to in flight, was not in a conspicuous position. In XH9 it was installed to the right of the pilot’s right knee (Figure 17). The screen was not well positioned for integration with an external scan, and it was not linked to any other cockpit displays.

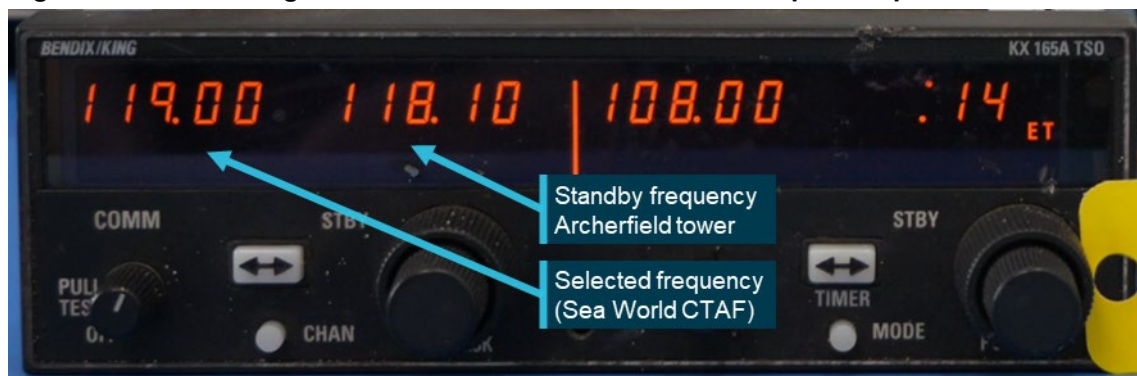
Figure 20: Bendix King KX-165A from VH-XH9 – indication on power up

- Com 1 – Garmin 430: Damaged beyond repair due to main rotor blade strike. The ATSB could not determine the settings on this unit. The volume knob on the unit was found to be set at approximately 66% (2/3 rotation).
- Com 2 – Bendix King KX-165A: The selected frequency was 119.00 MHz (local CTAF), with a standby frequency 118.10 MHz (Archerfield Airport Tower). The volume knob on the unit was found to be set at approximately 50% (see Figure 20).
- Audio Panel: Both transmit and receive functions had only Com 2 selected. The audio panel volume control, for both the pilot and for the passengers, was positioned at approximately 40%. The intercom mode was set to 'All'.

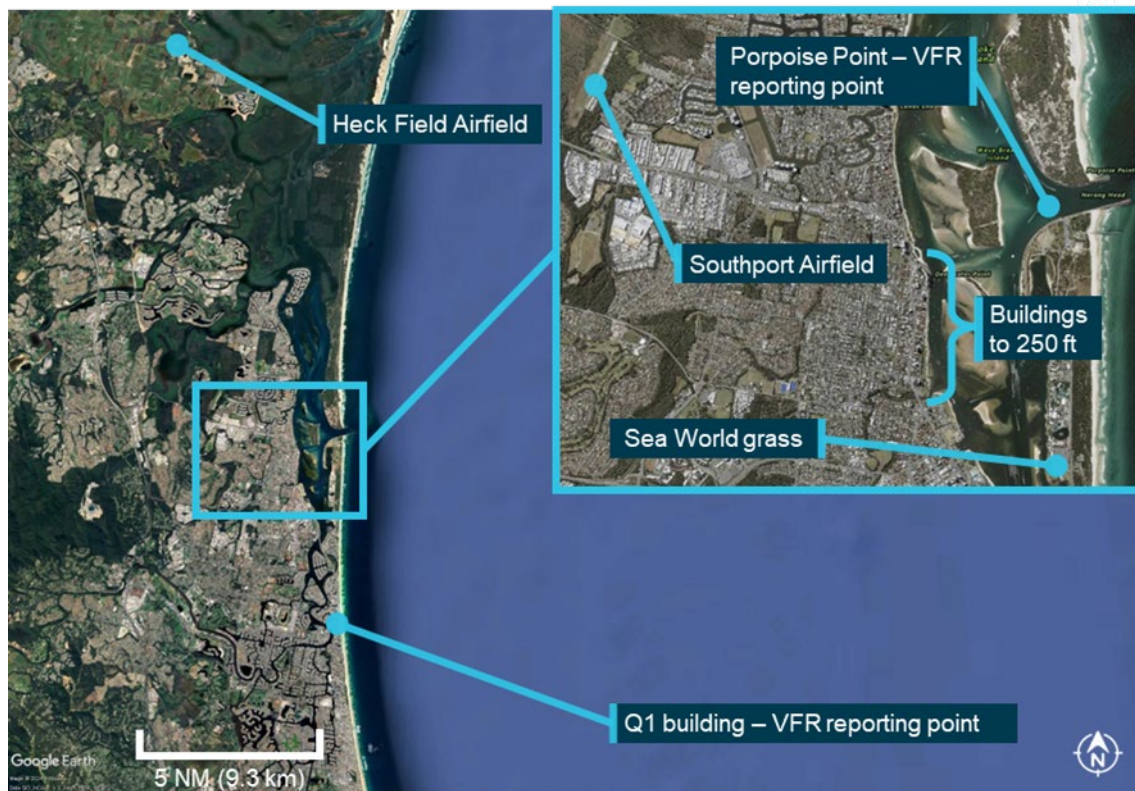
Figure 23: Southport Airfield and building shielding to Sea World

north-west of the Sea World Helicopters heliport (Figure 23). Southport Flying Club received CTAF radio calls through a regular vertical antenna. The estimated detection envelope for the antenna was 30 NM for aircraft above 500 ft. The system was equipped with an aerodrome frequency response unit (AFRU). If no-one had broadcast on the frequency within the last 5 minutes the AFRU would respond with the airfield name, otherwise it would respond with a short tone. CTAF recordings demonstrated that this system was functional.

The CTAF system at Southport Airfield clearly recorded sport aircraft equipped with 6-watt radios in the circuit area at Heck Field, 9 NM away. Sea World Helicopters' 5-minute and 10-minute flights were flown between 3 NM and 6 NM from Southport Airfield. Buildings along the foreshore of the Broadwater between Southport Airfield and Sea World Heliport were up to 250 ft tall. Therefore, at lower altitudes the built environment reduced the detection envelope, resulting in calls from aircraft around 200 ft and below near the Sea World Heliport not being detected at Southport Airfield.

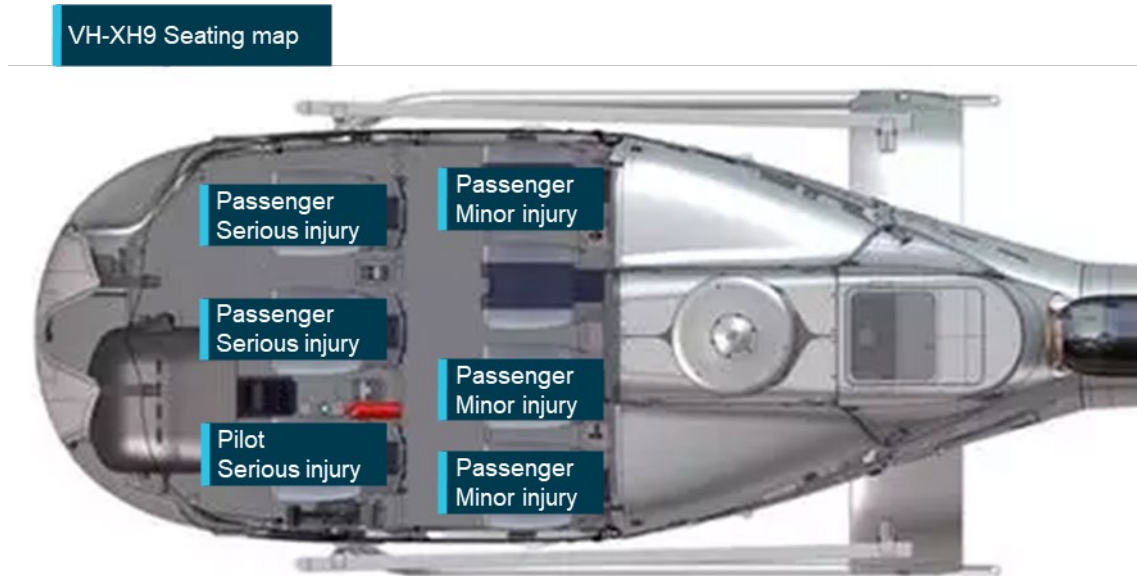
Figure 50: VH-XH9 seating map and injuries

The forward cabin of XH9 was significantly compromised by contact with the main rotor blades and Fenestron from XKQ, resulting in the windscreen and forward cabin structure being destroyed, with acrylic window debris entering the cabin causing serious injury to the pilot and 2 front passengers, and minor injury to the 3 rear passengers (Figure 50). The flight controls remained intact and allowed the pilot to continue flying.

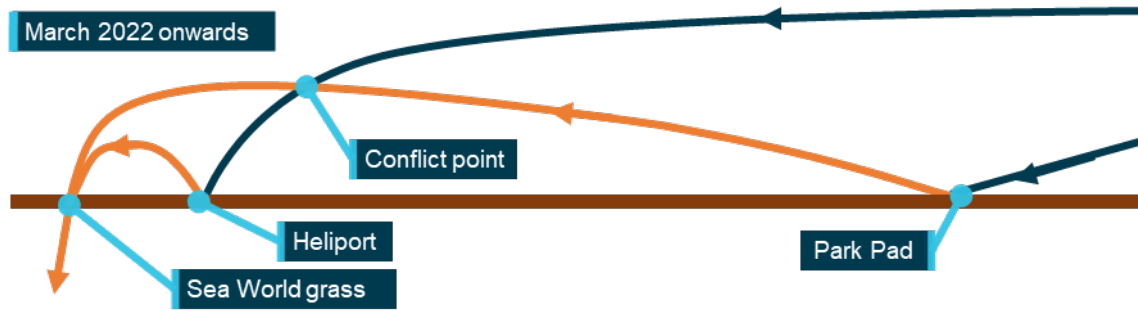
Figure 78: Conflicting flight paths to the south from March 2022 onwards

In March 2022 the park pad reopened and operated simultaneously with the main heliport. This final configuration was the one intended at purchase of the company in late 2018. Once the park pad opened, a conflict point was created near to the main heliport between outbound flights from the park pad and inbound flights to the heliport (Figure 78).

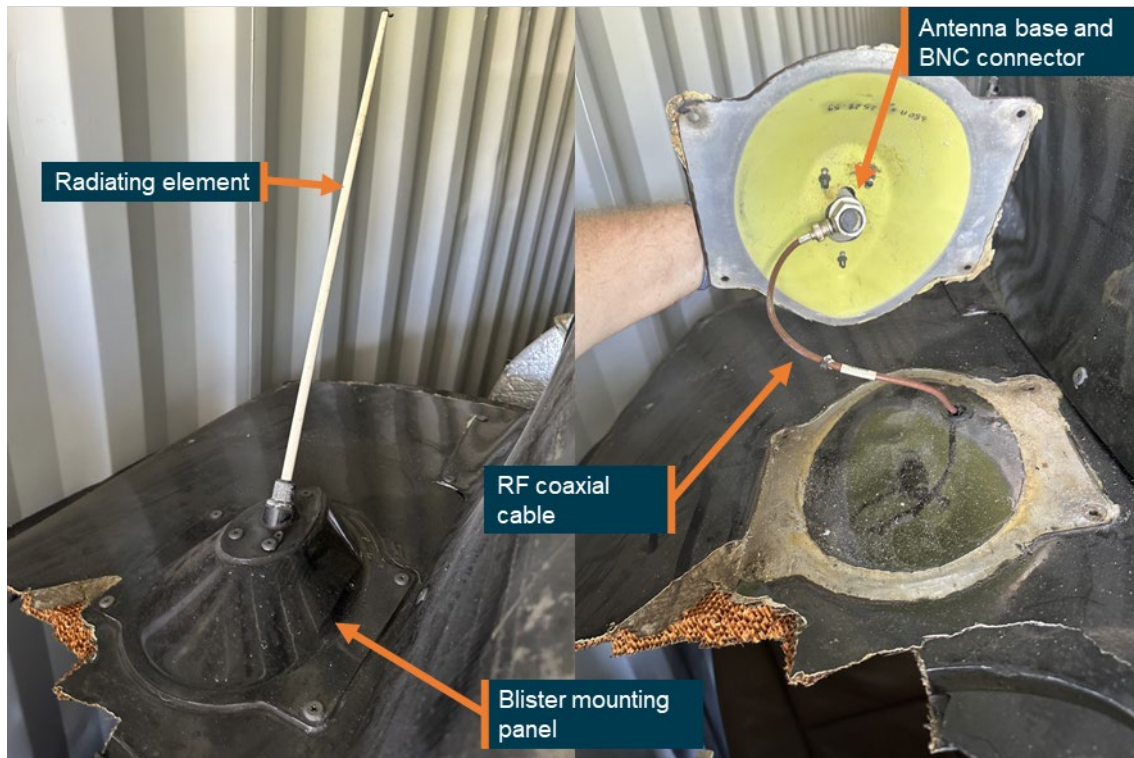
Figure A1: Removal of antenna components from XKQ

- the VHF antenna (manufactured by Chelton, part number 21-4B, serial number 9906)
- the airframe mounting blister panel for the antenna (manufactured by Airbus, part number 350A 65 25 28.59)
- a short length of radio frequency (RF) coaxial cable (manufacturer unknown, part identifier 1RCA23E) and its BNC connector (manufacturer unknown) (Figure A1).

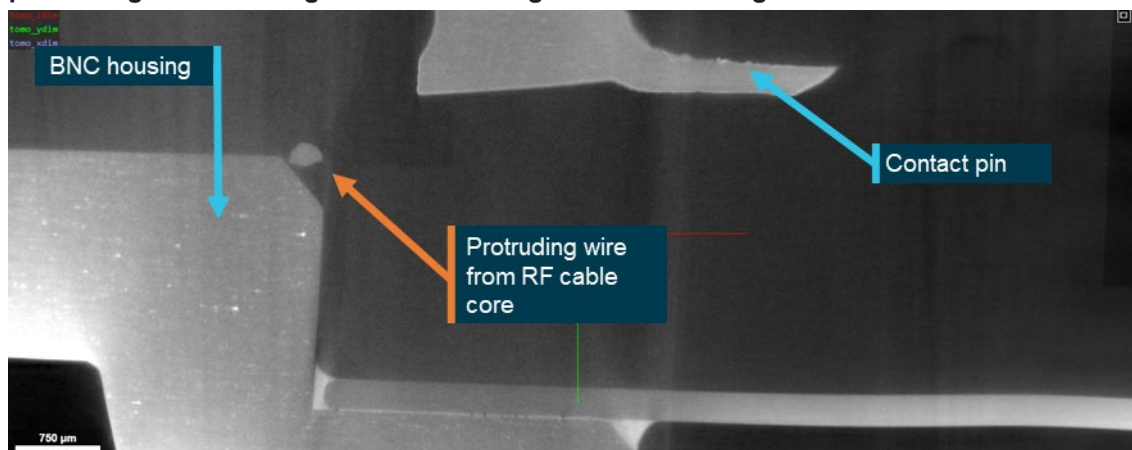
The micro-CT imaging enabled high-resolution non-destructive evaluation of the internal condition of the antenna and BNC connector. The micro-CT imagery did not identify any defects to the entire length of the radiating element, however a crack indication was identified within the soldered joint between the circuit board and the link wire within the antenna base (Figure A4). Additionally for the BNC connector, a potential defect was indicated where a single wire strand was not contained within the centre pin and was protruding sufficiently to be in contact with the connector body (Figure A5 and Figure A6).

Figure A6: Micro-CT of the helicopter's RF cable BNC connector: close view of the protruding wire showing it was contacting the BNC housing

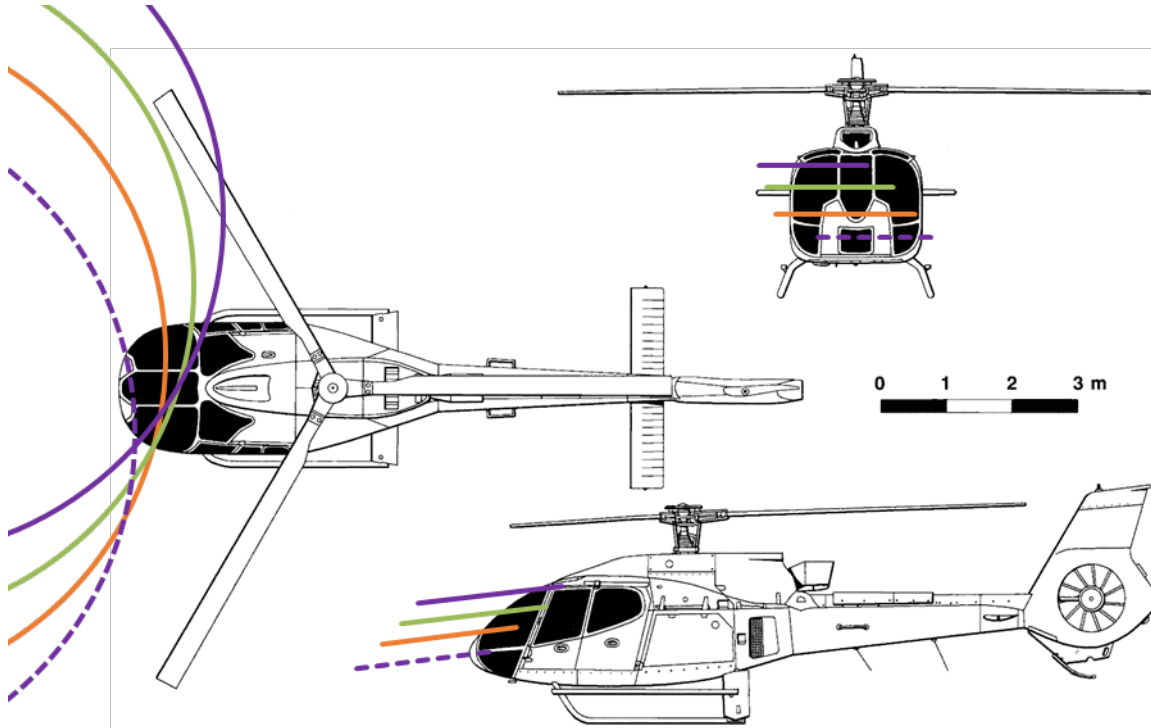
As evidenced by the damage to VH-XH9, the main rotor blades of VH-XKQ made 4 passes through the cabin of VH-XH9 (Figure B1). Debris and damage signatures along with injuries sustained by the occupants of VH-XH9 correlate to the right-to-left main rotor blade path (clockwise rotating main rotor system) through the cabin of VH-XH9. The initial impact was captured in video taken by the rear left outboard passenger of VH-XH9 (Figure B2), and the vertical and lateral position of VH-XKQ at the point of first contact aligns with the purple dotted line in the figure below.

Figure B1: VH-XKQ main rotor blade passes through the cabin of VH-XH9

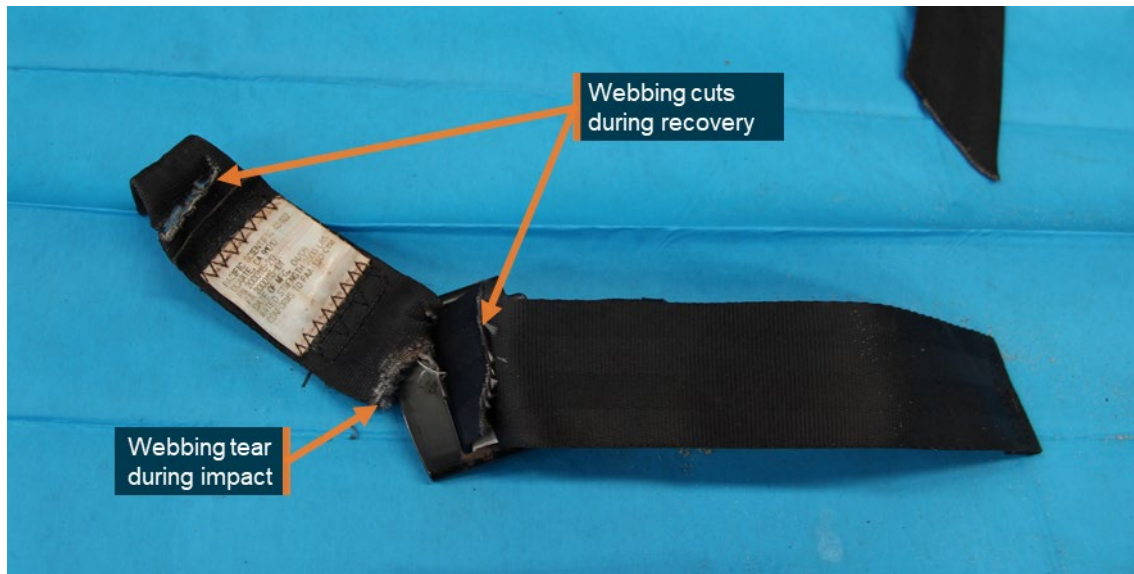
The seatbelt webbing of the right rear inboard seat was cut at the right lap belt adjuster. However, it did not fail completely (Figure B13) and was possibly caused by being caught between the seat bucket and that of the adjacent seat as they moved relatively.

Figure B13: Rear right inboard seat right lap belt

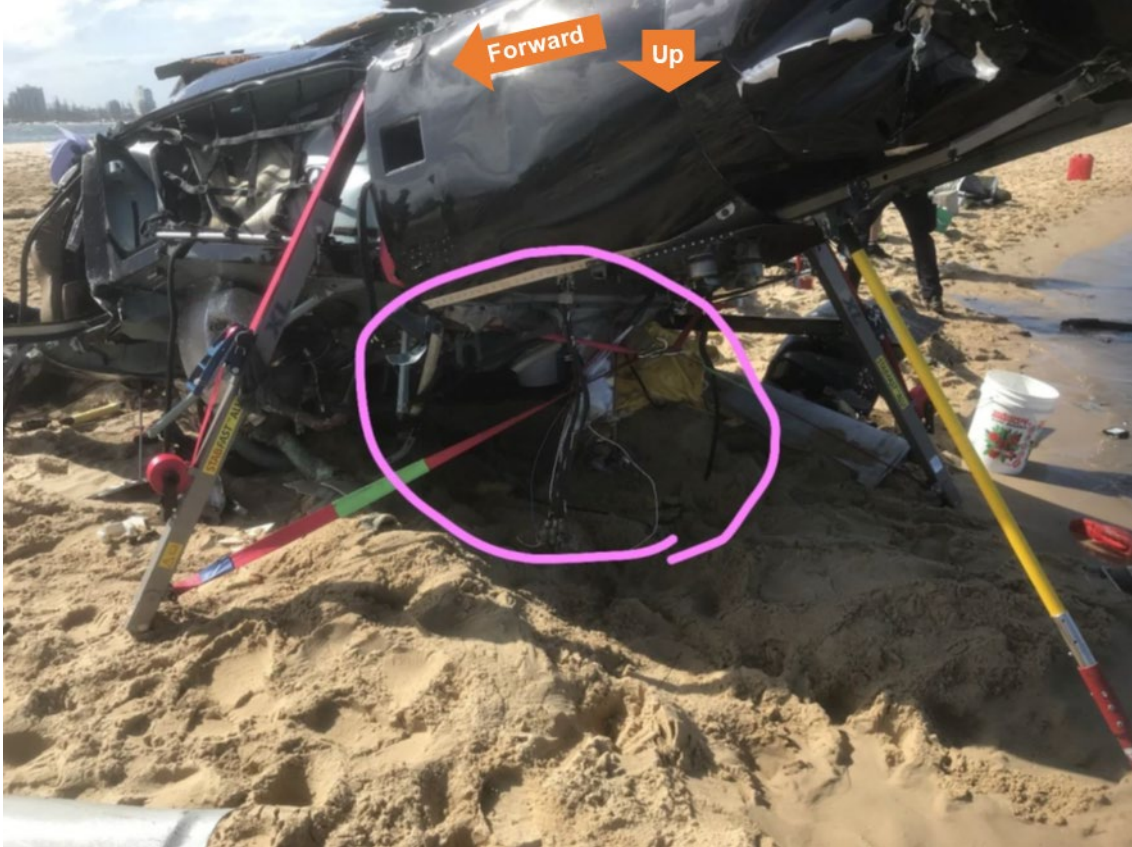
A Queensland Fire and Emergency Services (QFES) response and extrication report identified the extraction of a person subsequently identified as the rear left outboard passenger (described above). The passenger was located outside and underneath the helicopter wreckage, when they should have been restrained by their harness and seat and remained within the cabin (Figure B15).

Figure B15: VH-XKQ – location of the rear left outboard passenger

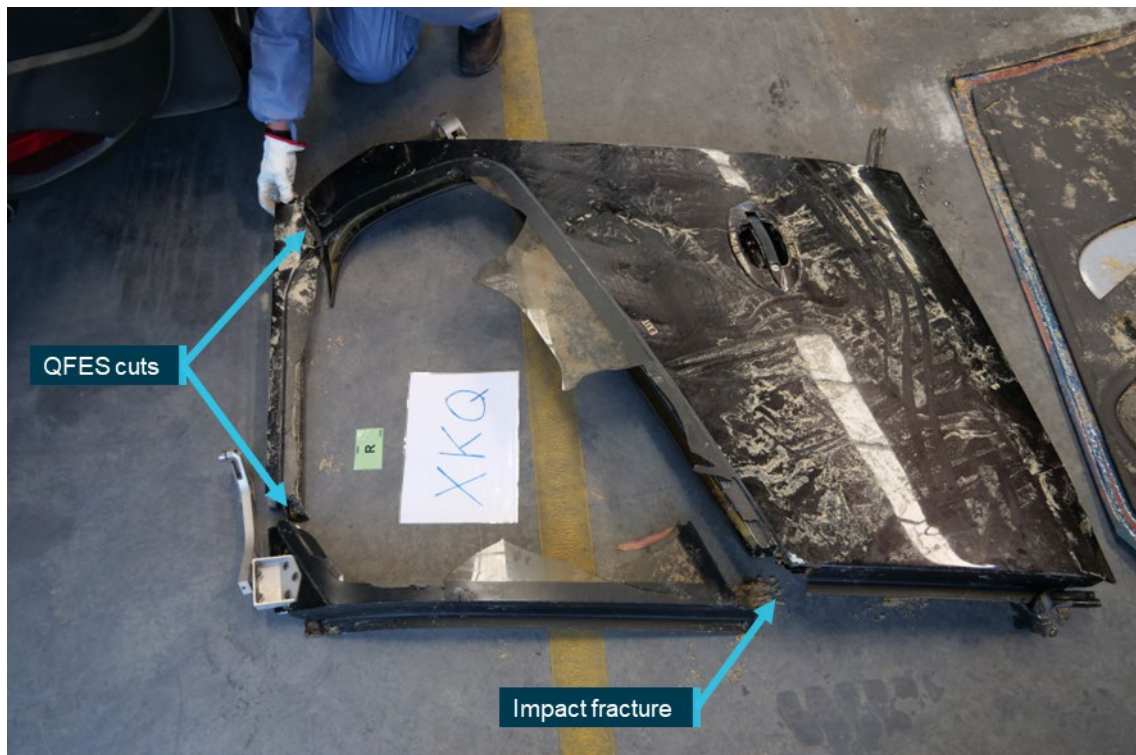
QFES extricated the passenger towards the rear after cutting a door frame (Figures B16 and B17). Specialist equipment was required to access the passenger and their extrication 'was impeded by what appeared to be the top of a door frame protruding up from beneath the top of the overturned airframe in the sand'. The door was subsequently identified as being the rear left passenger cabin door that the passenger was sitting next to.

Figure B17: VH-XKQ rear left cabin door
