Midair collision involving Eurocopter EC130 B4, VH-XH9, and Eurocopter EC130 B4, VH-XKQ

Main Beach, Gold Coast, Queensland, on 2 January 2023

ATSB Transport Safety Report

AO-2023-001

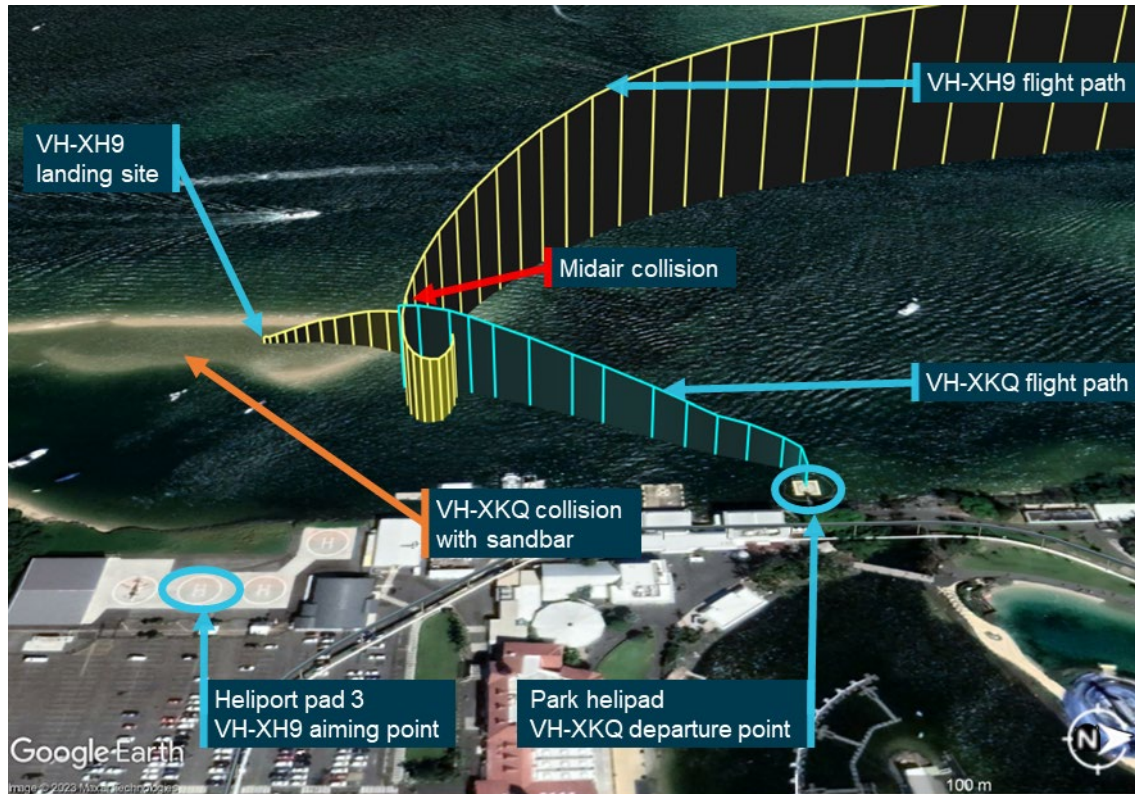
Figure 4: The converging flight paths of XKQ and XH9 leading to the midair collision

fragments. The pilot credited his sunglasses with saving his eyes from the shrapnel. The pilot reported that all flight instruments were missing or failed, the rotor system was damaged, and the engine rpm started to decay. Though injured during the collision, the pilot assessed controllability and found the flight controls remained intact. The pilot landed XH9 on the sandbar, a pre-determined forced landing area, at 1356:35 (Figure 4).

The pilot and 3 passengers on board XKQ were fatally injured, and 3 passengers were seriously injured. The pilot and 2 passengers on board XH9 were seriously injured and 3 passengers had minor injuries. XKQ was destroyed and XH9 was substantially damaged.

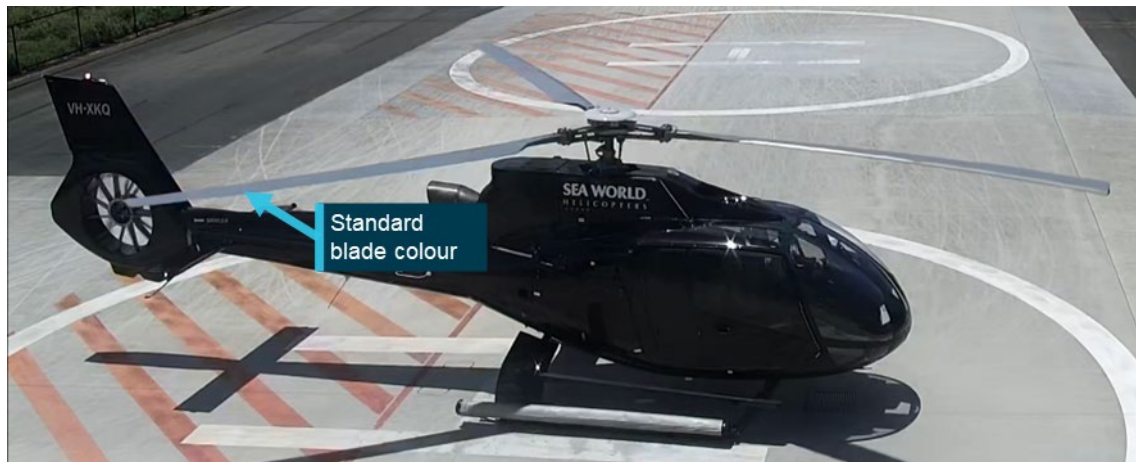
Figure 12: XKQ at the operator's heliport showing standard visibility blades

The top surface of the main rotor blades of XKQ, as shown in Figure 12, were not coated with a high-visibility paint scheme nor were they required to be.

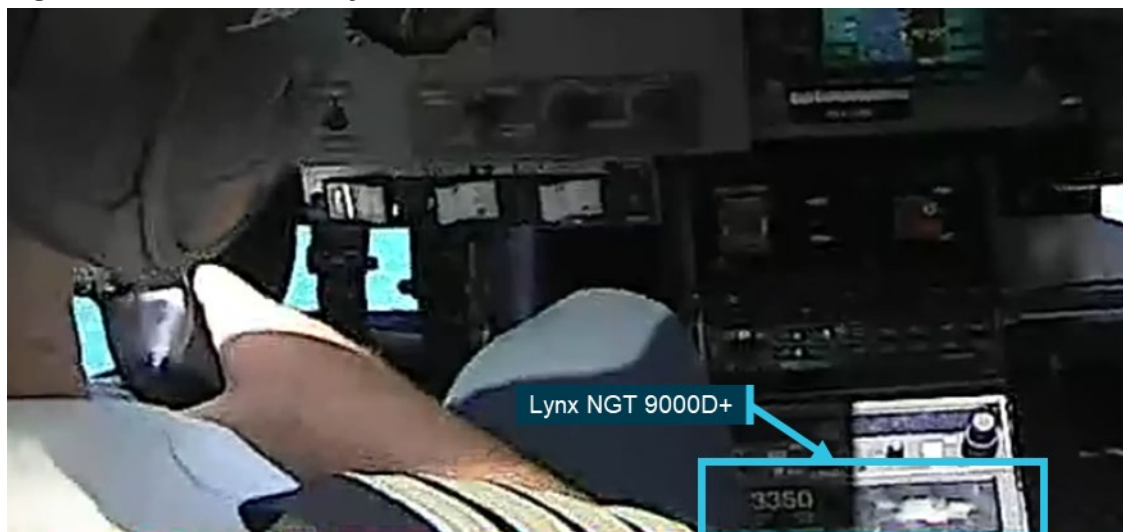
Figure 17: Location of L3 Lynx NGT 9000D+ in VH-XH9

The pilot of XH9 did not recall a visual display of traffic being available in XH9. Footage of previous flights in XH9 indicated the Lynx NGT displayed active traffic. However, the position of the transponder on the aircraft’s instrument console was consistent with the normal location of a transponder, which as a device pilots seldom refer to in flight, was not in a conspicuous position. In XH9 it was installed to the right of the pilot’s right knee (Figure 17). The screen was not well positioned for integration with an external scan, and it was not linked to any other cockpit displays.

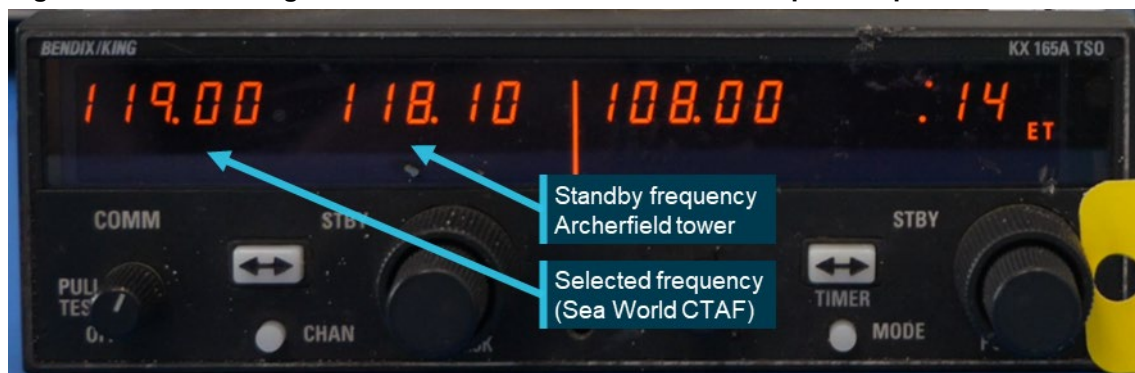
Figure 20: Bendix King KX-165A from VH-XH9 – indication on power up

- Com 1 – Garmin 430: Damaged beyond repair due to main rotor blade strike. The ATSB could not determine the settings on this unit. The volume knob on the unit was found to be set at approximately 66% (2/3 rotation).
- Com 2 – Bendix King KX-165A: The selected frequency was 119.00 MHz (local CTAF), with a standby frequency 118.10 MHz (Archerfield Airport Tower). The volume knob on the unit was found to be set at approximately 50% (see Figure 20).
- Audio Panel: Both transmit and receive functions had only Com 2 selected. The audio panel volume control, for both the pilot and for the passengers, was positioned at approximately 40%. The intercom mode was set to 'All'.

When powered, the transponder code showed 1200, the standard transponder code used for VFR flights outside controlled airspace. Review of the fault and events log identified only one valid fault. The fault was indicative of the power being cut to the transponder. This likely occurred as the rotor blades of VH-XKQ passed through the canopy and the back of the instrument panel of VH-XH9, cutting the wiring.

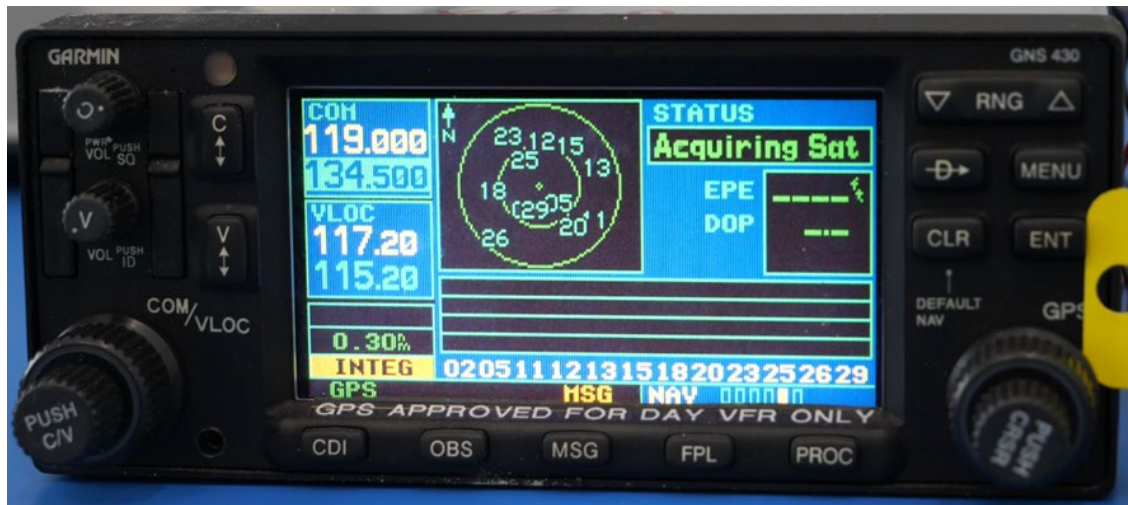
Figure 21: Garmin GNS430 (Com 1) from VH-XKQ – indication on power up after self-test

- Com 1 – Garmin 430: The selected frequency was 119.00 MHz (local CTAF), with a standby frequency 134.50 MHz (Gold Coast Airport Automated terminal information service). The volume knob on the unit was found to be set at approximately 75% (The intercom switch was found in the CREW selection prior to being removed from the helicopter. The audio panel crew volume was positioned at approximately 25% and the passenger volume control was positioned at approximately 75%. (Figure 21).

- Audio Panel: Both transmit and receive functions had only Com 1 selected. The intercom switch was found in the CREW selection prior to being removed from the helicopter. The audio panel crew volume was positioned at approximately 25% and the passenger volume control was positioned at approximately 75%.

As the Com 1 unit was being used for communications on the accident day it was tested at a CASA-authorized avionics maintenance facility, observed by the ATSB. The communication receiver and transmitter, along with the navigation and GPS, were functional. The transmission power at 9.5 W and modulation at 60% were found to be slightly low, however, the avionics technician advised it would not have affected normal operation. It was noted that various buttons required a 'heavy push' which can be encountered with older units.

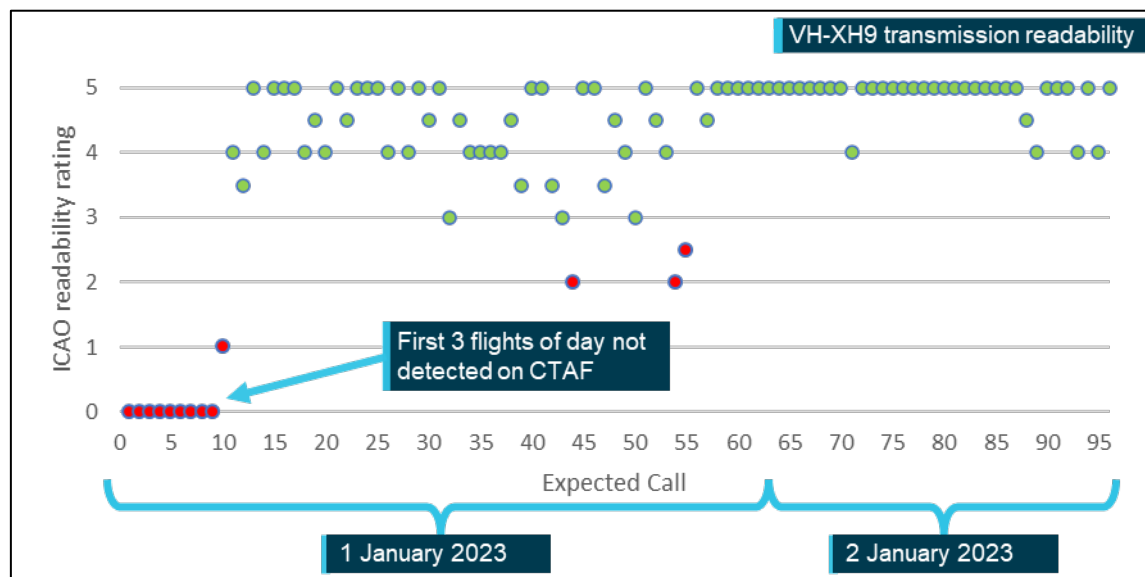
Figure 24: VH-XH9 transmission readability of scenic flight calls

Departure calls, position reports, and inbound calls from XH9 can be heard clearly over the 2 days of recordings. Of 96 total calls expected from XH9 (Figure 24), 87 were detected (90%). The 10% that were not detected all relate to the first 3 flights of 1 January 2023. The reason for those flights going undetected was not discerned. On 2 January the pilot of XH9 reported using Com 2, a Bendix KX165A, as they were dissatisfied with failing buttons on Com 1, a Garmin 430.

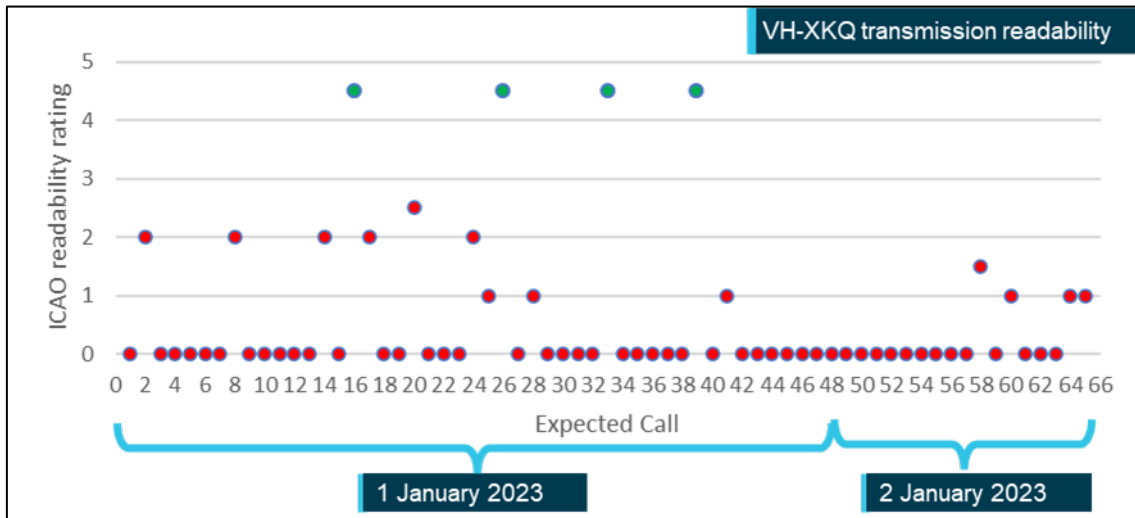
Figure 25: VH-XKQ transmission readability of scenic flight calls

Transmissions from XKQ had a much lower rate of detection and most of the calls detected were unreadable (Figure 25). Of the 65 standard calls expected, 17 were detected (26%) most of which were unreadable. Most (94%) of the expected calls over the 2 days from XKQ were rated as absent or unreadable. The ATSB gathered evidence from pilots operating in the vicinity of Sea World when XKQ was operating on 2 January 2023 and none reported noticing issues with XKQ's transmissions.

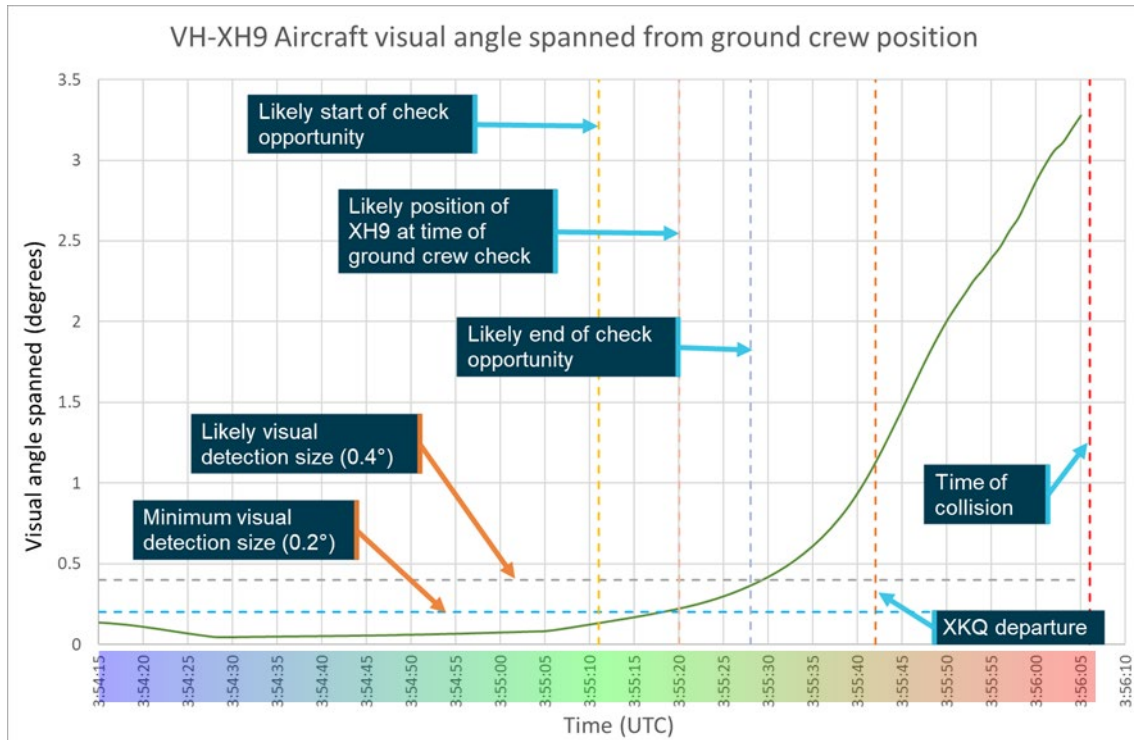
Figure 28: Visual angle VH-XH9 spanned from ground crew position

The data showed that during the 17 s opportunity to view it, the visual angle spanned by XH9 was below the reliably observable size of 0.4° , and for about the first half, below 0.2° (Table 7 and Figure 28). Further it had a low apparent movement from the point of view of an observer at the park pad, at around 0.4 deg/s (Figure 28).

Figure 28 shows the change in visual angle XH9 spanned from the point of view of the ground crew on the park pad, as XH9 travelled south along the Broadwater. The dots on Figure 28 represent a timeline based on the location of XH9 while XKQ was preparing for departure. These charts are to be read together.

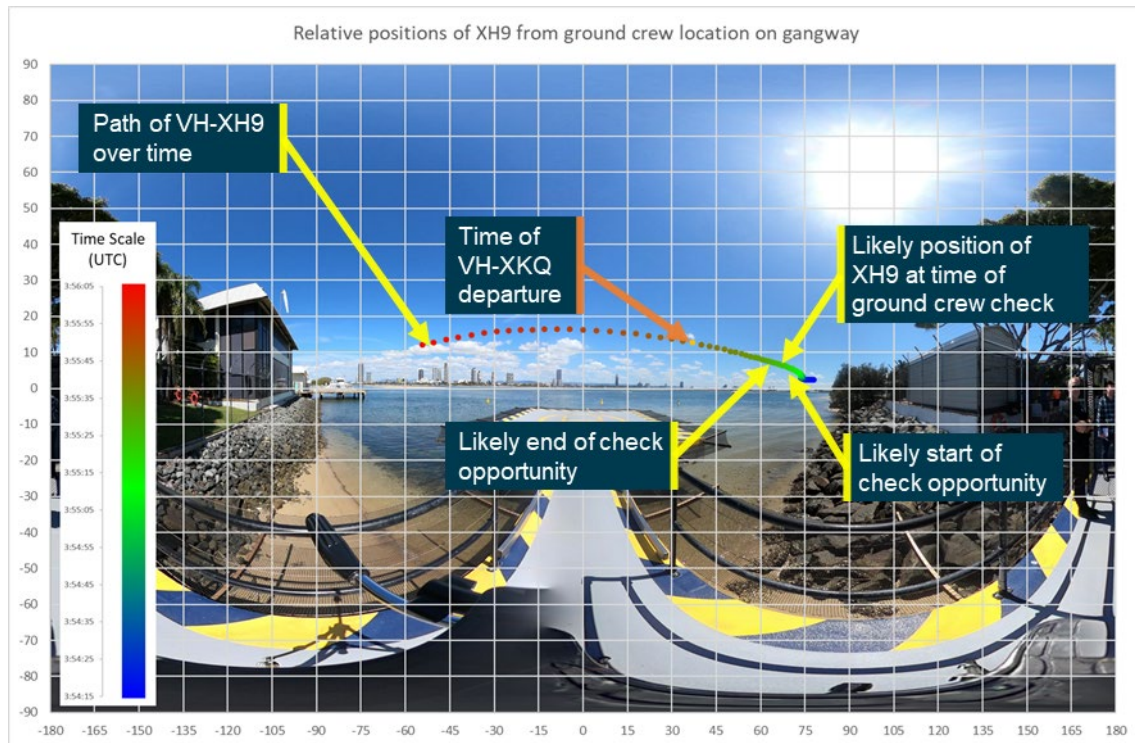
Figure 29: Passage of XH9 from the ground crew position

Note: The visual angle size of XH9 for the ground crew is depicted in Figure 28 and should be consulted to interpret this image.
Source: ATSB

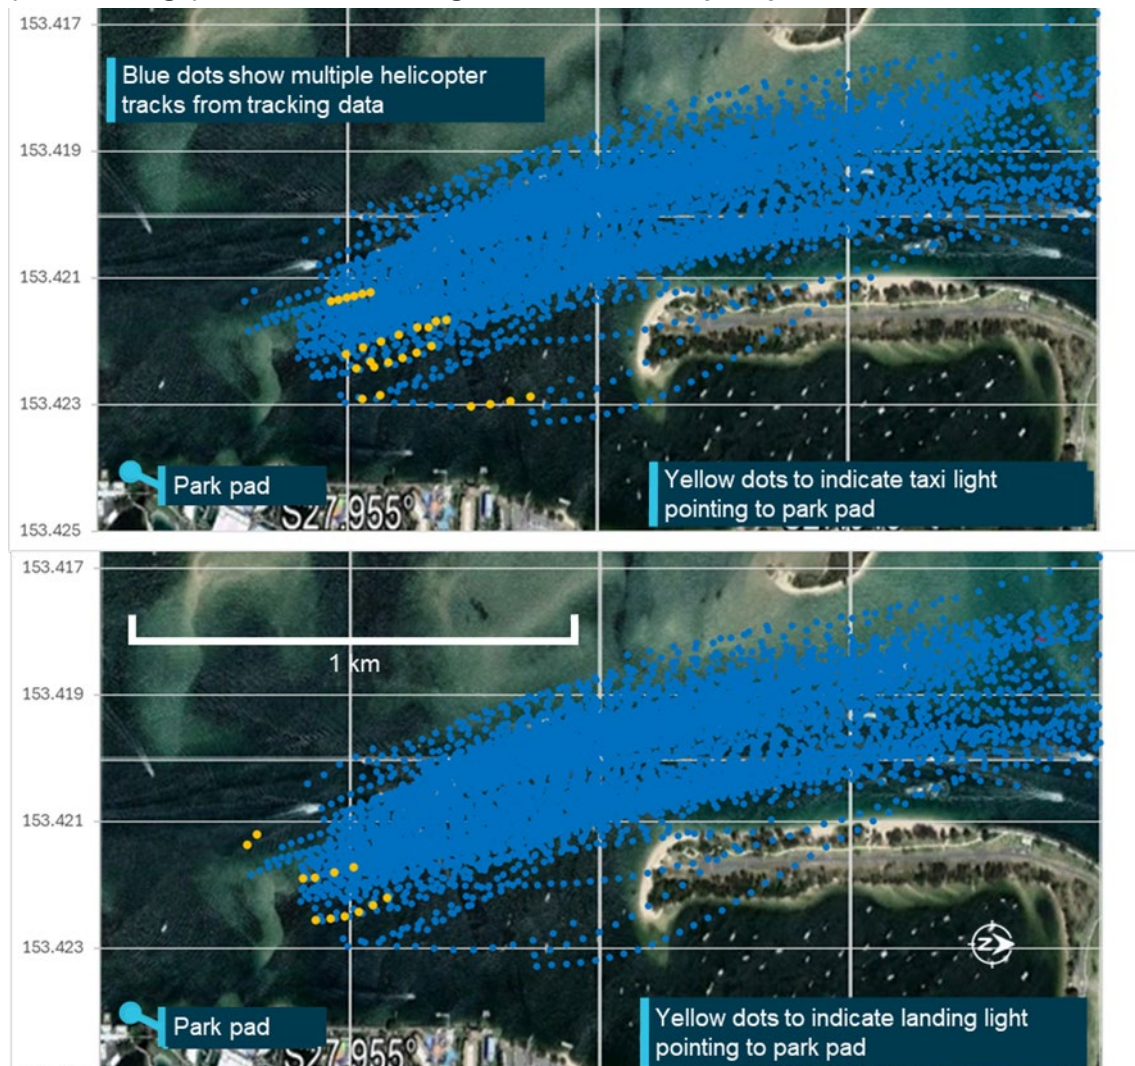
Figure 30: Orientation of EC130 showing when taxi lights (top image) and landing lights (bottom image) could be visible to ground crew on the park pad

Though XH9 was not displaying landing or taxi lights, the operator's procedures required helicopters to light their landing and taxi lights. While these lights may be useful for other aircraft, these lights would only aid ground crew detection in a narrow set of circumstances. The tight beams and orientation of the lights mean they would not often be pointing at the ground crew on the helipad (Figure 30). While angled away from the park pad the light would be less likely to be detected by an observer on the ground.

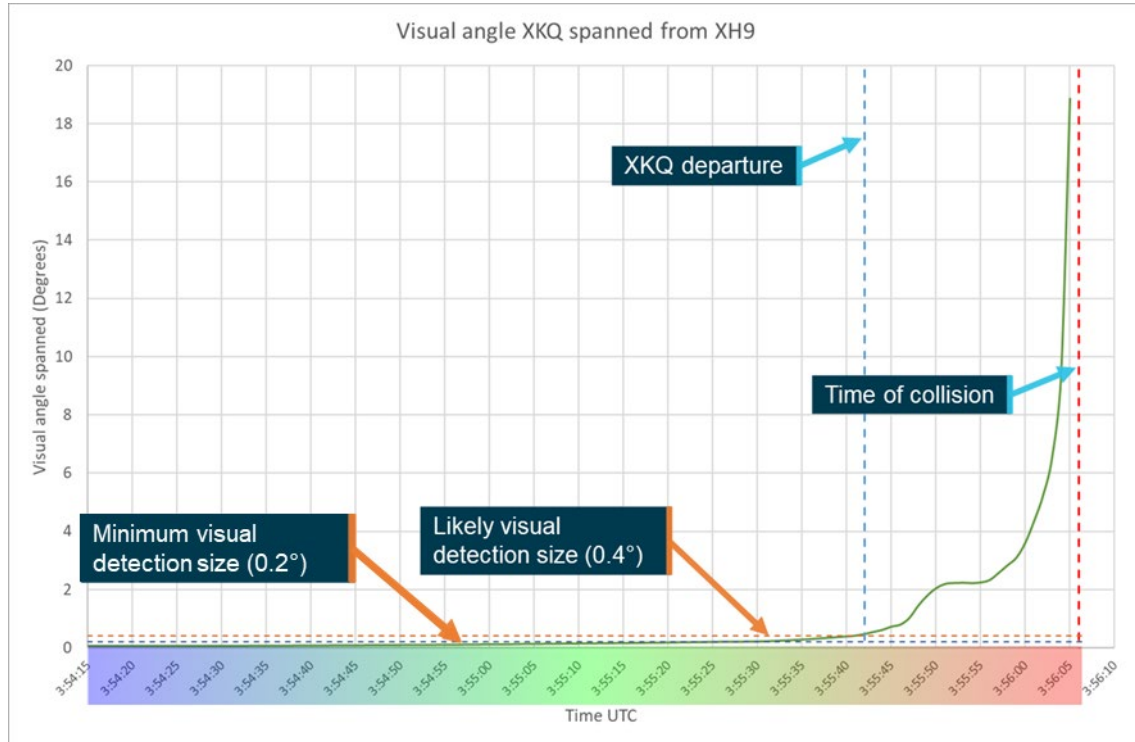
Figure 31: Plot of visual angle spanned by XKQ from the pilot's eye position of XH9

The *Visibility study* also examined the position of XKQ from the pilot of XH9's perspective. Figure 31 shows the visual angle XKQ spanned from the eye position of the pilot of XH9 as they progressed through their approach.

Visual angle spanned by XKQ is not depicted in Figure 32 and it must be read in conjunction with Figure 31, where the coloured dots are represented by a coloured bar on that chart.

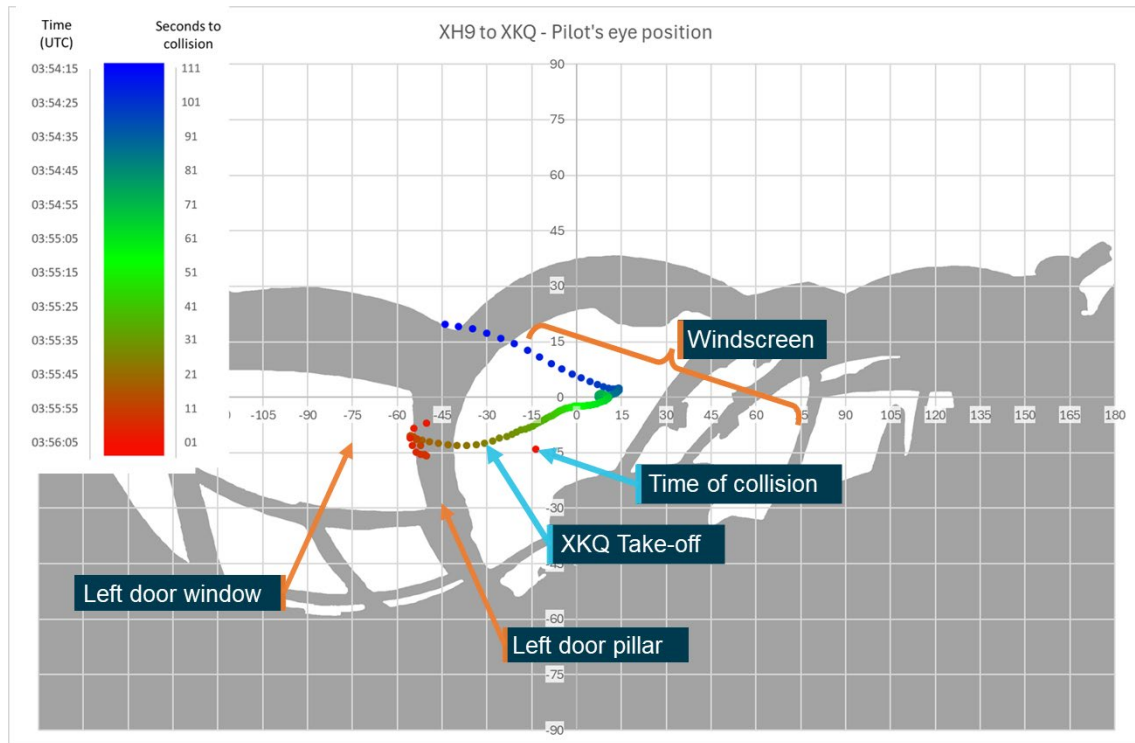
Figure 32: Relative position of XKQ overlaid on pilot of XH9's eye position

Figure 32 illustrates the position of XKQ and line of sight from the pilot's eye position of XH9. Over the 111 second period captured in the analysis, from this position, their line of sight would be as depicted in the chart. Note that it is likely that the pilot's head position and gaze changed during this period.

Note: Timescale reads from 111 seconds to collision (blue) while XKQ was still on the pad to time of collision (red).
Source: ATSB

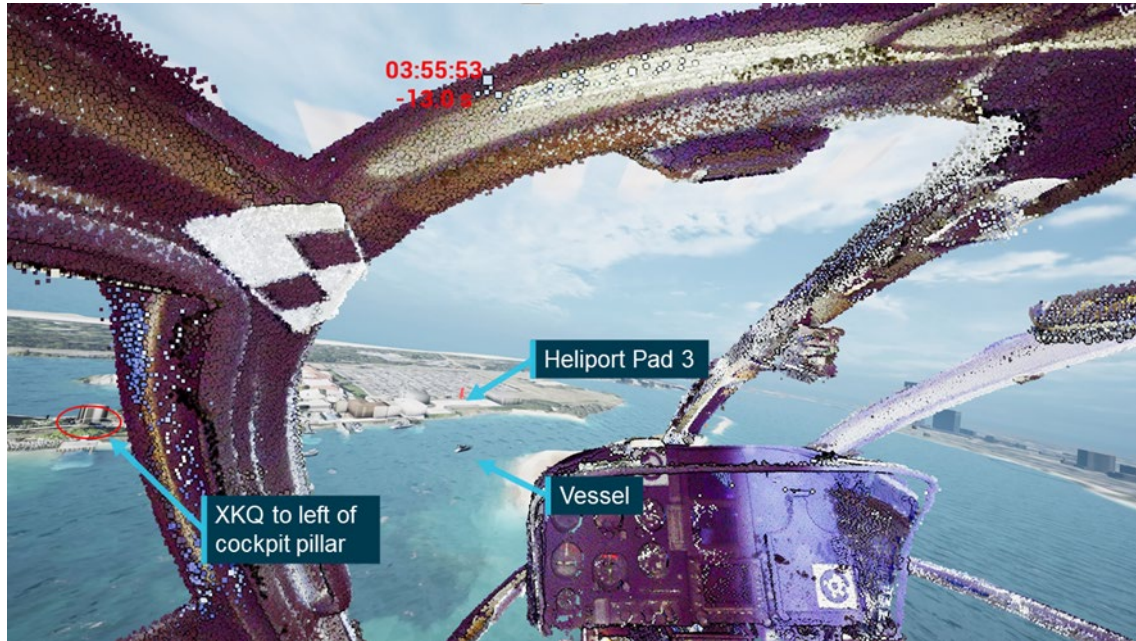
Figure 33: Relative positions of Heliport Pad 3, vessel and XKQ at 13 s prior to impact

The *Visibility study* also reviewed the relative position of the vessel that the pilot of XH9 avoided while approaching to land. The vessel and heliport 3 at the heliport appeared centrally within the pilot's windscreen, while XKQ was to the left, behind or outside of the cockpit pillar. Figure 33 shows the recreation of the pilot's likely view of these elements 13 s prior to collision. Figure 34 shows the recreation 6 s before the collision when XKQ and the marine vessel were shielded by the cockpit structure. These times (13 and 6 seconds) encompass the estimated time required to detect an aircraft and manoeuvre to avoid collision from a distance and at close quarters. The FAA (2022) cited research that found identifying a collision risk, reacting and manoeuvring to avoid a midair collision takes on average 12.5 s. The ATSB (2002) cited research that found close proximity events can be resolved more quickly, stating it could take from around 3.9 s to 5.9 s to recognise the hazard (1.5–3.5 s), take avoiding action (0.4 s) and have the aircraft respond (2.0 s).

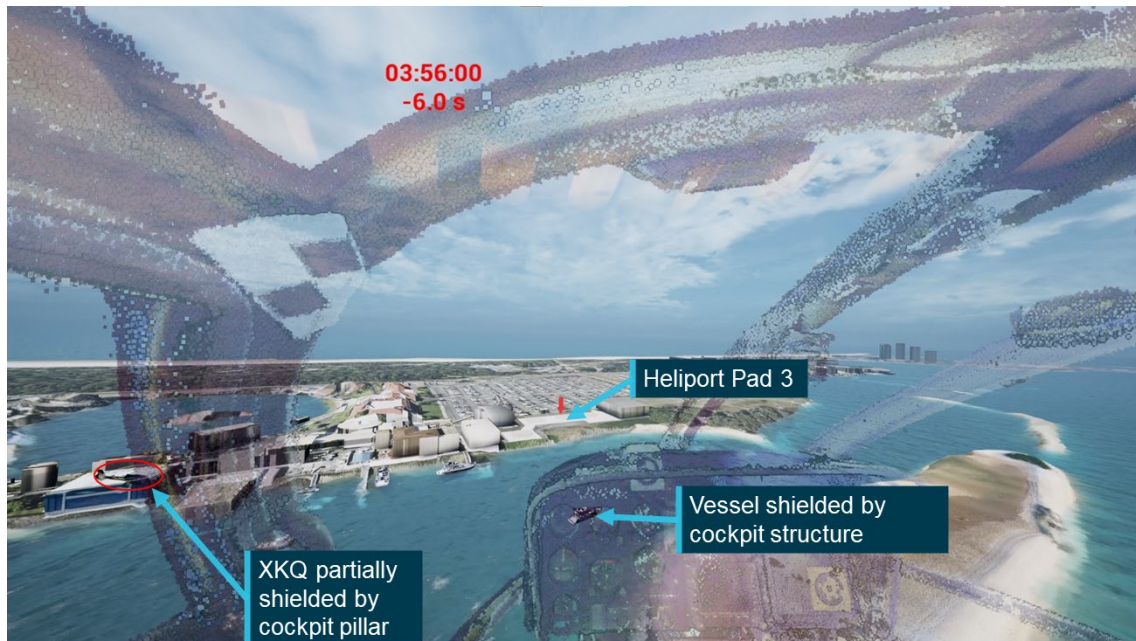
Figure 34: Relative positions of Heliport Pad 3, vessel and XKQ at 6 s prior to impact

The opacity of the cockpit structure has been reduced to 60% to show the relative positions of both XKQ and the vessel which were likely partially or fully obstructed from pilot's eye position.

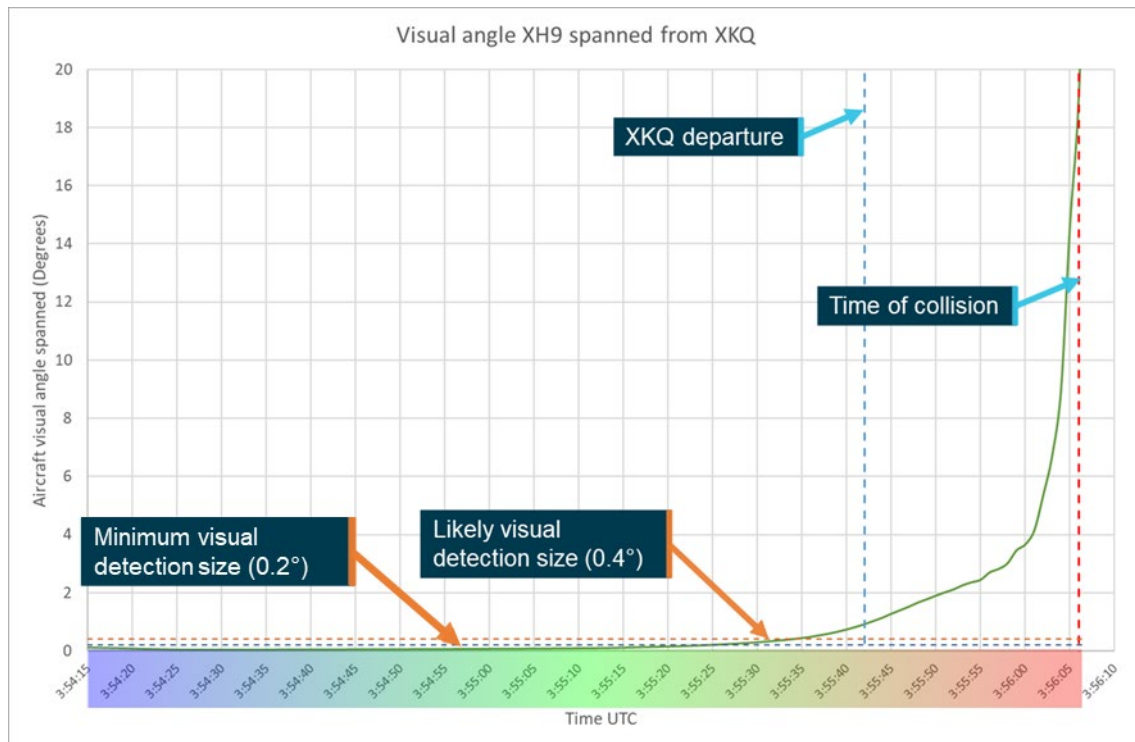
Figure 35: Plot of visual angle spanned by XH9 from the pilot's eye position of XKQ

Figure 36 illustrates the position of XH9 from the designed eye position of the pilot of XKQ. The *Visibility study* determined that from between 111 and 56 s before the collision, as the pilot of XKQ was preparing to depart, XH9 was visible through the pilot's rear left window unshielded by cockpit structures. Looking in that direction would have required the pilot to rotate around 160° to look over their left shoulder, and due to the distance between the helicopters at that time, the visual angle that XH9 spanned was below the threshold of likely visual detection (Figure 35).

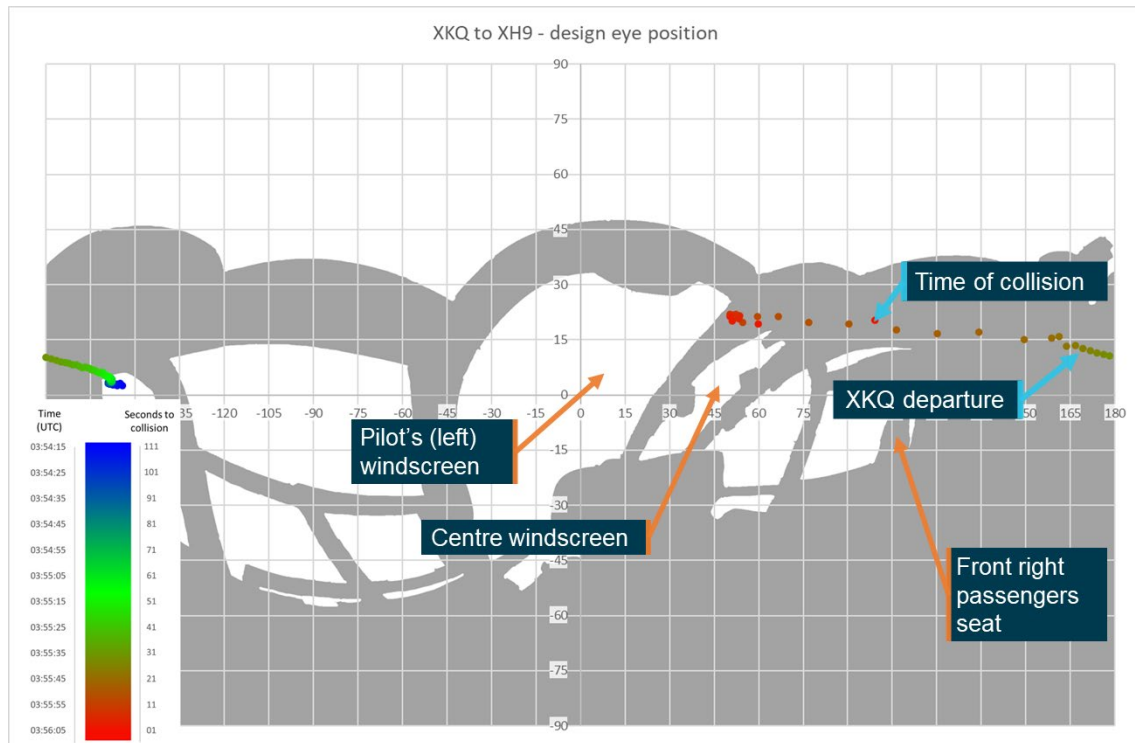
Figure 36: Relative position of XH9 overlaid on pilot of XKQ's eye position

As XH9 approached the park pad, its apparent location from the designed eye position of the pilot of XKQ moved behind, then to the right. From 32 seconds prior to the collision, when XH9 was approximately 615 m from the park pad, it was obscured by cockpit structures. This is shown in the green dots in Figure 36. As XKQ picked up into the hover, the apparent location of XH9 moved upwards and from right to left, shielded by airframe structure. This is shown as the red dots in Figure 36. Figure 36 and Figure 37 should be read in conjunction with Figure 35.

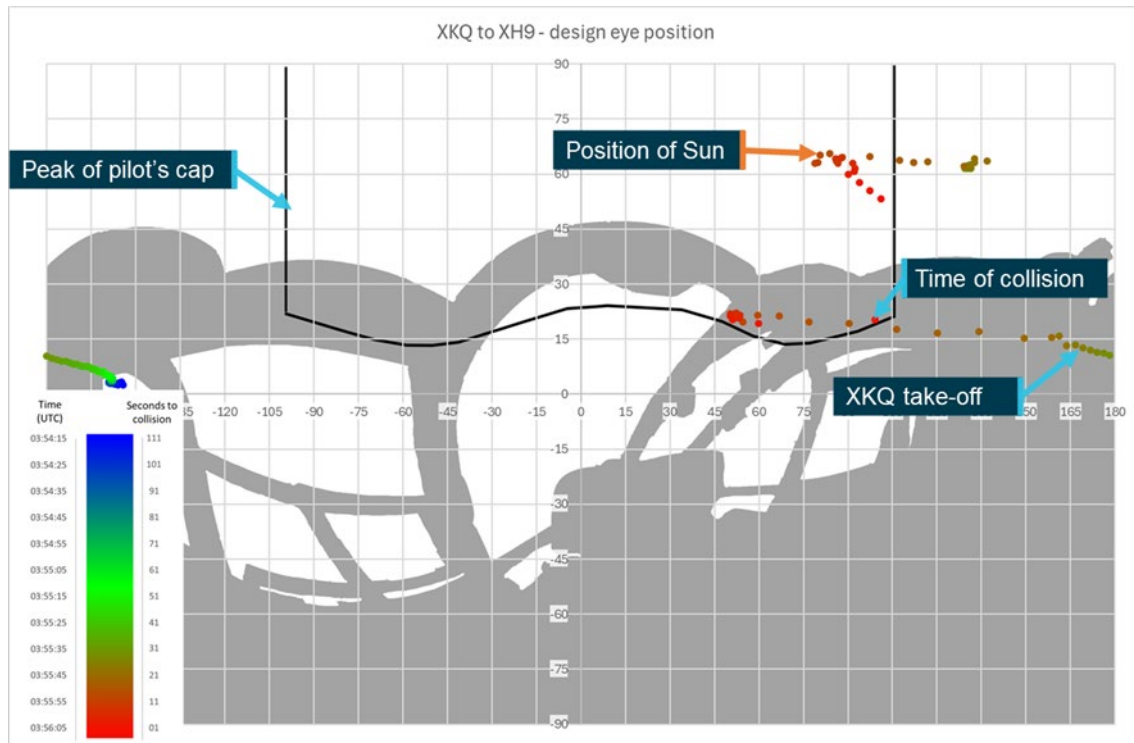
Figure 37: Relative position of XH9 from XKQ overlaid with shielding of pilot's cap

The pilot of XKQ was wearing a peaked baseball cap and the *Visibility study* also reviewed the potential impact of the pilot's cap. As XH9 was shielded from the pilot's eye position before XKQ departed the park pad, the pilot's cap would not have made sighting XH9 more difficult. Where the sun is visible, or close to the edge of the field of view, the sun's glare can reduce a pilot's ability to locate traffic. Given the location of the peak of the cap, as shown in Figure 37, and the relative position of the sun, the pilot's cap likely reduced the direct and indirect impacts of the sun on the pilot's vision.

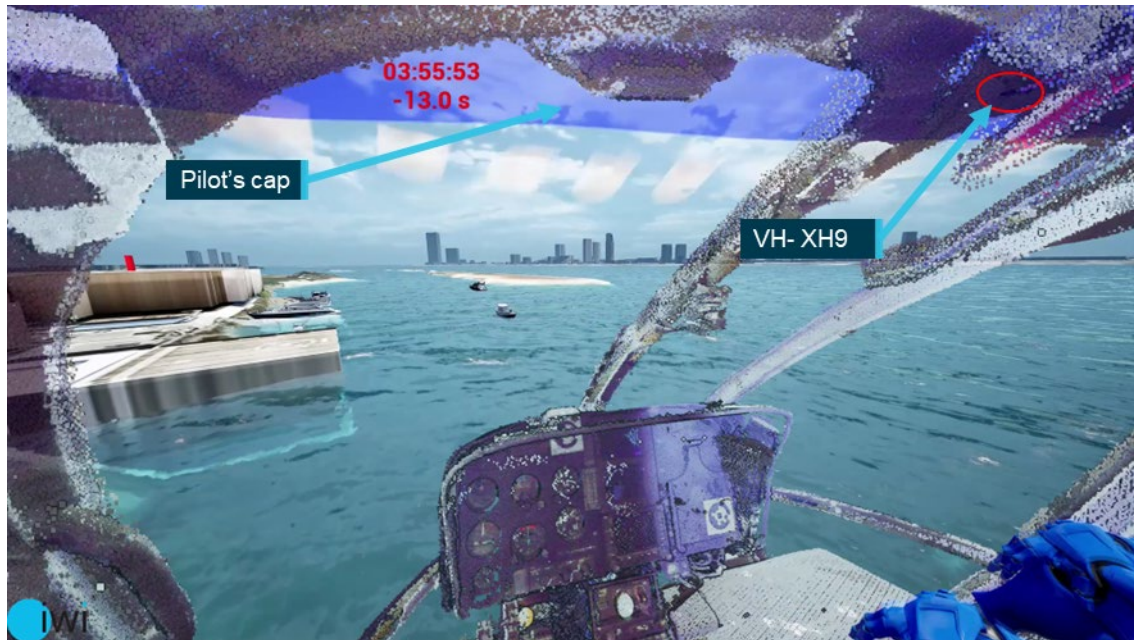
Figure 38: Simulated view from XKQ, 13 s before collision (looking straight ahead)

Figure 38 and Figure 39 show simulated views from the pilot's location in XKQ, 13 s and 6 s before the collision. In Figure 38 the view shows the relative location of XH9 behind the roof structure of XKQ.

Note: Pilot's cap is represented by the transparent blue section at the top of the image.
Source: iwi GmbH, annotated by the ATSB

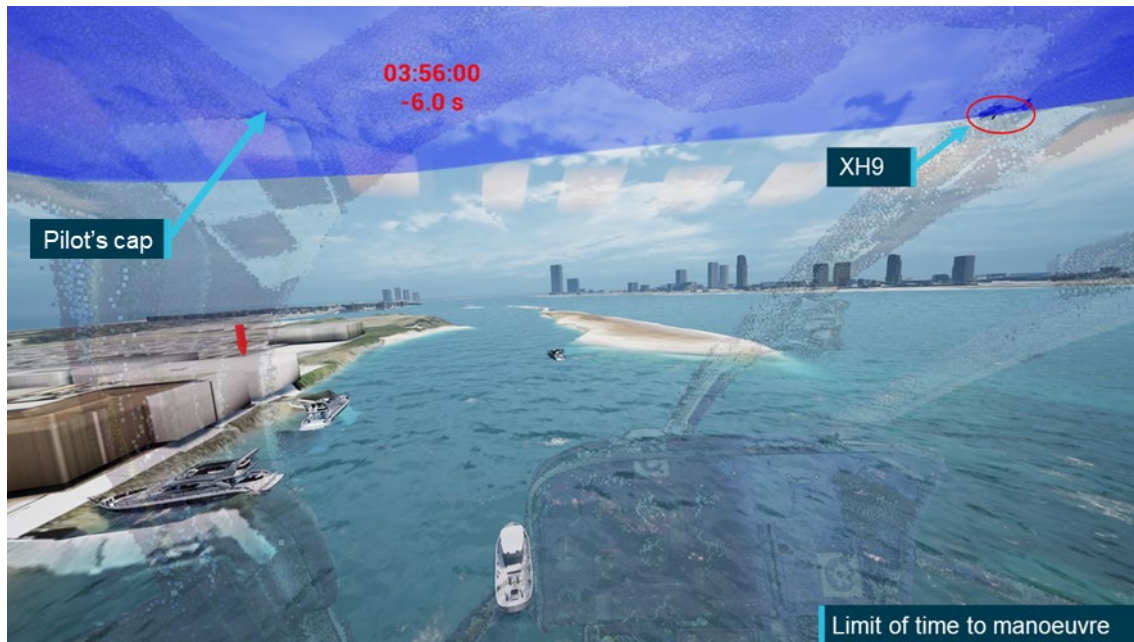
Figure 39: Simulated view from XKQ, 6 s before collision (looking straight ahead)

Note: Pilot's cap is represented by the transparent blue section at the top of the image.
Source: iaviation GmbH, annotated by the ATSB

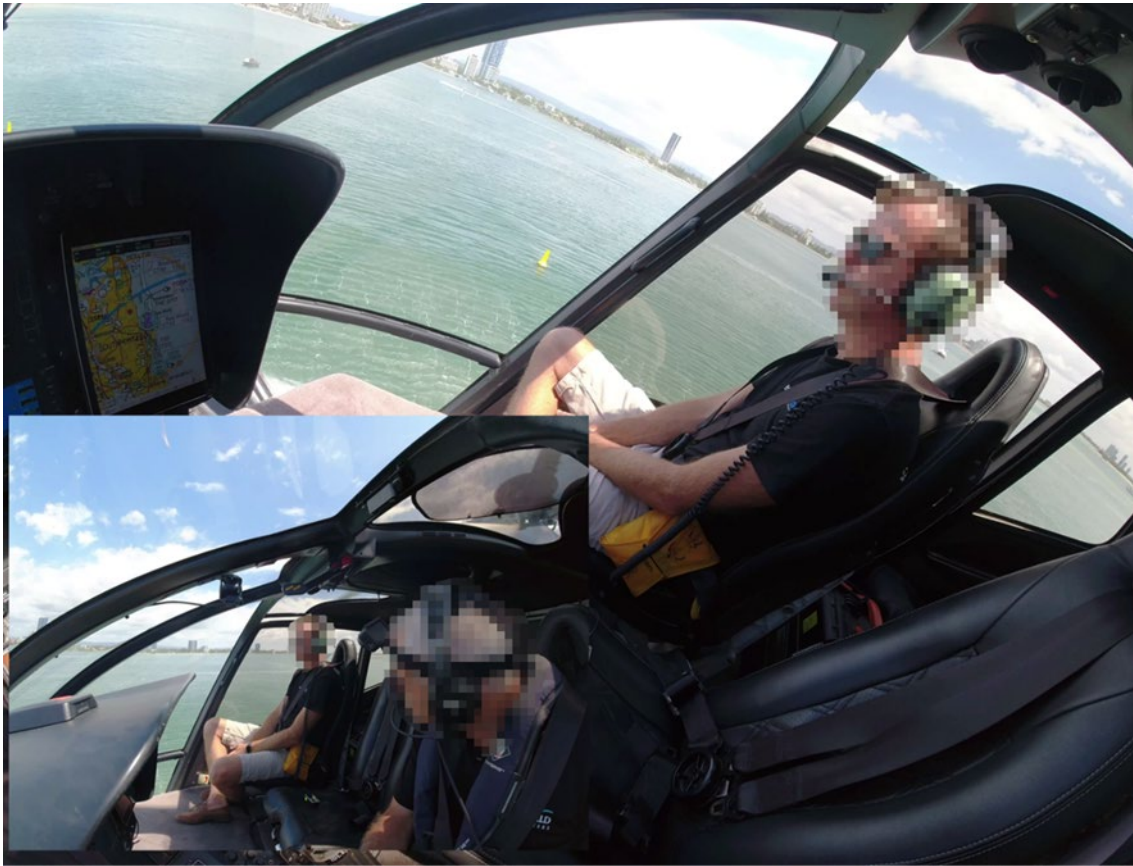
Figure 40: Still images during EC130 visibility testing captured from the operator's video

Following their review of the draft report, the operator provided a video titled 'EC130 vision test'. The video was frame-in-frame footage of the new HOFO lifting an EC130 into a hover at the park pad. Action cameras were mounted to the pilot's head and on the left of the cabin looking right (Figure 40). The recording showed a helicopter hovering at the park pad, the pilot coordinating with an inbound helicopter and using scanning techniques to demonstrate detection of an inbound helicopter.

The video demonstrated that if a pilot is aware of an inbound helicopter, coordinates with it and waits in a high hover over the helipad to establish visual contact, that they can see it and track its progress. The operator's vision test's value to the investigation lay solely in demonstrating the scanning techniques employed by the operator. The ATSB analysed the expected outcome of the scanning techniques demonstrated in the operator's video via the results of the sensitivity analysis in the *Visibility study*.

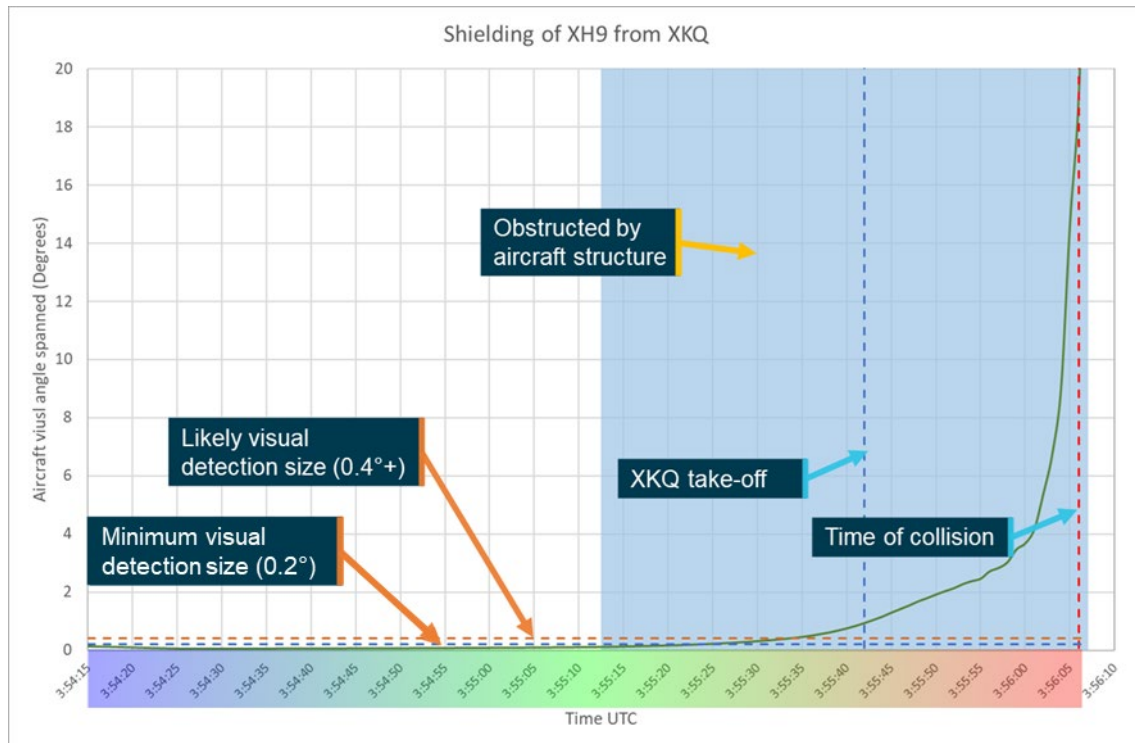
Figure 41: Shielding chart of pilot of XKQ’s calculated eye position

The first scanning movement was announced as a 'normal scan'. It was conducted when the pilot knew the helicopter was there and the pilot rotated their head about 75 degrees to the right without their head moving from the nominal position before acquiring the inbound helicopter. This movement would not have revealed a conflict for the pilot of XKQ. From their eye position, XH9 was shielded the entire time of the flight (Figure 41).

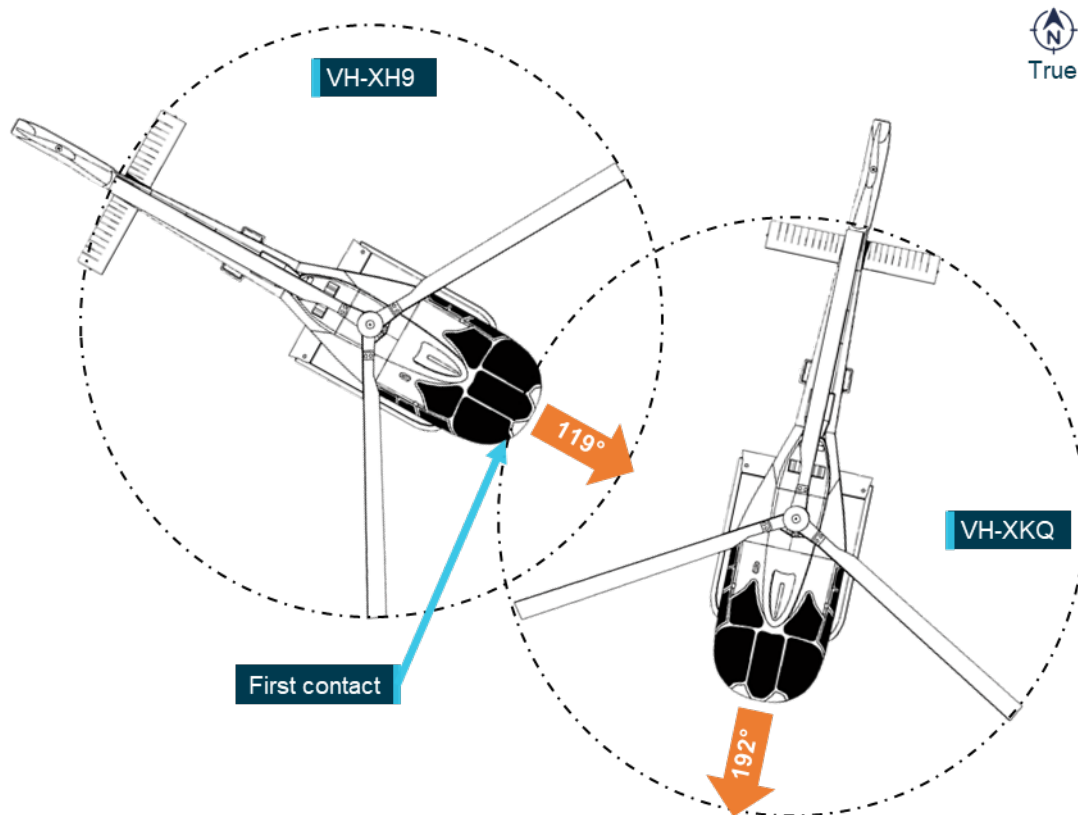
Figure 43: Flight paths at time of collision

Tracking data showed that, at the time of the collision, the helicopters had a relative flight path angle of 73° (Figure 43). XH9 was approaching to land at 27 kt groundspeed, descending at 640 fpm³⁴ while XKQ was climbing at 42 kt and 590 fpm.

The first contact was made with XKQ directly in front of XH9 when the main rotor blades of XKQ pierced the lower forward cabin windows and windscreen frame structures. Due to their relative flight paths, the main rotor blades of XKQ passed through XH9's forward cabin multiple times. The nose of XH9 then collided with the Fenestron of XKQ.

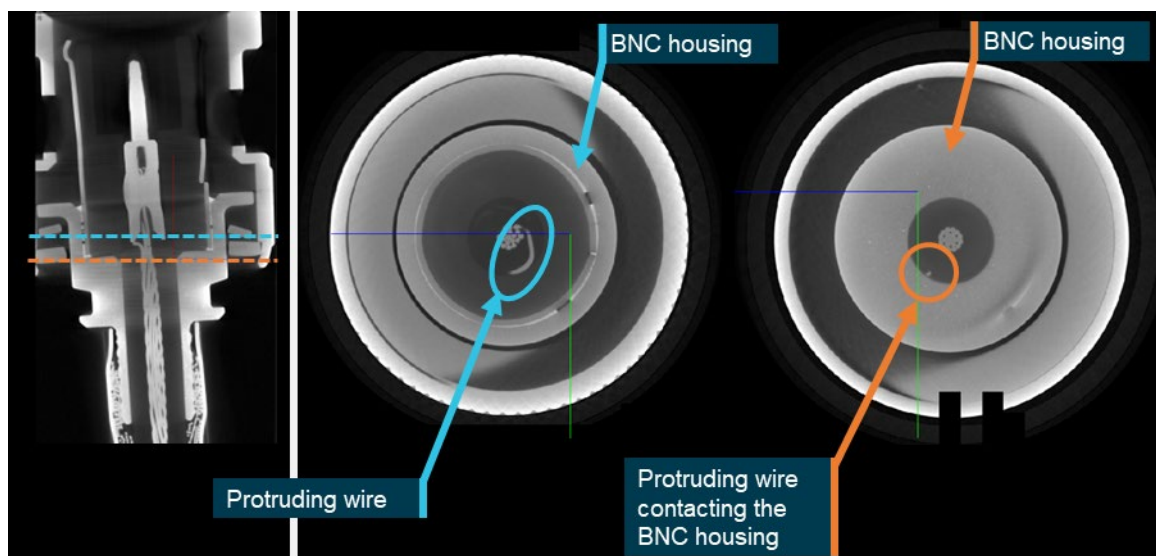
Figure 47: An X-ray of the RF cable BNC connector identified a single RF cable wire protruding from the connector pin (prior to destructive examination)

The scans identified a crack indication within the soldered joint between the circuit board (Figure 46) and the link wire to the antenna base. Additionally, a potential defect was indicated where a single wire was identified to be protruding from the centre pin from within the BNC connector (Figure 47).

The X-ray image was captured when the BNC connector was intact prior to destructive sectioning.
Source: Australian National University CTLab, annotated by the ATSB

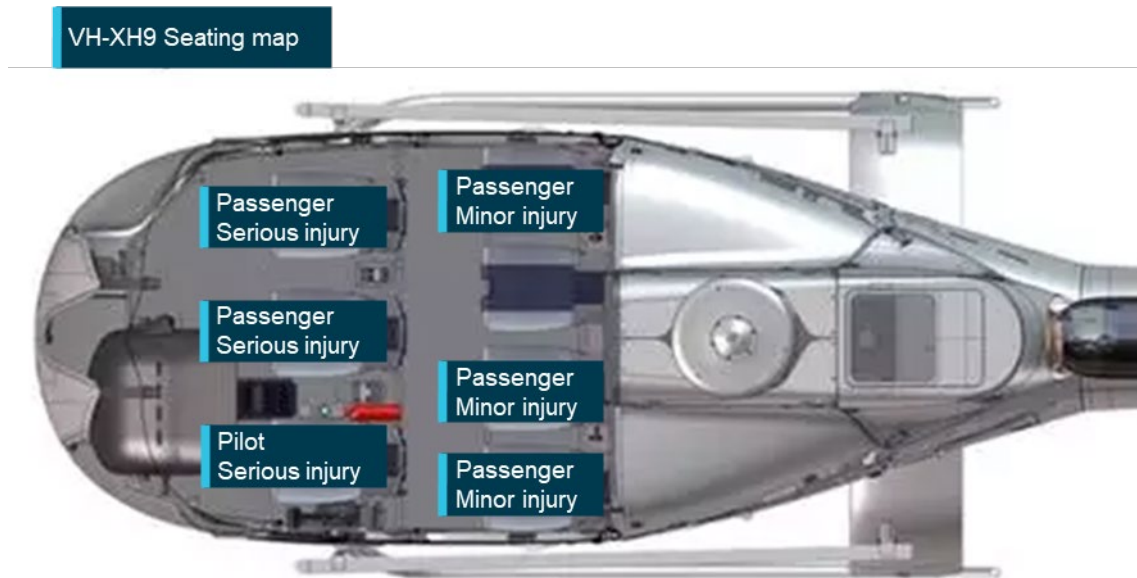
Figure 50: VH-XH9 seating map and injuries

The forward cabin of XH9 was significantly compromised by contact with the main rotor blades and Fenestron from XKQ, resulting in the windscreen and forward cabin structure being destroyed, with acrylic window debris entering the cabin causing serious injury to the pilot and 2 front passengers, and minor injury to the 3 rear passengers (Figure 50). The flight controls remained intact and allowed the pilot to continue flying.

Following the contact with XKQ, and after momentary loss of control, the pilot landed on a nearby sandbar. While it was later identified that passengers were not correctly restrained (see *Use and fitment of seatbelts* below), this was of no consequence due to the controlled landing. All passengers were able to self-evacuate and were treated by first responders, with the pilot and 2 passengers being later transported to a local hospital.
