Midair collision involving Eurocopter EC130 B4, VH-XH9, and Eurocopter EC130 B4, VH-XKQ

Main Beach, Gold Coast, Queensland, on 2 January 2023

ATSB Transport Safety Report

AO-2023-001

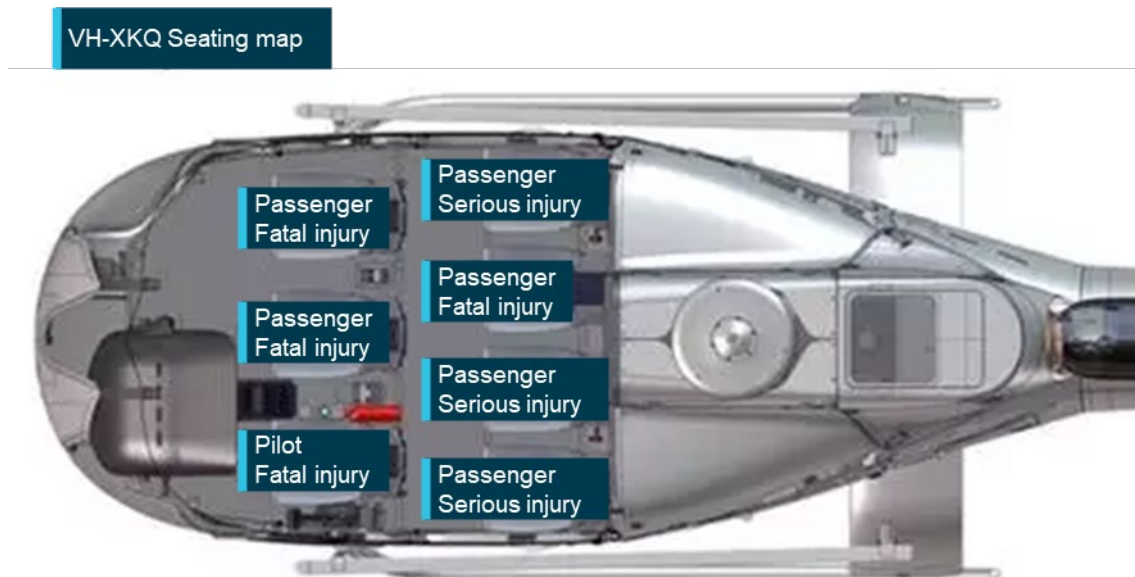
Figure 51: XKQ seating map and injuries

As a result of the impact with terrain, the pilot and 3 passengers were fatally injured, and 3 passengers were seriously injured (Figure 51). It was determined that the impact experienced by the occupants of XKQ was at least 7 times more severe than that considered to be a 95th percentile survivable accident. Therefore, the ATSB considered this accident, based on existing survival data, to be normally not survivable, even though there were 3 survivors. This demonstrates the complexity of accident dynamics and the limitations of existing, outdated research and tools to support analysis of aircraft with composite airframes and multipoint safety harnesses.

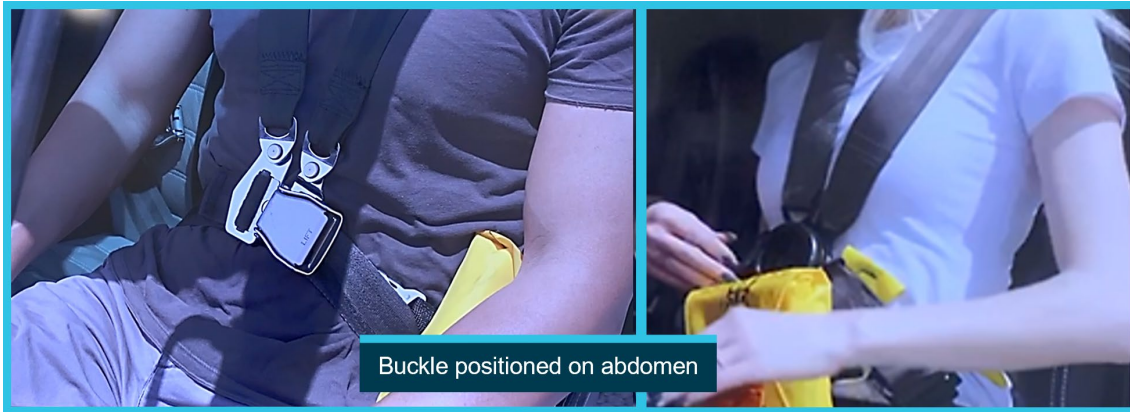
Figure 52: Still images from Sea World Helicopters passenger safety briefing video

Sea World Helicopters provided information to passengers about how to fit the different types of seatbelts on each of its helicopter types in its pre-flight safety briefing video, however aspects of existing guidance material were contradicted by examples shown in the video (Figure 52). This was due, in part, to the positioning of the constant wear lifejacket worn by passengers in the briefing video.

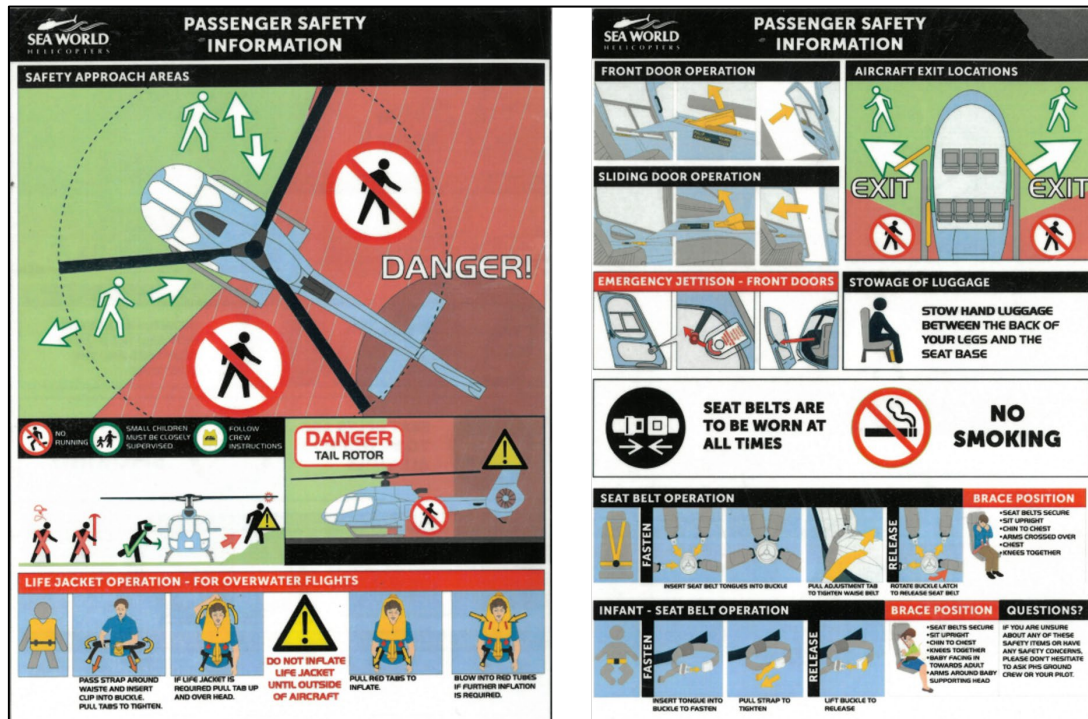
Figure 56: Sea World Helicopters safety briefing card

The operator had a safety briefing card specific to the EC130 (Figure 56) available for use. Among other things, the card depicted the location and operation of the EC130 doors and the brace position. The card also showed the fitment of 4-point restraints, however, the restraints were shown fitted to a seat and not a person, and the lap belt was not shown to be tightened before inserting the shoulder straps. While the card was available for use (although its exact location on the day of the accident could not be determined), the time available for passengers to review the card before take-off following boarding was limited.

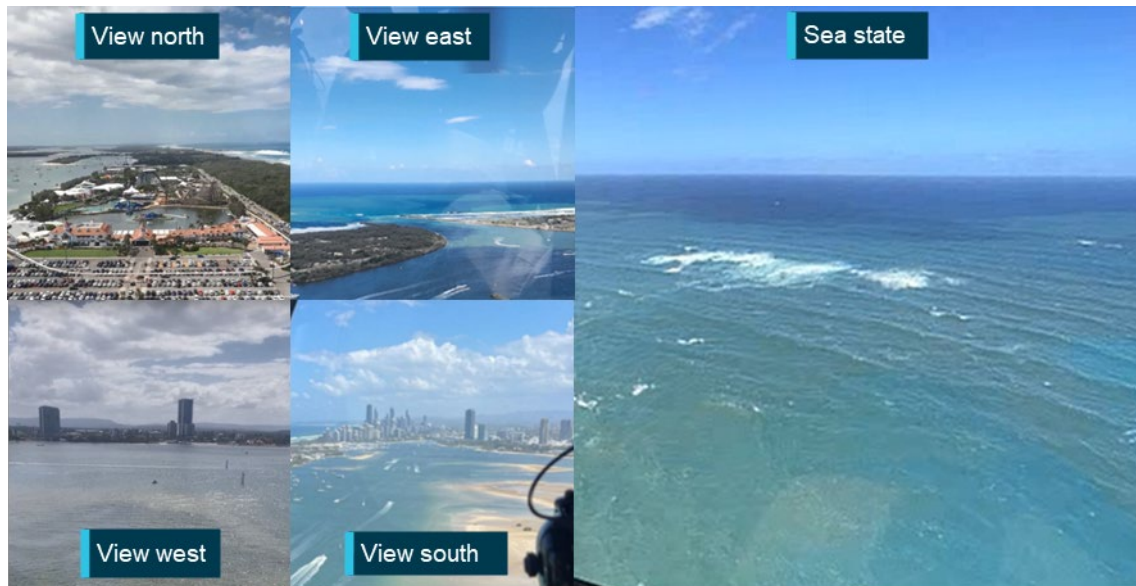
Figure 57: Passenger photographs showing in-flight conditions

The conditions from passenger photographs near Porpoise Point showed good visibility and small waves and a few whitecaps starting to form on the surface of the sea, suggesting wind speeds of 11 to 16 kt (Figure 57). The windssock at the park pad showed an approximate 12 kt easterly wind at the time of departure.

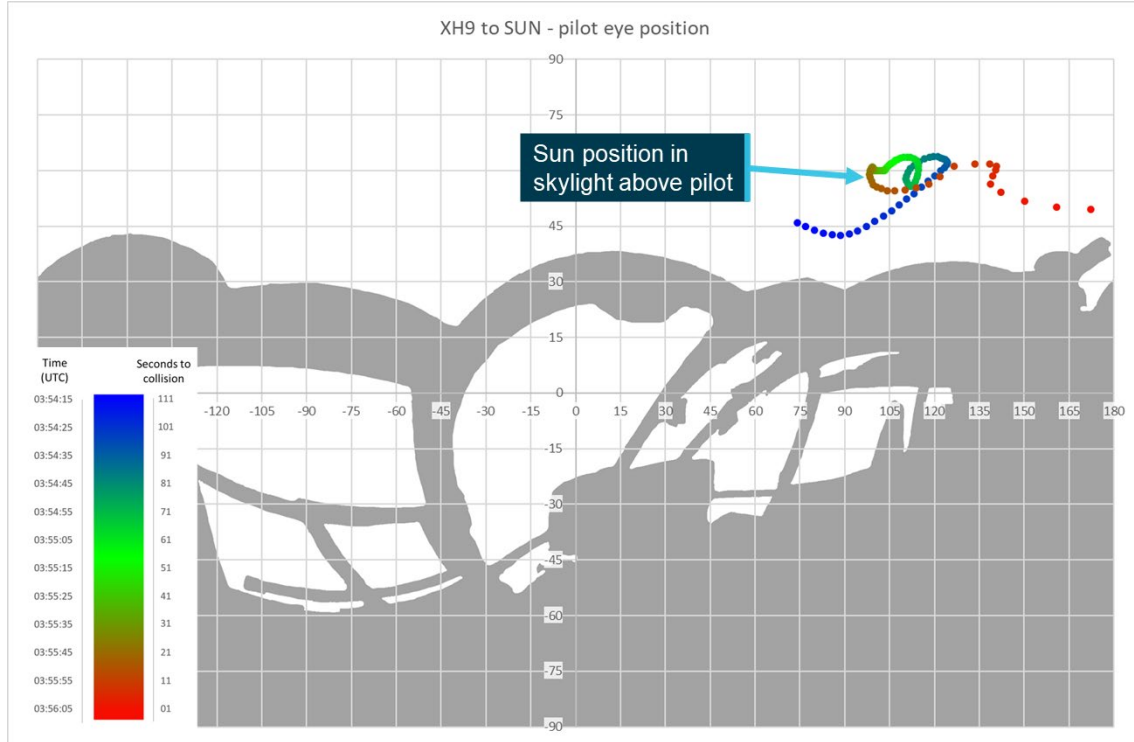
Figure 59: XH9 pilot – relative position of sun

The position of the sun relative to the helicopters and the collision location and altitude was obtained from the Geoscience Australia sun and moon position calculator.⁵⁰ The location of the sun relative to designed pilot eye position within both XH9 and XKQ for the final 111 seconds of flight prior to the midair collision is displayed at Figure 59 and Figure 60. The location data is presented over a 2-dimensional equirectangular developed from the *Visibility study*.

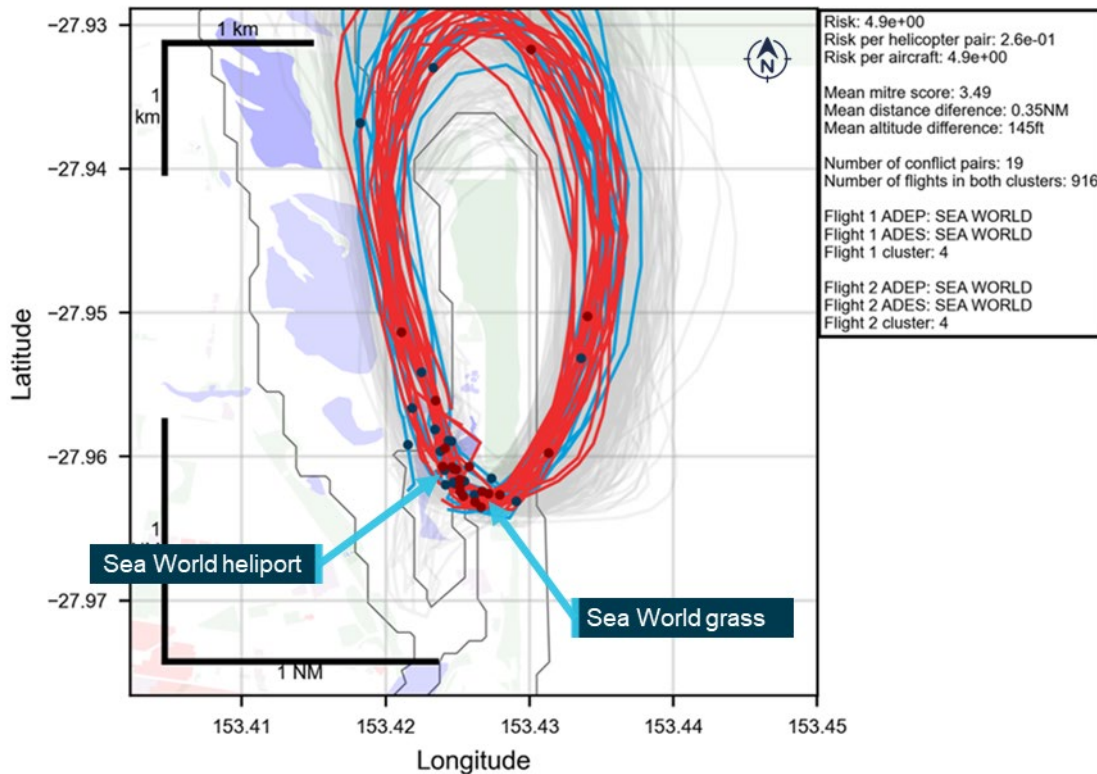
Figure 65: Airservices Australia results on 2022 flight data

The risk metric can be interpreted as the expected number of at-risk (of collision) events in 2022, and hence could be larger than one. Of 916 5-minute flights (tour 1 or tour 6)⁶ identified, 19 aircraft pairs were identified as being a potential conflict pair. The analysis found the highest risk cluster was associated with Sea World 5-minute flights arriving and departing from the helipads within 700 ft of each other. Across all clusters created by local helicopter tour operators, the highest risk collision pairs were detected at the Sea World helipads and over Sea World grass (Figure 65).

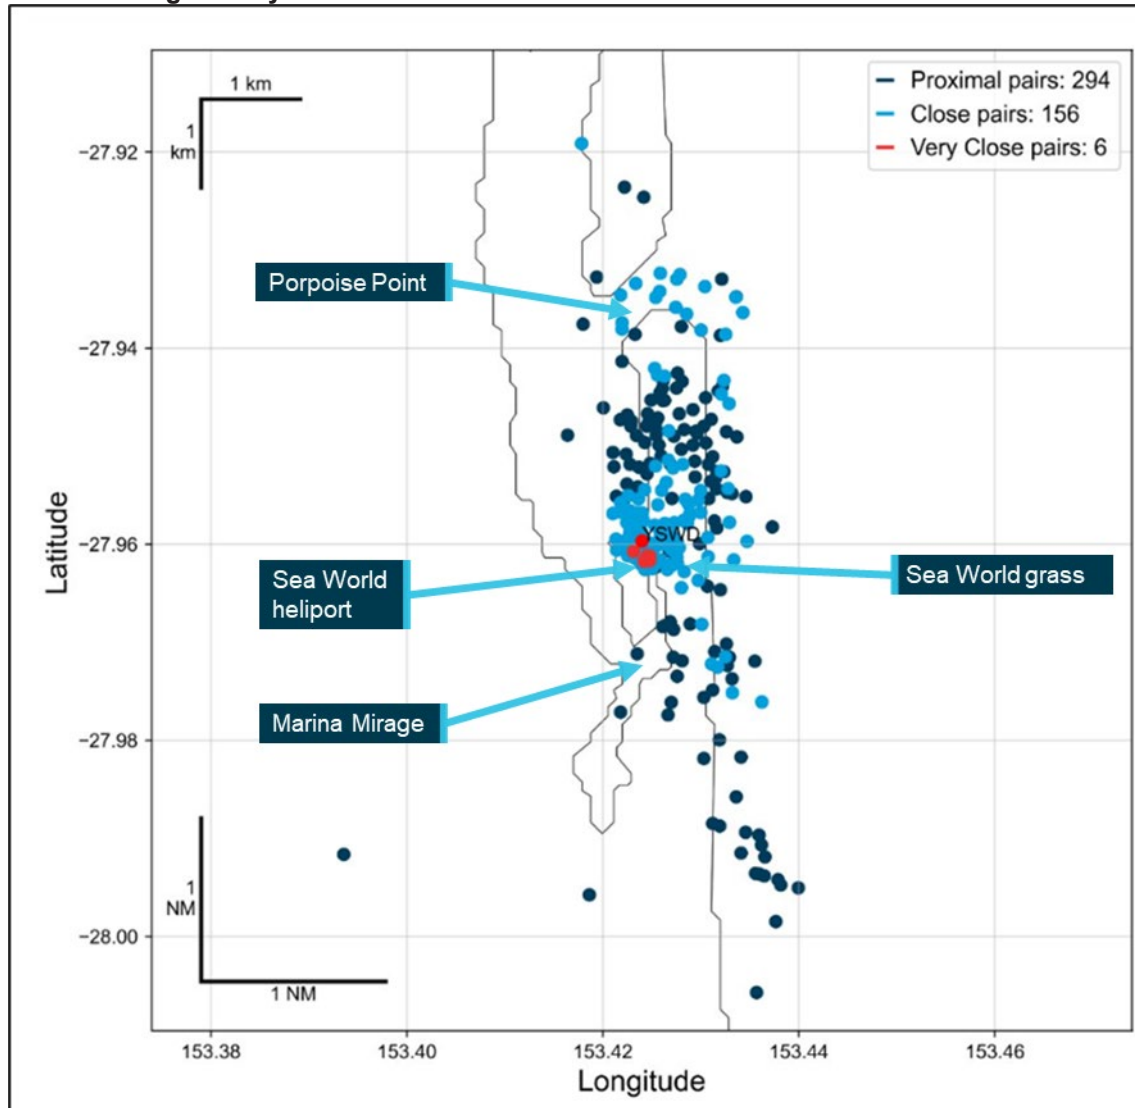
Figure 66: Flight proximity results of Sea World Helicopter aircraft for the 90 days prior to and including the day of the accident

The analysis noted that 5 of the 6 events had occurred after the introduction of the EC130 in the 2 weeks leading up to the accident. At the same time, flights conducted by Sea World Helicopters had increased 2-fold with the commencement of peak tourism season.

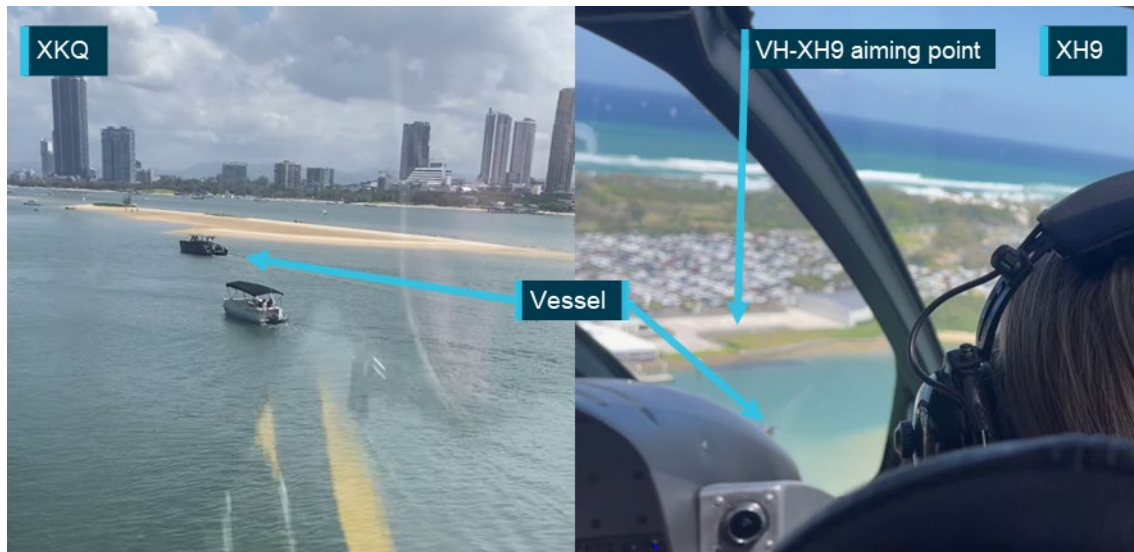
Figure 71: Vessels on the departure path of XKQ and approach path of XH9

Small open top recreational vessels were susceptible to downwash and outwash from approaching and departing helicopters (Figure 71). Overflying vessels on the water risked causing damage or injury on board the vessel and foreign object damage⁶⁰ to the helicopter.

The operator's pilots reported the practice of manoeuvring on approach or waiting on departure to avoid tall vessels and affecting others with downwash. Both helicopters involved in the accident encountered vessels in their vicinity on the accident flight (Figure 72).

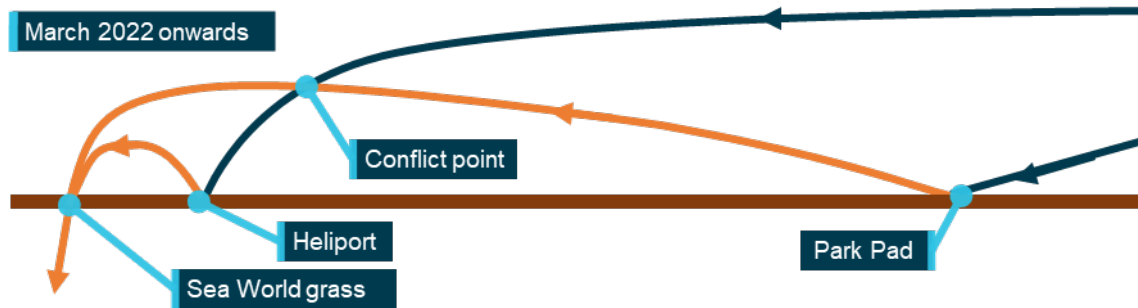
Figure 78: Conflicting flight paths to the south from March 2022 onwards

In March 2022 the park pad reopened and operated simultaneously with the main heliport. This final configuration was the one intended at purchase of the company in late 2018. Once the park pad opened, a conflict point was created near to the main heliport between outbound flights from the park pad and inbound flights to the heliport (Figure 78).

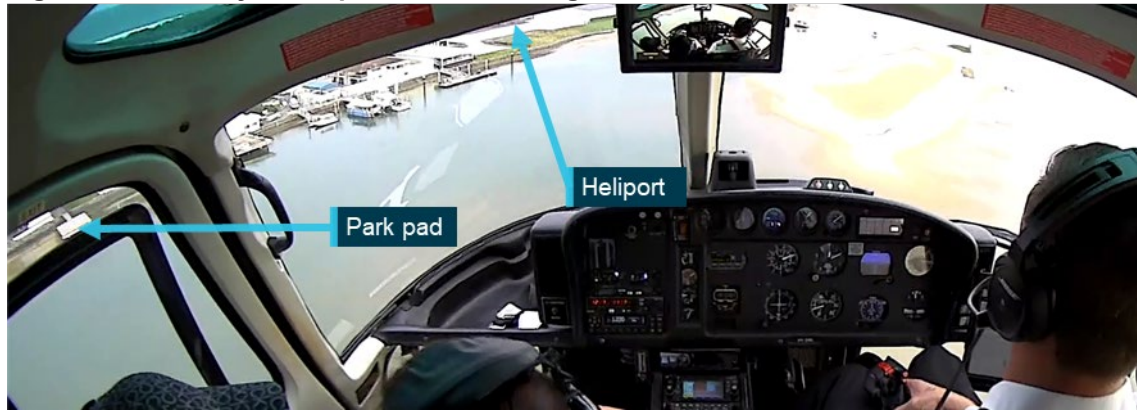
Figure 79: Visibility of helipads in final configuration

Additionally, this configuration made it more difficult for a pilot approaching the heliport to observe activity on the park pad as it was now in the periphery or even outside of the pilot's vision on approach (Figure 79).

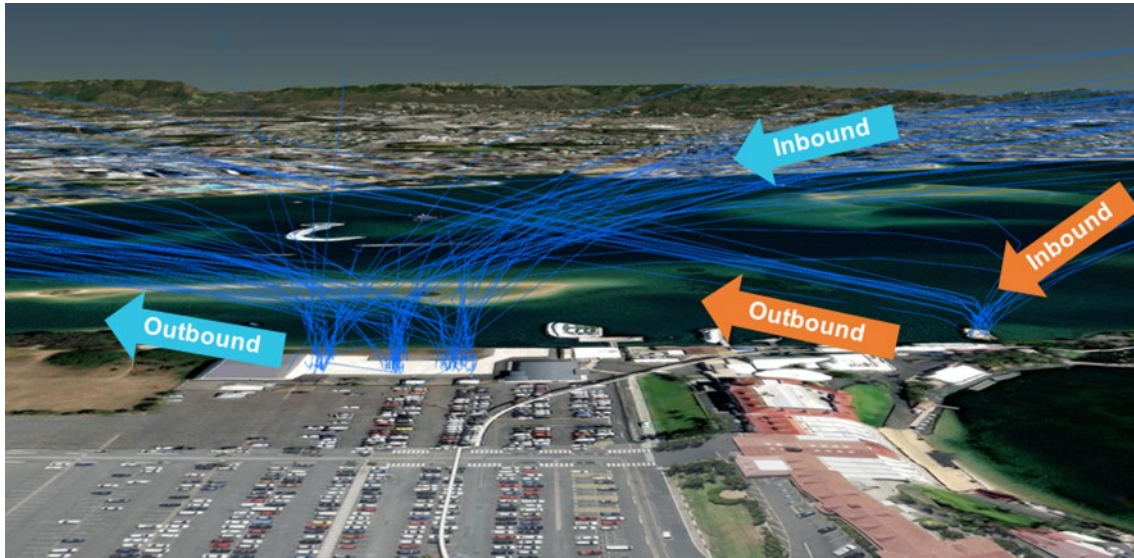
Figure 80: Traffic flow to and from the park pad (orange) and heliport (blue)
26 December 2022 to 2 January 2023

The conflict point created can be seen in the visual representation below of all flight paths from 26 December 2022 to 2 January 2023 in XH9, XKQ and one of the operator's AS350 helicopters (Figure 80). As can be seen, outbound flight paths from the park pad intersected with inbound flight paths to the helipad at the same height. This also corresponded with where the helicopters collided.

The operator was aware of the conflict point and stated that the intersecting flight paths used at Sea World were controlled through airmanship,⁶² communication and rules of the air as at any aerodrome with intersecting runways.

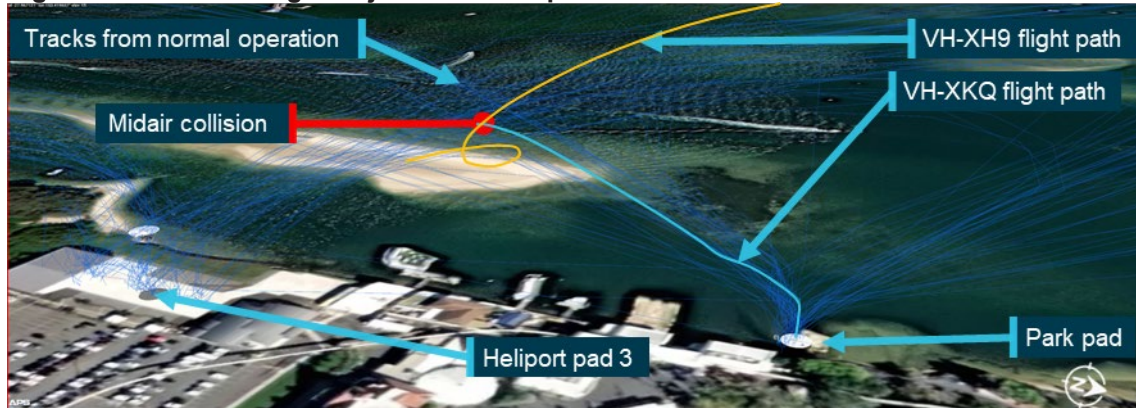
Figure 81: Accident flight trajectories with prior tracks

Video and GPS data showed XKQ tracked directly from the park pad to the sandbar, which matched normal operations from the park pad. Taking off at the park pad and flying directly to the sandbar without a clearing turn appeared to be standard practice. Also, the track of XH9 was shown to be similar to previous flights. The flight paths of both helicopters prior to the accident were within the bounds of normal operation (Figure 81).

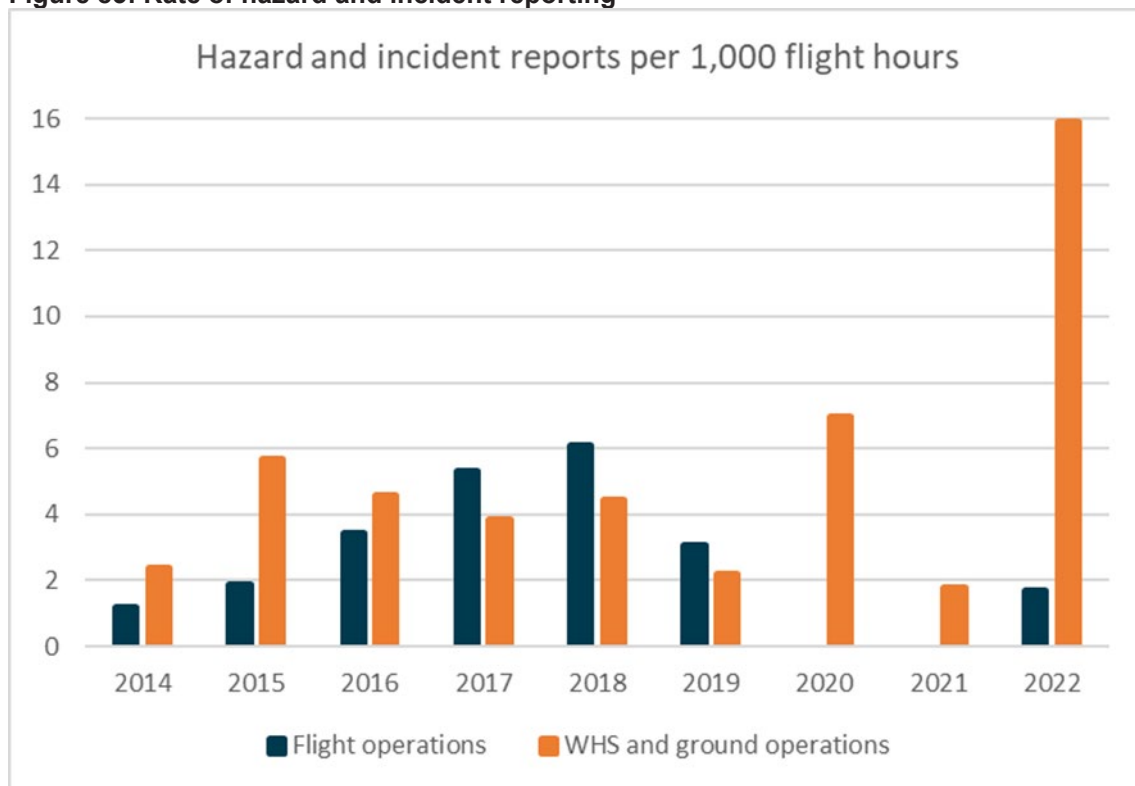
Figure 83: Rate of hazard and incident reporting

The operator stated that up until May 2022, safety at Sea World Helicopters was supported by part-time offsite management through their other helicopter company. Interviews with pilots and SMS records showed during the period of offsite management, which included COVID-19, little use of the SMS or its procedures was made for management of aviation safety risk (Figure 83). Though the other helicopter company had extensive and long running tourism operations, there was no evidence of either operation sharing hazards or risks or informing each other's improvement of aviation safety risk via the SMS.

A review of contemporary evidence found some offsite support in the form of advice to the HOFO, generating forms, and an internal audit⁶³ for conformance with Sea World Helicopters' exposition was carried out in August 2022. However, there was no evidence of day-to-day material support, and the SMS appeared to be effectively inactive during the period of offsite management.

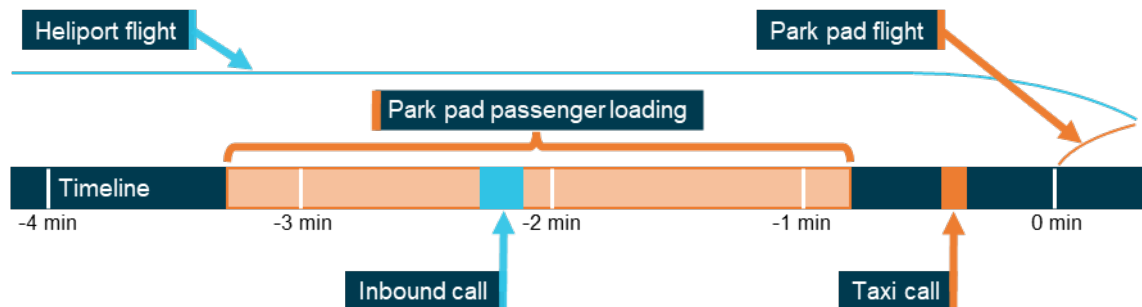
Figure 85: Timing of inbound call relative to loading activities of conflicting helicopters

For pilots whose departure profile from the park pad may conflict with the arriving helicopter (to the heliport), they would need to focus on the inbound call during passenger loading, then hold that information in memory, and remember to coordinate with the arriving helicopter after completing their pre-flight procedures (Dismukes & Nowinski, 2007).

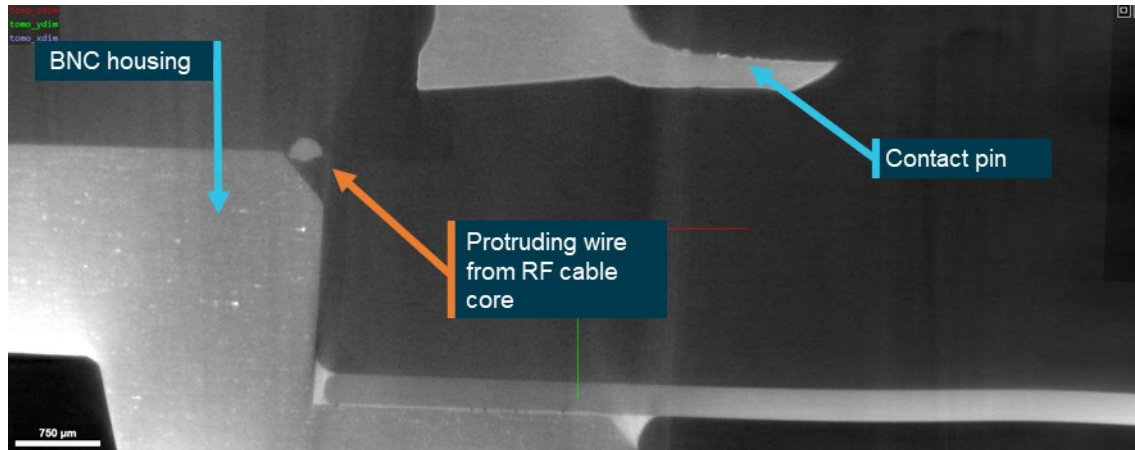
Figure A6: Micro-CT of the helicopter's RF cable BNC connector: close view of the protruding wire showing it was contacting the BNC housing

Close visual examination of the centre pin confirmed that a single wire from the core of the coaxial cable was confirmed to be uncontained and looped outside of the contact pin (Figure A9 and Figure A10). Chelton indicated that an electrical fault could develop in the connector of the RF cable installed on the aircraft if that wire contacted the main body of the BNC connector. Because the wire was found protruding and wrapped within the BNC connector body, it is considered highly likely to have been introduced during the assembly process and was not an artefact from the accident sequence.

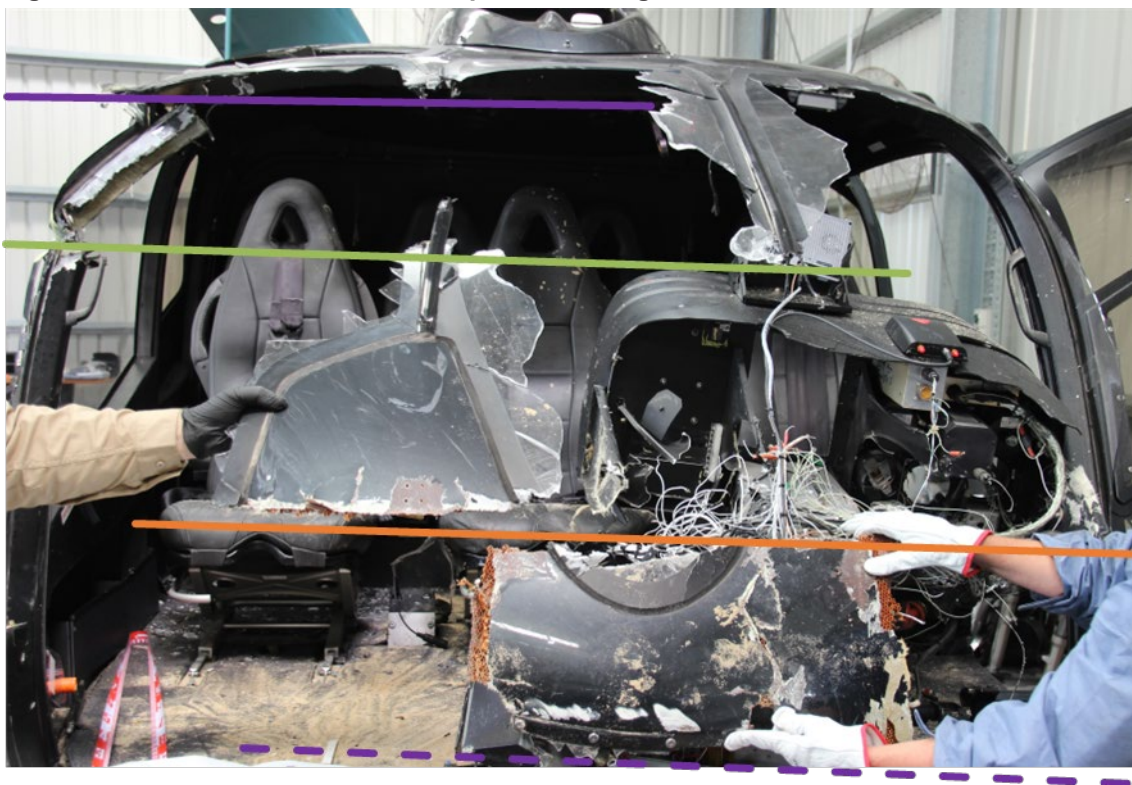
As evidenced by the damage to VH-XH9, the main rotor blades of VH-XKQ made 4 passes through the cabin of VH-XH9 (Figure B1). Debris and damage signatures along with injuries sustained by the occupants of VH-XH9 correlate to the right-to-left main rotor blade path (clockwise rotating main rotor system) through the cabin of VH-XH9. The initial impact was captured in video taken by the rear left outboard passenger of VH-XH9 (Figure B2), and the vertical and lateral position of VH-XKQ at the point of first contact aligns with the purple dotted line in the figure below.

From Spidertracks position data recovered after the accident, the closing vertical velocity of the 2 helicopters was 6.2 m/s (1,220 fpm). Additionally, the relative (closing) horizontal velocity was determined to be 21.9 m/s (42.6 kt) crossing paths at 73°. Assuming the nominal main rotor blade rotation rate of 400 revolutions per minute (rpm), the relative incremental change in height equated to approximately 0.31 m and a horizontal position change of 1.10 m per blade pass. This aligned closely with the vertical spacing of the cut marks identified in the cabin of VH-XH9 and the projected relative horizontal paths (Figure B3).

Figure B3: VH-XKQ main rotor blade passes through cabin of VH-XH9

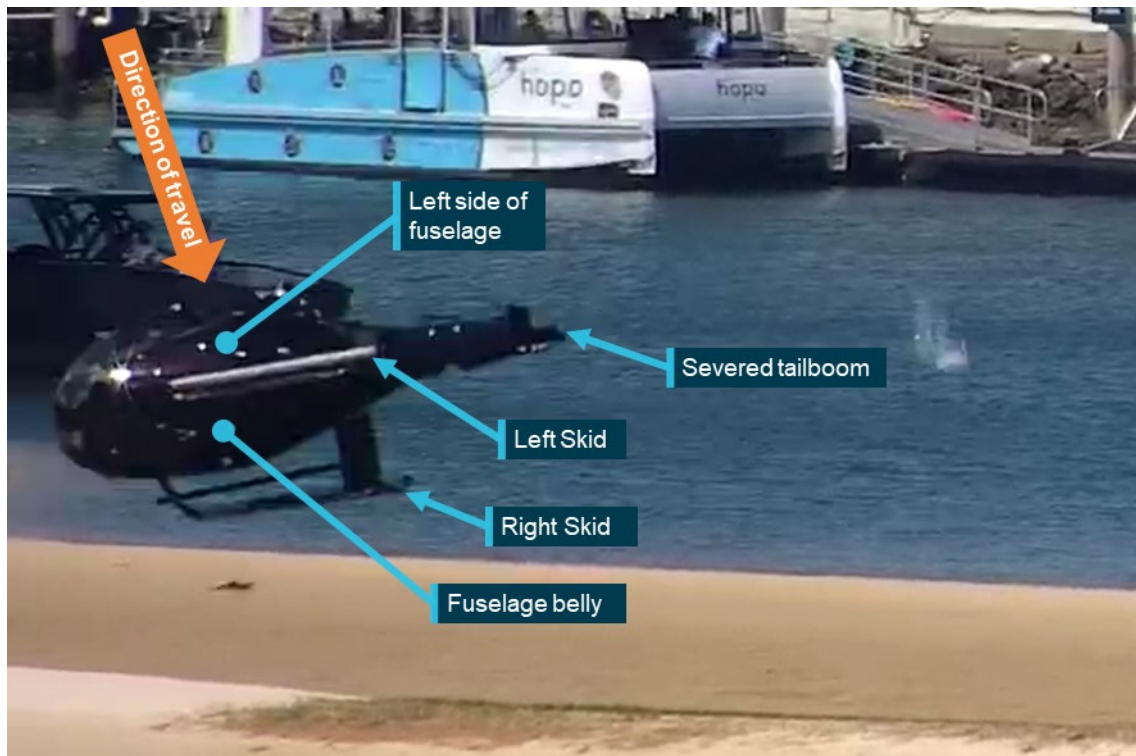
At the time of collision with terrain, the fuselage was slightly nose down and rolled substantially to the right travelling in the direction of the right side and belly, relative to the fuselage body axis. The fuselage impacted gently sloping wet sand at the water's edge. The ground impact was captured by CCTV from multiple angles. Figure B6 shows the CCTV frame before VH-XKQ made contact with the ground.

Figure B6: VH-XKQ impending impact with ground

The fuselage struck the sand and compressed, fracturing the door frames, the floor and undercarriage skids. The polymer fuel tank fractured into many pieces under the hydraulic loading, releasing fuel in multiple directions. The fuselage then bounced very little (0.5–1.0 m) indicating the wet sand and fuselage absorbed considerable energy before rolling through 270° to the left stopping upside down approximately 5 m away.

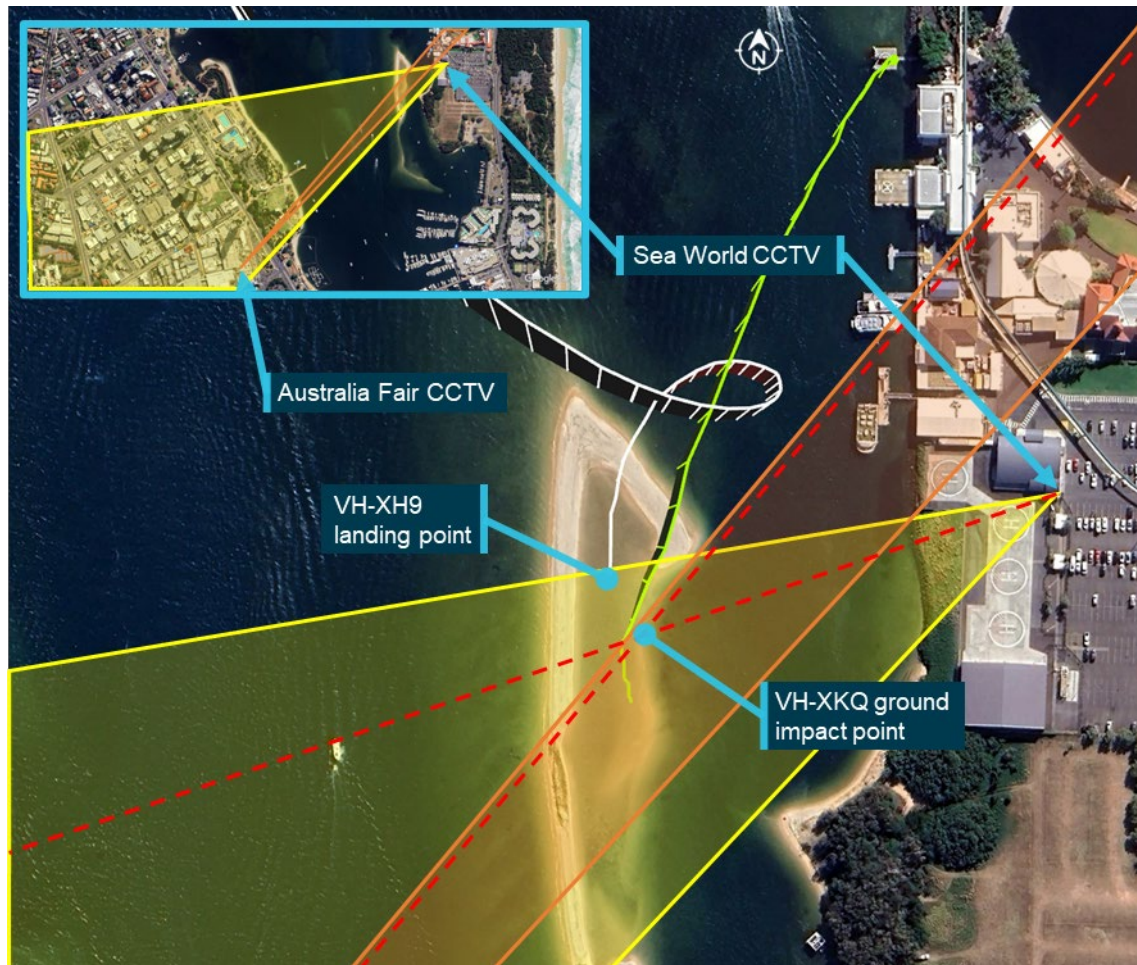
Figure B7: CCTV vision angles

Yellow lines mark the extremities of Sea World CCTV vision. Orange lines mark the extremities of the Gold Coast Safety Camera Network Australia Fair CCTV vision. Dashed red lines indicate the lateral position of the ground impact in each frame. Source: Google Earth, annotated by the ATSB

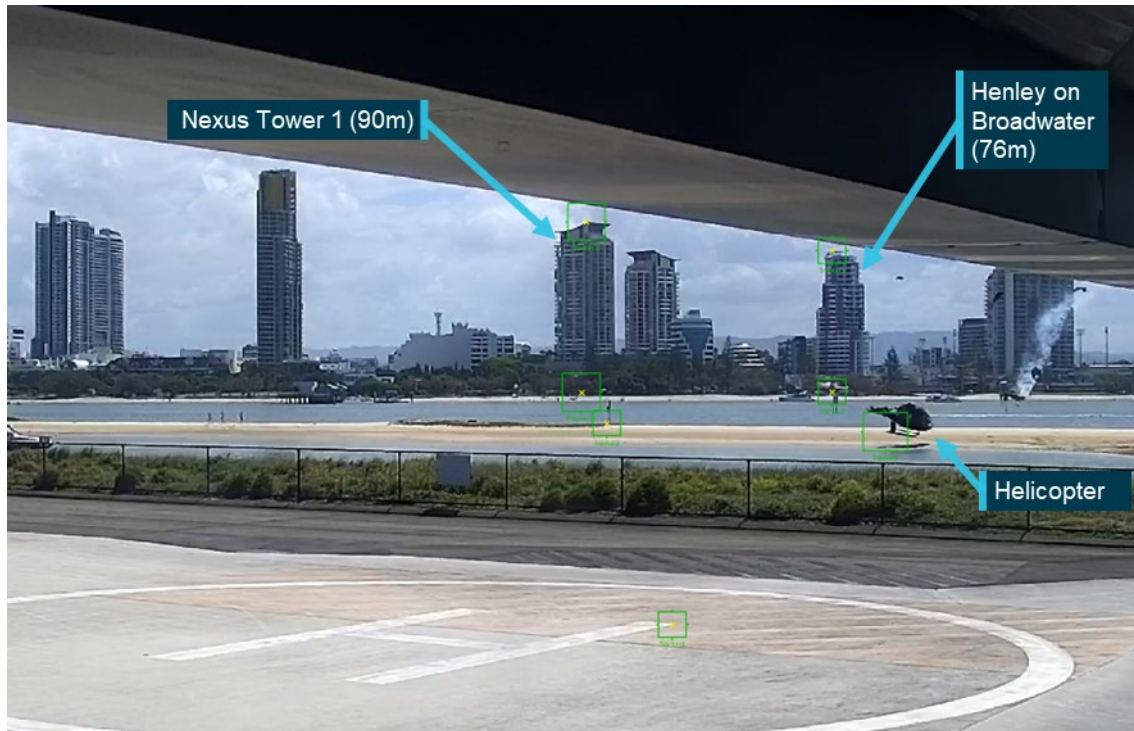
Figure B8: Sea World CCTV (with buildings used to scale from)

Given the relative distance to the aircraft, the fuselage was determined to be 0.084 metres/pixel. The position of the fuselage (skid) was determined over the last 11 frames and gave an average vertical velocity of 24.3 m/s.

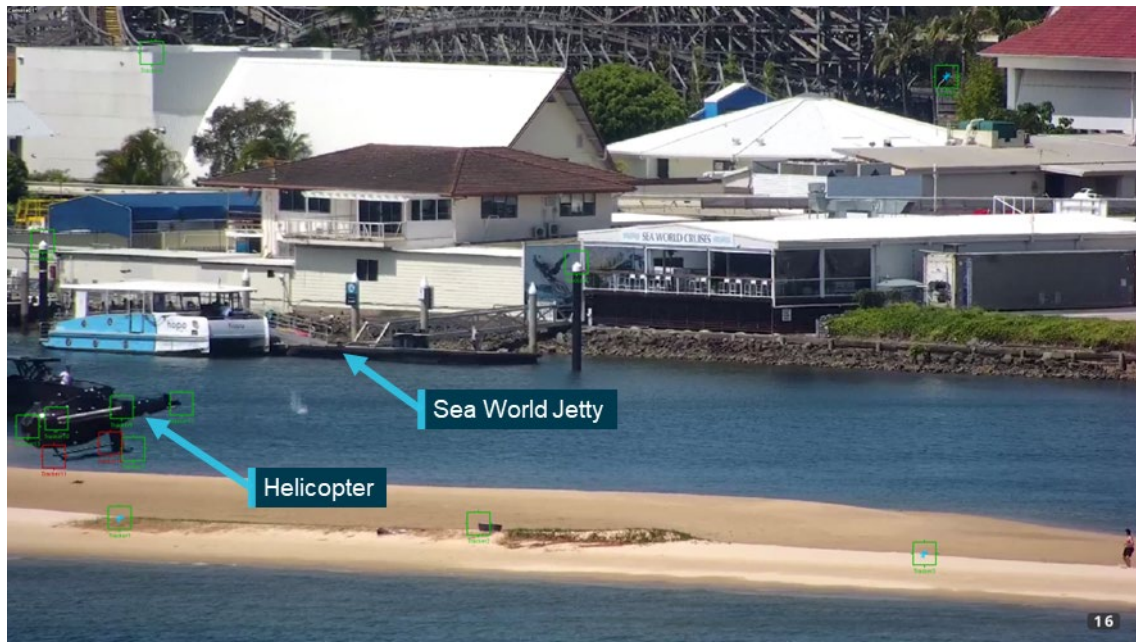
A Gold Coast Safety Camera Network (GCSCN) CCTV camera on the Australia Fair shopping centre rooftop, zoomed in on the Sea World ferry jetty complex, recording at 25 fps caught the moment of ground impact and 0.7 seconds prior. Due to the framing of the vision, the midair collision was not captured (Figure B9).

Figure B9: View of VH-XKQ just prior to impacting the sandbar

Using motion tracking software, the right skid step was identified as a stable and visible source to scale off. The length of the step was used to scale the vertical and lateral movement of the landing skids and steps over the last 0.28 seconds (8 frames) and the nose and tail over the last 0.12 seconds (4 frames).

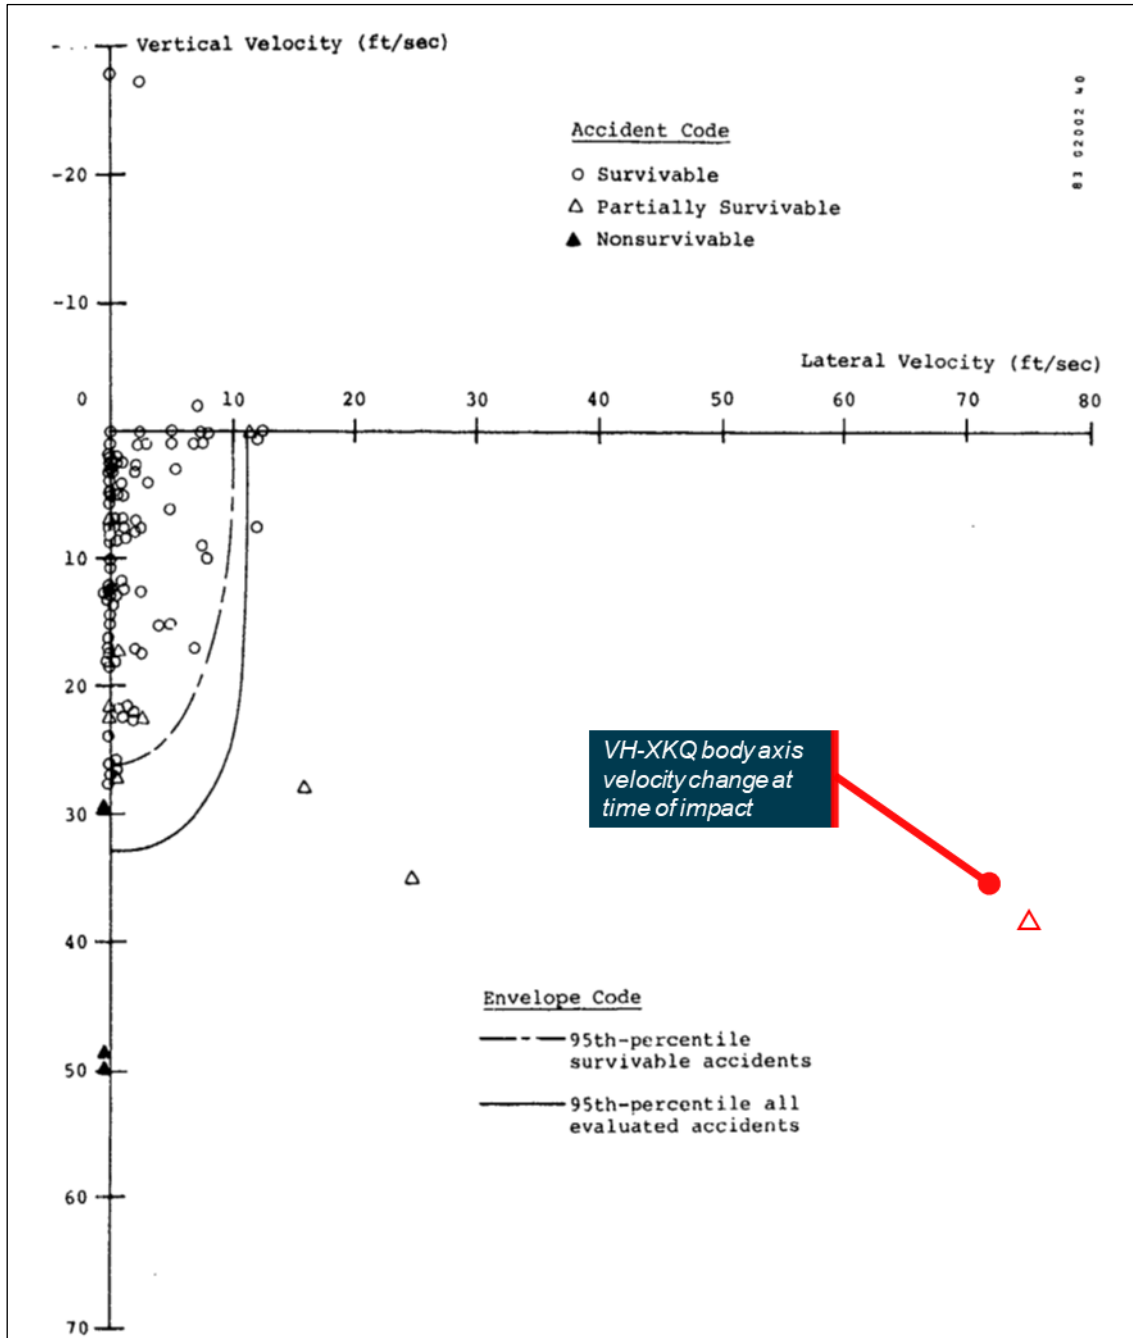
Coltman et al. (1985) plotted vertical, longitudinal, and lateral components of determined impact velocities for all accidents and noted which were survivable, partially survivable, or non-survivable. The relevant values determined by the analysis for VH-XKQ (Table B2) were 11.6 m/s (38.1 ft/s) downward and 22.8 m/s (74.8 ft/s) lateral, with longitudinal velocity change being negligible. For lateral velocity components, data suggested that the 95th percentile survivable level is 3 m/s (10 ft/s) which is associated with typical rollover velocities, which reinforces that the VH-XKQ impact is extraordinary. Coltman et al. (1985) coded a three-dimensional survivability velocity envelope. The lateral vertical plot is provided in Figure B10 with the impact velocity components for VH-XKQ also plotted. The calculated impact velocity for VH-XKQ was at least 3 times more extreme than the next most severe partially survivable accident documented. By comparing the values of the plotted point to the 95th percentile survivable accident curve, it can be argued that the VH-XKQ ground impact was at least 7 times more severe than the 95th percentile survivable accident.

Figure B10: Lateral vertical survivability envelope of helicopter accidents (VH-XKQ identified by red triangle)

When VH-XKQ impacted the ground, the lateral vertical velocity was at least 7 times more severe than the 95th percentile of historical survivable accidents. The accident was at least 3 times more extreme than the next most severe partially survivable accident documented. Source: Analysis of Rotorcraft Crash Dynamics for Development of Improved Crashworthiness Design Criteria, 1985, annotated by the ATSB

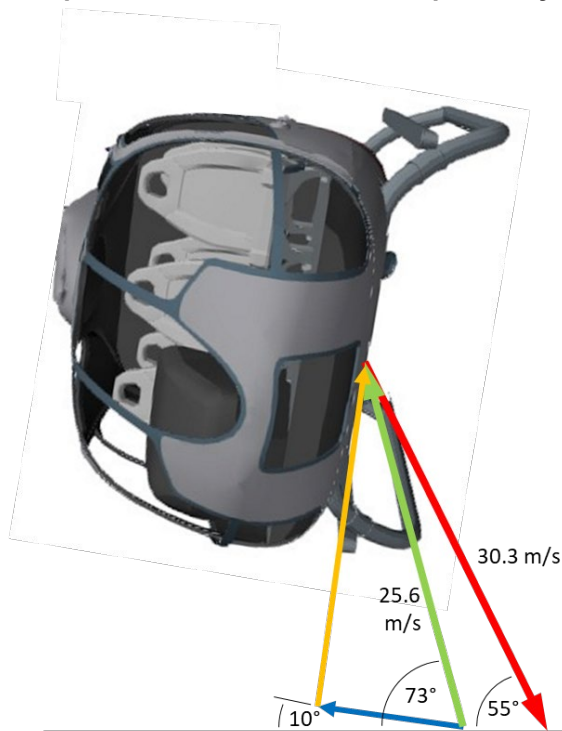
Orientation was determined visually to be approximately 80° rolled right with the longitudinal axis less than 10° nose down. The impact/direction vector relative to the body axis is complicated by the lack of precise measurements and by the fact the horizontal velocity did not immediately reduce to zero (Figure B11). However, it could be observed to be predominately laterally right followed by a not insignificant down (z axis) component. Any longitudinal component was minimal in comparison.

Figure B11: Visualisation of the impact vector (red), reaction vector (green) and components relative to the helicopter body axis

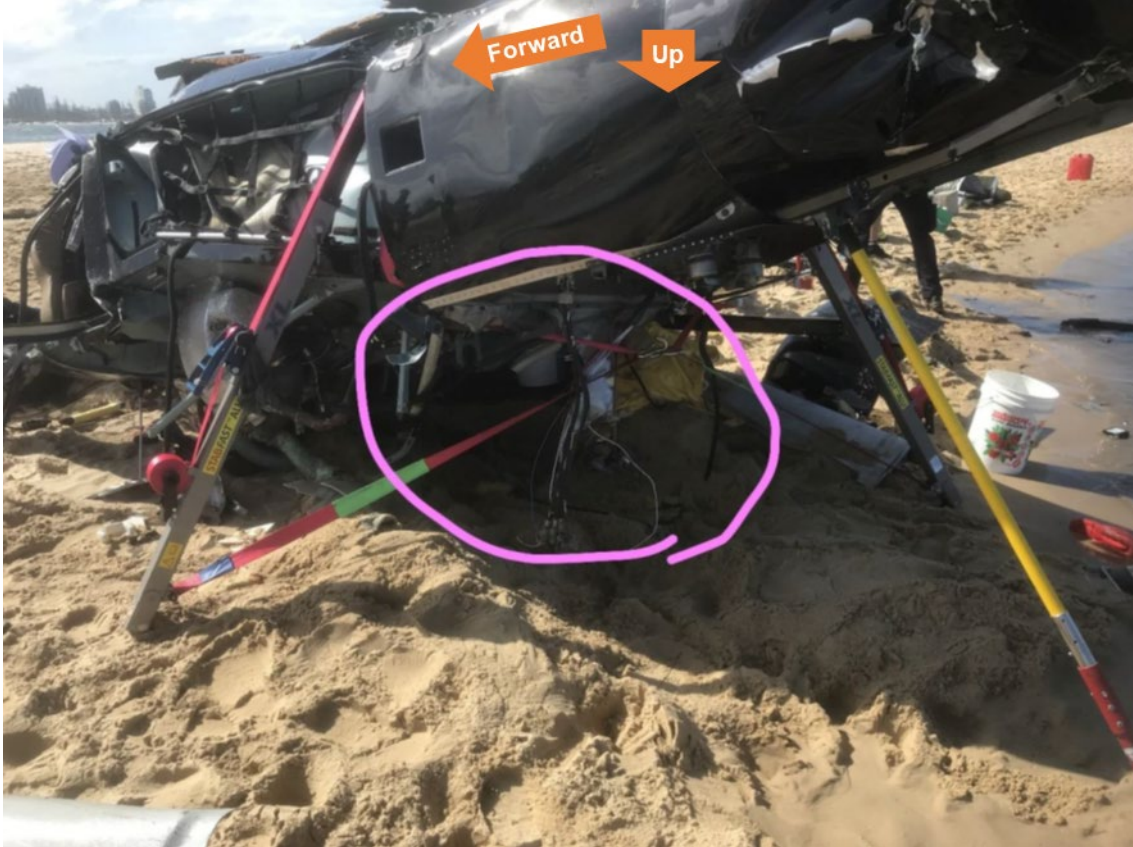
A Queensland Fire and Emergency Services (QFES) response and extrication report identified the extraction of a person subsequently identified as the rear left outboard passenger (described above). The passenger was located outside and underneath the helicopter wreckage, when they should have been restrained by their harness and seat and remained within the cabin (Figure B15).

Figure B1587: VH-XKQ – location of the rear left outboard passenger

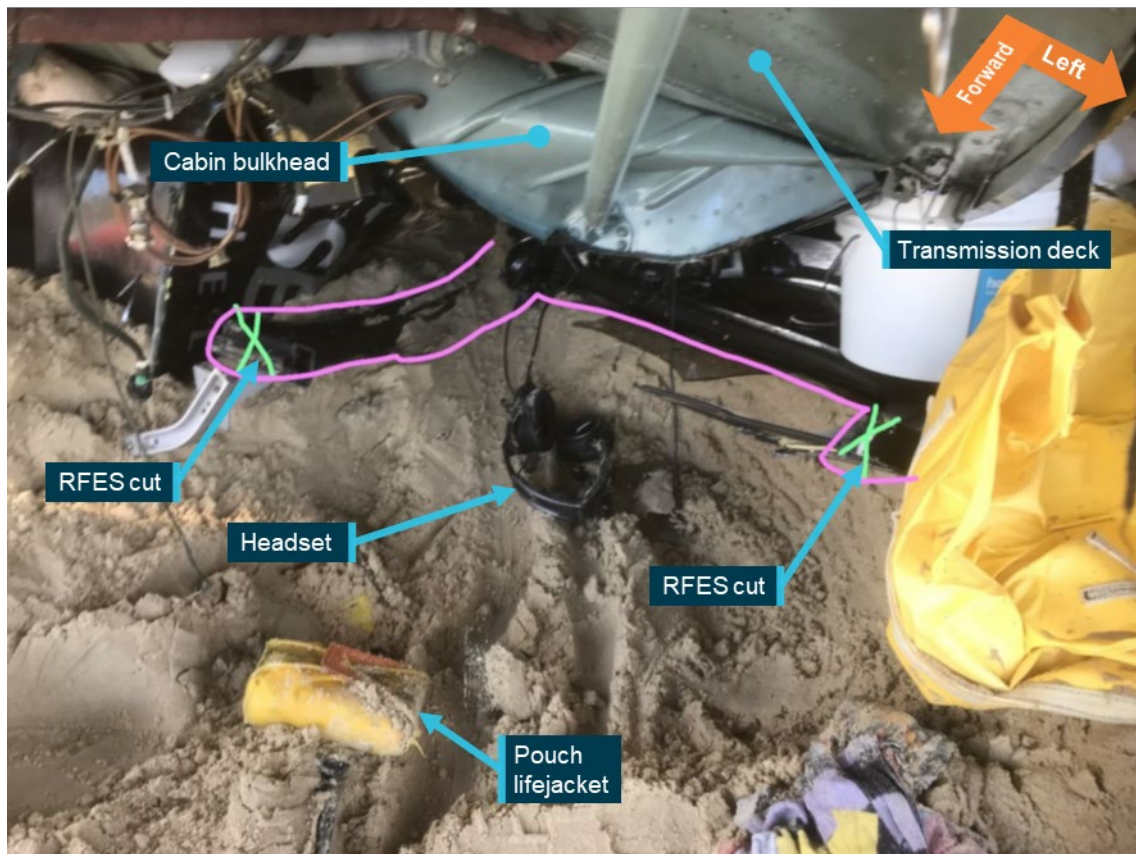
QFES extricated the passenger towards the rear after cutting a door frame (Figures B16 and B17). Specialist equipment was required to access the passenger and their extrication 'was impeded by what appeared to be the top of a door frame protruding up from beneath the top of the overturned airframe in the sand'. The door was subsequently identified as being the rear left passenger cabin door that the passenger was sitting next to.

Additionally, the QFES report indicated the constant wear lifejacket had to be cut away using a rescue knife (Figure B16). The passenger in interview recalled their safety harness being cut. The passenger's safety harness was found to be undamaged and could not have extended to the position where the passenger was found trapped. Therefore, it was likely the passenger had recalled the lifejacket strap being cut as opposed to their safety harness. This also meant the safety harness likely inadvertently released at some time during the accident sequence.

Figure B1688: VH-XKQ – site of rear left outboard passenger
