# Incorrect configuration involving Embraer E190, VH-UYI

Near Honiara International Airport, Solomon Islands on 23 February 2024

AO-2024-007

Final – 3 April 2025

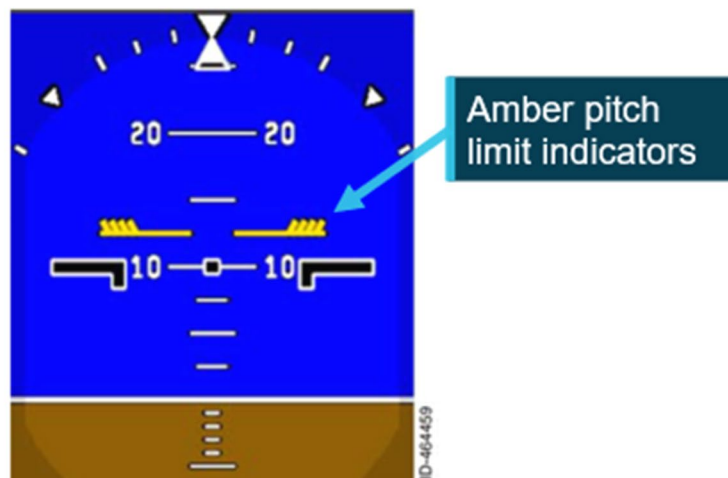
The PLI indicator is pitch-based. The PLI indicator is displayed with the following conditions:

- When airspeed is higher than  $1.2 V_{STALL}$ , the PLI is not displayed.
- When airspeed is less than or equal to  $1.2 V_{STALL}$  but greater than  $1.13 V_{STALL}$ , the **PLI** is displayed in green.
- When airspeed is less than or equal to  $1.13 V_{STALL}$  but greater than  $V_{SHAKER}$ , the **PLI** is displayed in amber.
- When the airspeed is less than or equal to  $V_{SHAKER}$ , the **PLI** is displayed in red.
