# Collision between container ship *Maersk Shekou* and tall ship *STS Leeuwin II*

Fremantle, Western Australia, on 30 August 2024

## **ATSB Transport Safety Report**

MO-2024-001

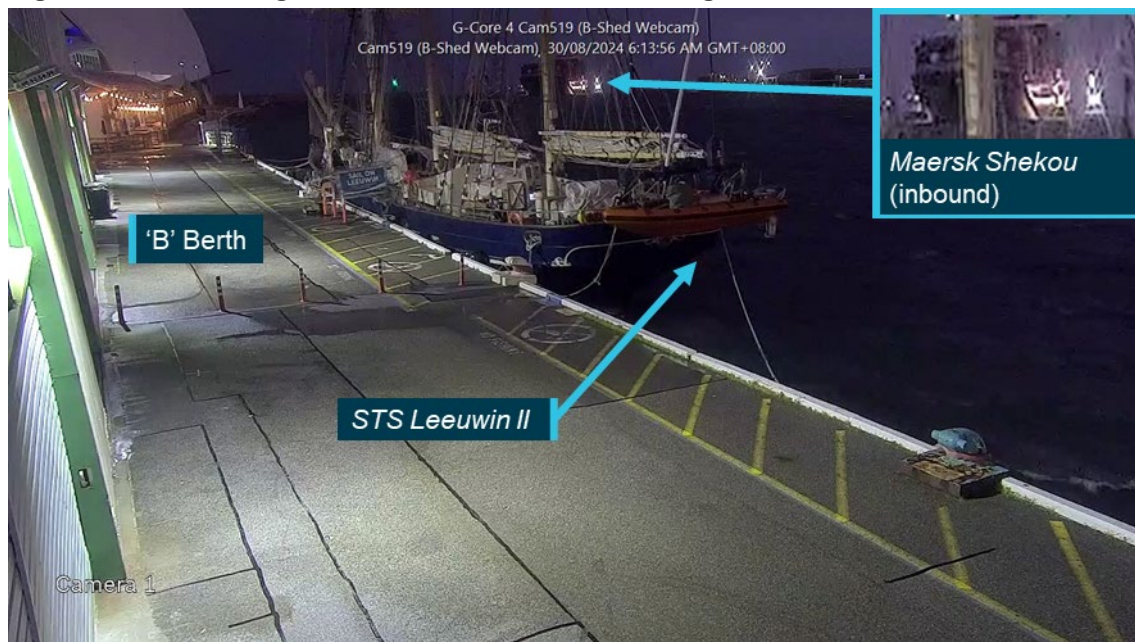
**Figure 3: CCTV footage of *STS Leeuwin II* at its mooring with *Maersk Shekou* inbound**

At 0615:47, the *Maersk Shekou*'s engine achieved its full ahead potential of 76 RPM and the helmsman maintained the rudder in the amidships<sup>14</sup> position. The ship was proceeding at 7.2 knots on a steady 083.5° heading, into the path of *STS Leeuwin II*, which was less than a ship's length away, and moored port side alongside B berth at Victoria Quay (Figure 3).
