Interrupted engine start and evacuation involving Saab 340B, VH-ZRK

Melbourne Airport, Victoria, on 5 April 2022

ATSB Transport Safety Report Aviation Occurrence Investigation (Defined) AO-2022-019 Final – 4 December 2024 Cover photo: Melbourne Airport

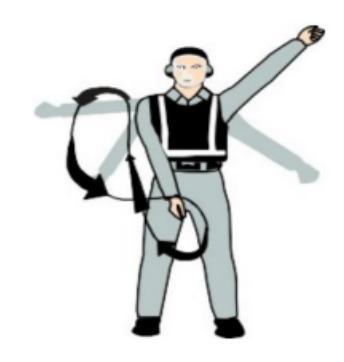
Move right hand in a fanning motion from shoulder to knee, while at the same time pointing with left hand to area of fire.

Night signal, the same with wands.

The Rex policy and procedures manual, referenced by flight crew, included the standard marshalling signals and a description for the hand signal for aircraft smoke, which was the same for fire, but no image was included. The flight crew recalled that they could not remember the signal for fire and had not covered it specifically in their training. The captain recalled learning the signal during their command upgrade through their own initiative and the FO learnt the signal in their previous employment.
