Fuel starvation and forced landing involving Cessna 310R, VH-DAW

About 5 km south-east of Derby Airport, Western Australia on 20 June 2023

ATSB Transport Safety Report

AO-2023-029

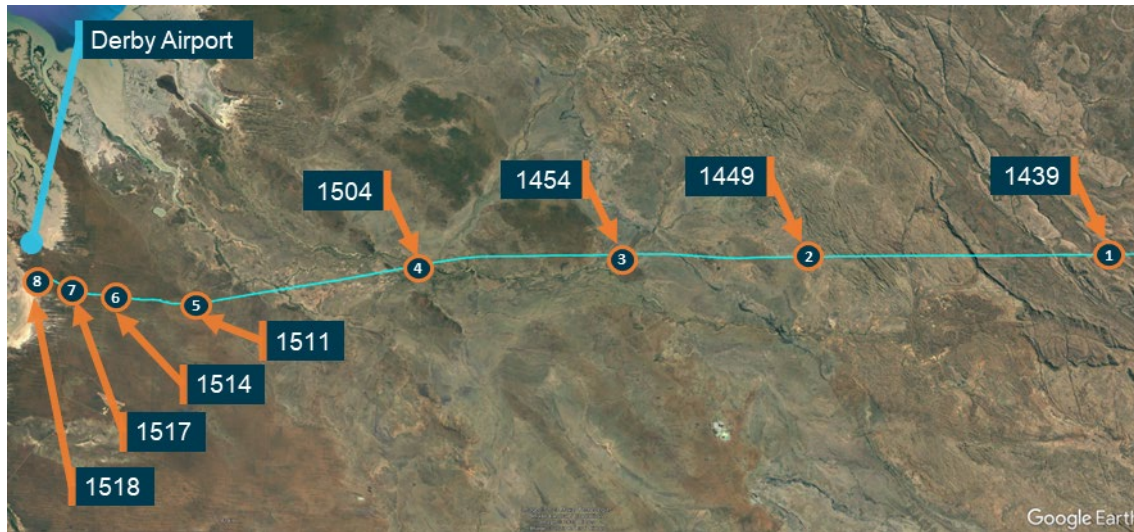
Figure 2: VH-DAW flight path

After checking the fuel gauges, the pilot determined there was enough fuel in the left main tank (approximately 45 L) to run both engines to Derby. The pilot then selected the right engine to crossfeed from the left main fuel tank and referred to the quick reference handbook for engine failure in flight checklist to determine a possible cause for the surging.

1. Change from main tanks to auxiliary tanks; 2. Change the left engine from auxiliary tank to main tank; 3. Right engine surge – changed the right engine to right main tank; 4. Right engine surge – crossfeed right engine off left main tank; 5. Inbound call for Derby Airport; 6. Dual engine surge; 7. Mayday call; 8. Accident site.
