Collision with terrain involving Cessna 150M, VH-WWU

40 km north-west of Northampton, Western Australia, on 21 March 2025

ATSB Transport Safety Report

Aviation Occurrence Investigation AO-2025-014 Preliminary – 28 May 2025 Released in accordance with section 25 of the Transport Safety Investigation Act 2003

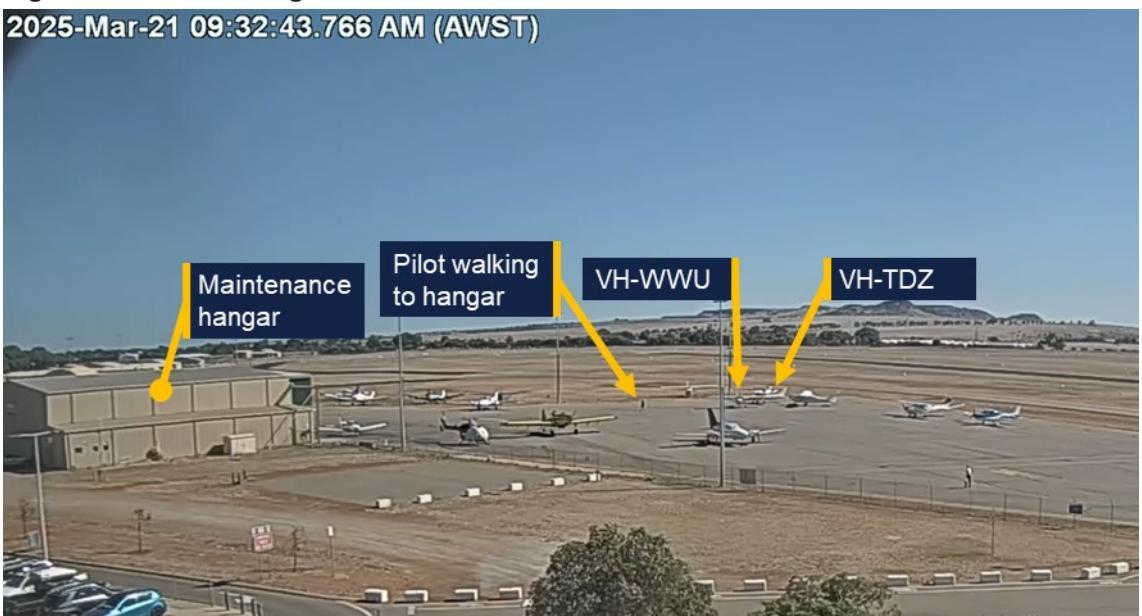
Figure 1: Aircraft changeover

Between 0925 and 0931, the pilot manoeuvred VH-WWU out of the parking bay and moved VH-TDZ into it. Once completed, the pilot walked to the maintenance hangar (Figure 1). Witnesses at the airport reported that the pilot appeared unwell and had mentioned having had severe gastroenteritis in the preceding days. Witnesses did not report any apparent speech or physical impairment.
