Midair collision involving Jabiru J430, VH-EDJ, and Piper PA-25-235, VH-SPA

Caboolture Airfield, Queensland, on 28 July 2023

ATSB Transport Safety Report

AO-2023-036

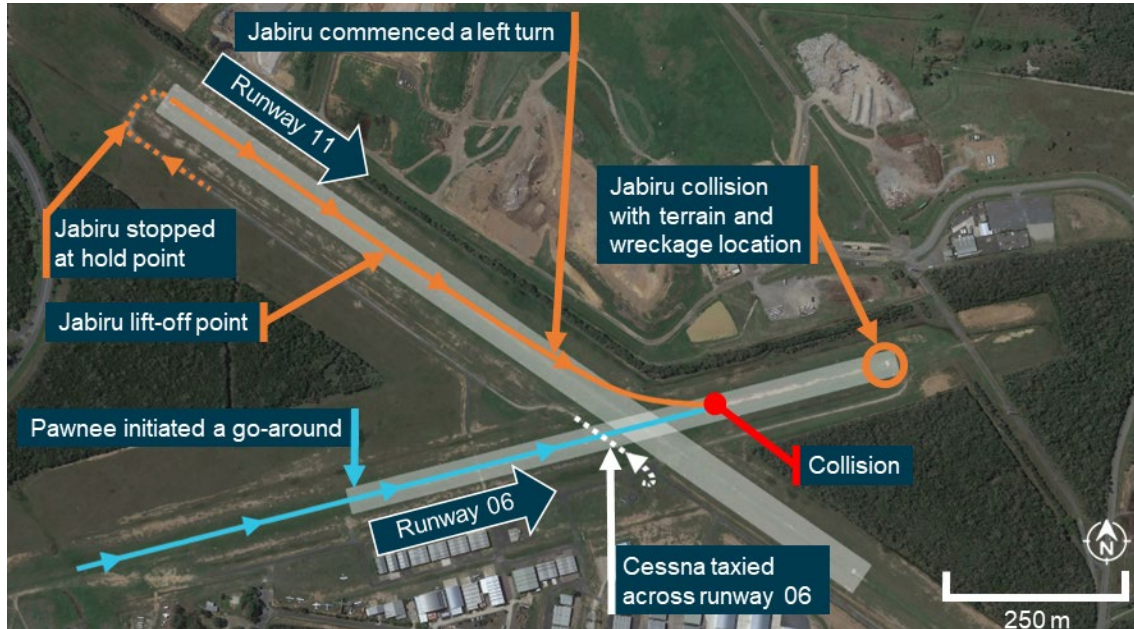
Figure 2: Approximate tracks of the involved aircraft based on video recordings and recorded track data

Dotted lines indicate aircraft taxiing.
Source: Google Earth, annotated by the ATSB

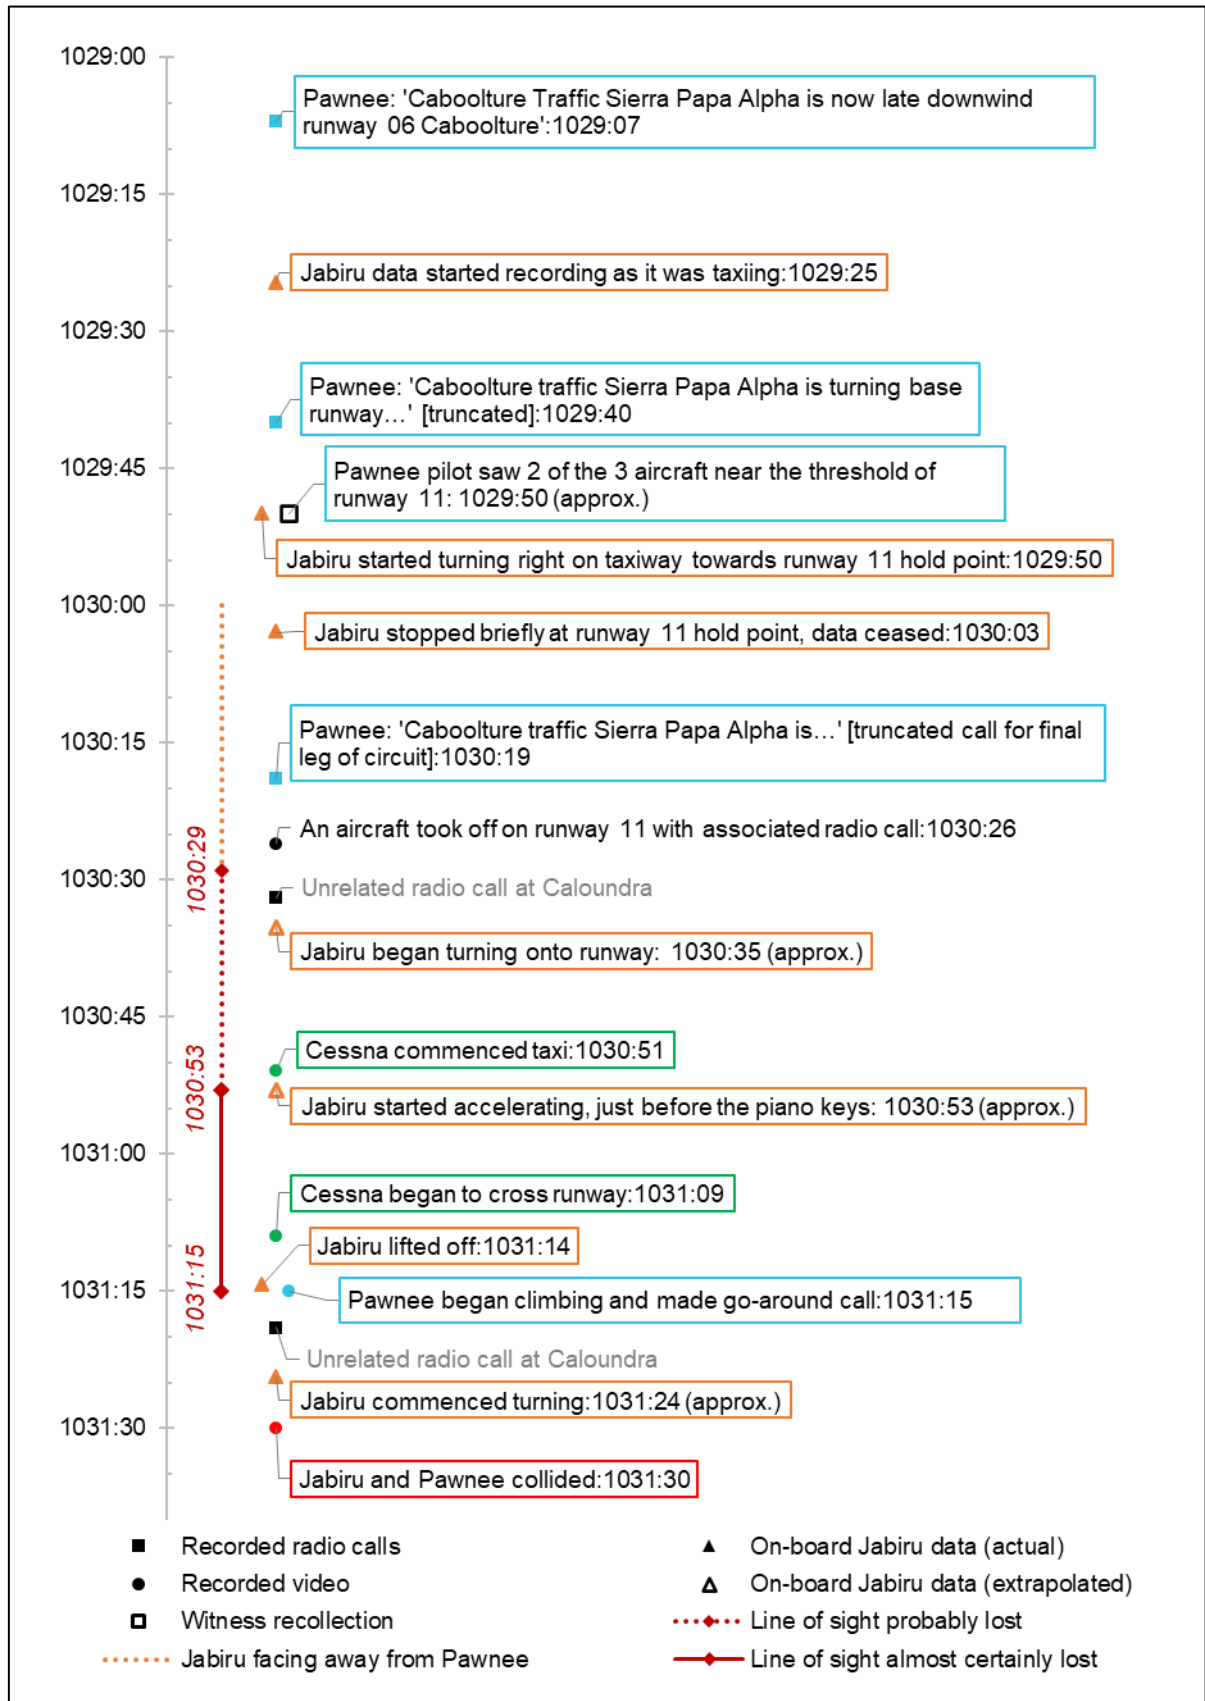
Figure 3: Sequence of events

An eyewitness stated that after waiting at the hold point, the Jabiru taxied onto the runway and immediately began the take-off roll. The recorded data was incomplete at this point, but ATSB analysis estimated that the Jabiru likely began to turn onto runway 11 at about 1030:35, establishing the runway heading a few seconds later. Take-off would have commenced at about 1030:53. Two witnesses reported hearing the Jabiru pilot make a 'rolling' (take-off) call on runway 11, while 7 other witnesses, including the Pawnee pilot, stated that they did not remember hearing a rolling call. No witnesses recalled any other calls from the Jabiru.

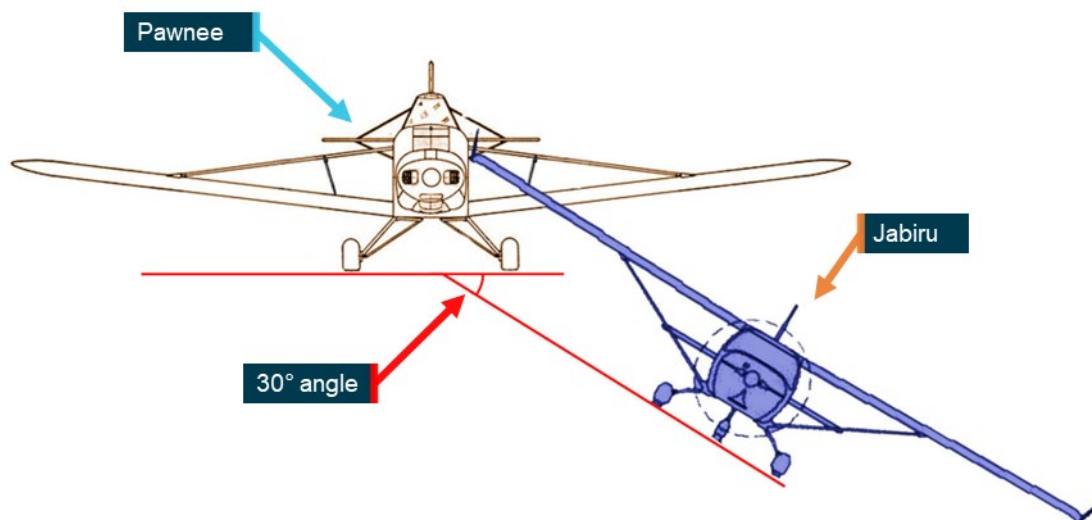
Figure 6: Approximate collision attitudes

Based on the damage to each aircraft (described below), and the aileron and wing tip found near the runway intersection, the ATSB determined that the Pawnee's left wing leading edge collided with the Jabiru's right wing trailing edge. Damage signatures indicated that the relative angle between the 2 aircraft was about 30° in roll (Figure 6). There was no impact with the Pawnee's propeller.

This is a simplified diagram designed to illustrate the approximate difference in height and roll attitudes between the aircraft at the point of collision. The image does not reflect differences in pitch and yaw.
 Source: ATSB, Piper Aircraft and Jabiru Aircraft

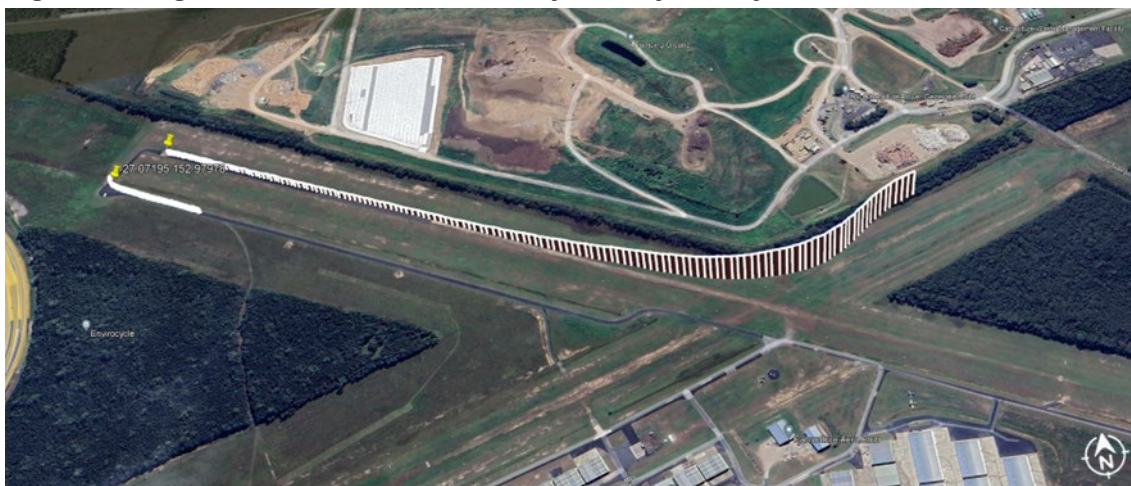
Figure 15: Flight data recovered from the Dynon SkyView system in the Jabiru

The Jabiru was fitted with a Dynon SkyView SV-HDX1100 avionics system. The system was capable of recording flight data installed in the cockpit. Flight data from the accident flight was recovered from the damaged device at the ATSB’s engineering facility in Canberra (Figure 15). The unit recorded the latter part of the Jabiru’s taxi towards the hold point for runway 11, turning onto the perpendicular taxiway from about 1029:49–1029:59, and the data terminated at 1030:03 when the Jabiru was at the hold point. This likely coincided with the Jabiru coming to a stop, as reported by a witness, while another aircraft was departing on runway 11. Assuming the Jabiru’s average taxi speed from the hold point to the runway was the same as the recorded segment, the ATSB estimated that the Jabiru would have been stopped for about 2 seconds before commencing taxi to the runway, starting to turn onto the runway heading at about 1030:35.

The GPS data recording was re-established at 1030:56, as the Jabiru was on the threshold markings of runway 11, rolling on the runway's heading at 13 kt. Data showed the Jabiru accelerating and taking off, then initiating a left turn before colliding with the Pawnee at a height of approximately 130 ft.

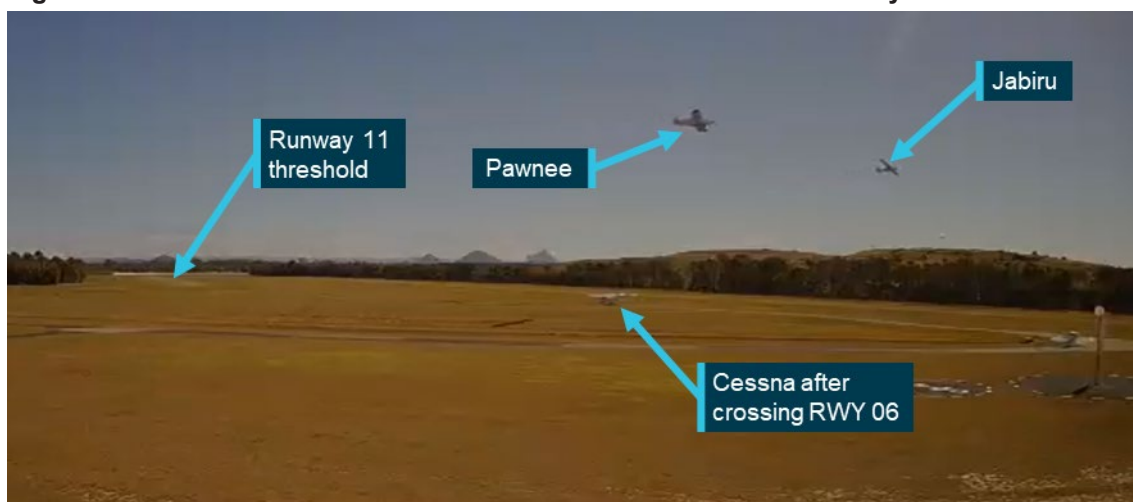
Figure 16: Still from a CCTV camera located to the south of the runway intersection

An example of the footage provided by the CCTV system is shown in Figure 16. Timestamps from the CCTV footage were adjusted to align with the times provided by the Jabiru's recorded GPS data.

Using the CCTV recordings, the ATSB logged aircraft movements in the hour prior to the accident. From 0930 until the Pawnee took off with the first glider at approximately 1005, there were 15 movements on runway 11. While the Pawnee was airborne on the first flight, an additional aircraft landed on runway 11. The next movement was the Pawnee landing on runway 06, then taking off with the second glider at 1022.

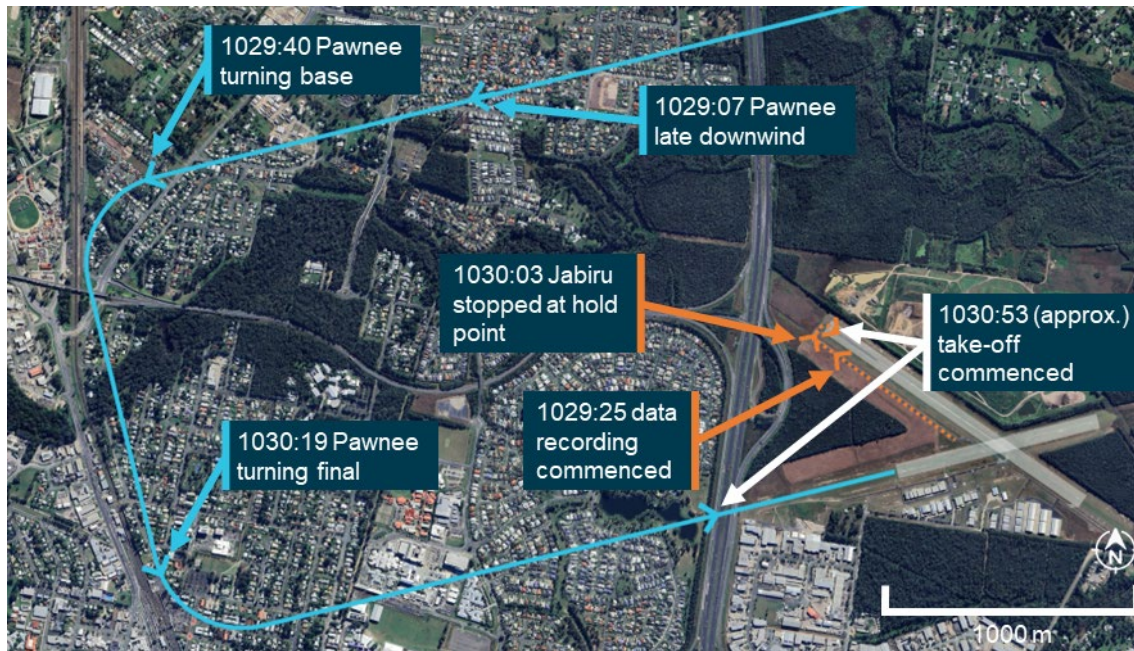
Figure 17: Approximate positions of the Jabiru and Pawnee

While taxiing towards the hold point near the threshold of runway 11 (facing north-east from about 1027:25 to about 1029:58), the Jabiru pilot might have been able to observe the Pawnee in the downwind or base legs of the (runway 06) circuit. Once the Jabiru had turned towards the hold point, the Pawnee was on or turning onto the base leg, putting it almost directly behind the Jabiru. Approximate positions of the Pawnee and Jabiru are shown in Figure 17.

Positions of the Pawnee were approximated based on CTAF transmissions, assuming a 1 NM wide circuit. The take-off time was estimated by extrapolating the Pawnee's position backwards from when recorded data recommenced at 1030:56. Source: Google Earth, annotated by the ATSB
