# **Loss of control and in-flight break-up involving Robinson R66, VH-KFT**

Near Hawks Nest, New South Wales on 26 October 2023

## **ATSB Transport Safety Report**

AO-2023-051

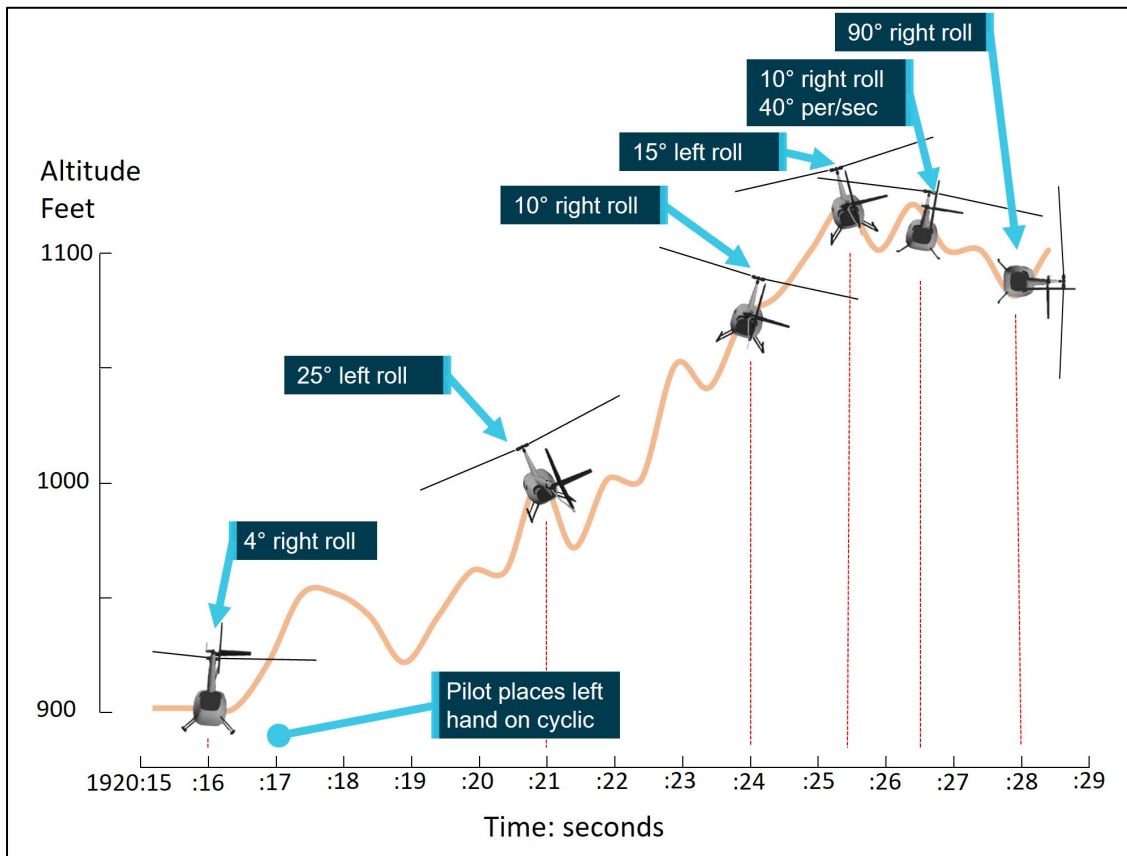
**Figure 2: Aircraft attitude and altitude timeline**

The following sequence of events was identified from the onboard video and covers the period from when the helicopter crossed the southern shoreline of Yacaaba Headland until the accident (Figure 2 and Figure 19):

As the helicopter reached an excessive roll angle it sustained an in-flight break-up and impacted the waters of Providence Bay, near Hawks Nest. The pilot was fatally injured.

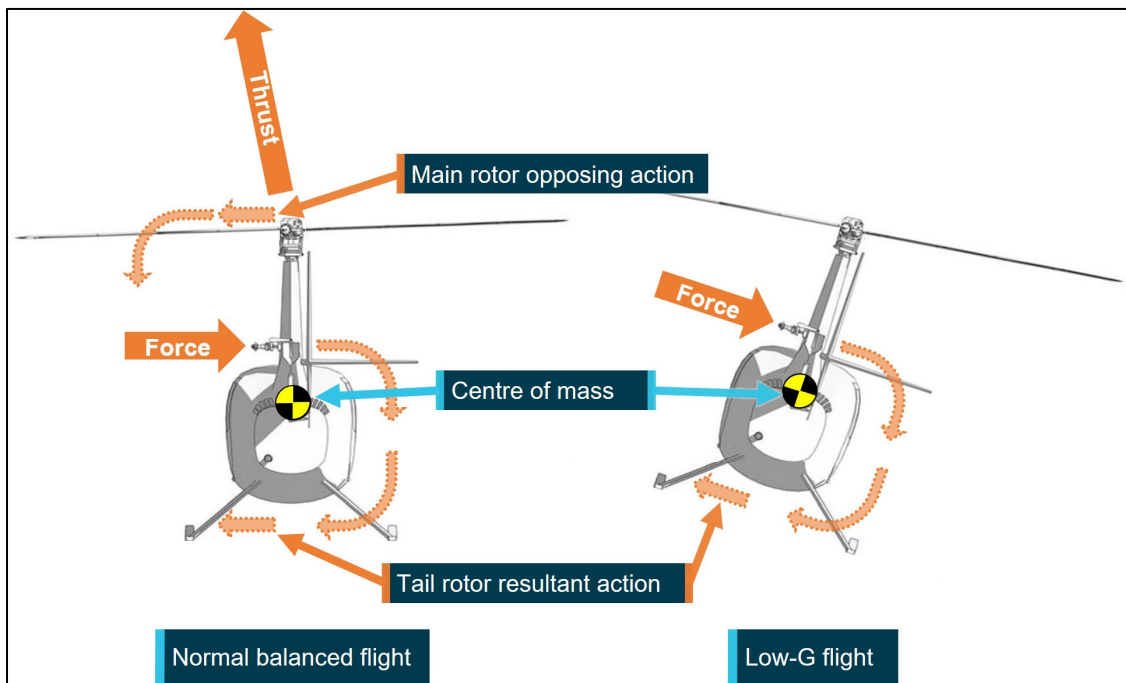
**Figure 8: Tail rotor force in flight and low-G**

The tail rotor in Robinson aircraft is located above the aircraft's centre of gravity, which results in the force from the tail rotor also causing the aircraft to rotate about its horizontal, or roll, axis, in addition to the yaw movement (Figure 8). This rolling force is small and is corrected by main rotor roll inputs.

During a low-G condition the influence of the main rotor forces on the fuselage, which include the right roll countering force are reduced. However, the right rolling moment produced by the asymmetric stabiliser and tail rotor are still present. This results in the fuselage rolling to the right (Figure 8 and Figure 9). At higher airspeeds the right roll rate increases with increasing horizontal stabiliser down force and the pilot's ability to counteract the roll reduces with reducing G. Reducing airspeed reduces the rolling moment, but reloading the rotor with gentle aft cyclic restores the main rotor force influence and allows the pilot to correct the condition.

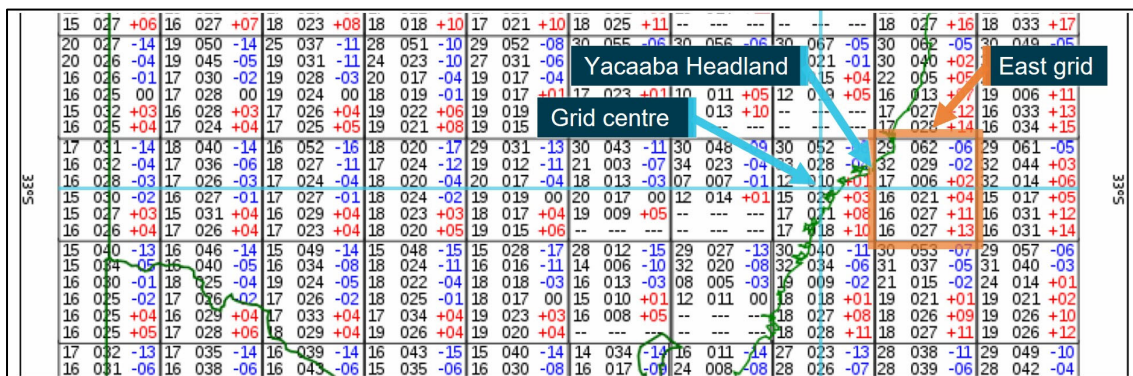
Figure 11: Grid point wind temperature forecast

The grid point wind temperature (GPWT) forecast issued and valid at the time of the pilot's departure predicted 17 kt and 21 kt at 1,000 and 2,000 ft altitudes respectively. Of

In this instance the centre point of the grid encompassing Yacaaba Headland was about 73 km, south-west of the headland, and located over land. Wind speed over land is typically lower than the same wind over water, this is due to the land creating friction between the wind and surface. In that context, the GPWT region located over sea to the east of the headland was likely more representative of the actual conditions at Yacaaba Headland at the time of the accident (Figure 11). This grid predicted 27 kt at 1,000 and 2,000 ft.

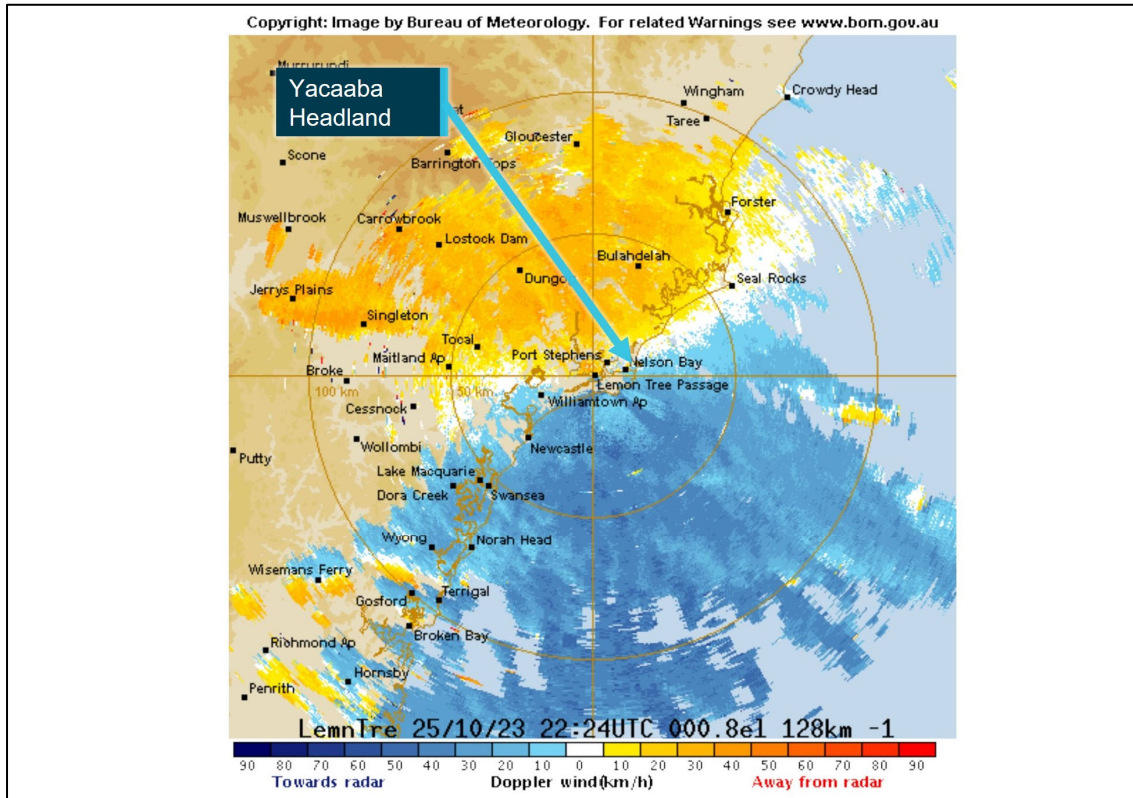
Figure 12: Doppler wind image

Doppler wind radar located at Lemon Tree Passage, about 15 km east-south-east of Yacaaba Headland, recorded wind speed between 5–22 kt (10–40 km/h), from 150°–170° at 0924, about 4 minutes after the accident (Figure 12). However, doppler wind radar is limited to measuring the radial component of wind only, that is wind heading directly toward or away from the radar. Also, the doppler beam is designed to be emitted at a slightly elevated angle to avoid interference from nearby objects or topography. This results in the beam measuring windspeed at an altitude that increases with the distance from the radar.<sup>12</sup> An additional complication is produced by a beam refraction due to temperature and humidity.

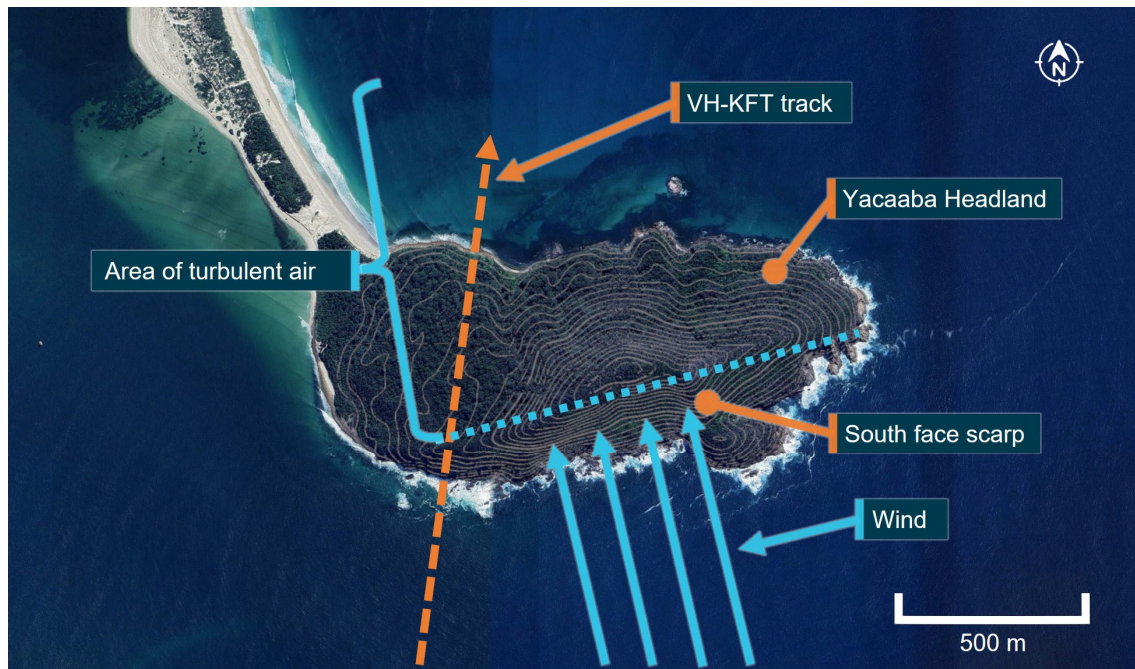
**Figure 15: Turbulent areas around Yacaaba Headland**

Yacaaba Headland is connected to the mainland by an isthmus, resulting in the headland peak being surrounded by sea, or low terrain in all directions. The headland measures about 1.8 km from east to west, and about 750 metres north to south. The headland rises steeply from the sea surface to the peak at 218 metres (715 ft), over about 200–250 metres south to north. The peak forms part of a ridge from east to west, reducing in altitude to about 80–100 metres (260–320 ft) at the point where the aircraft crossed, forming a steep scarp (about 45°) on the southern face of the headland (Figure 14 and Figure 15).
