# **Pilot incapacitation, loss of control and collision with terrain involving Gulfstream 695A, VH-HPY**

55 km south-east of Cloncurry Airport, Queensland on 4 November 2023

## **ATSB Transport Safety Report**

AO-2023-053

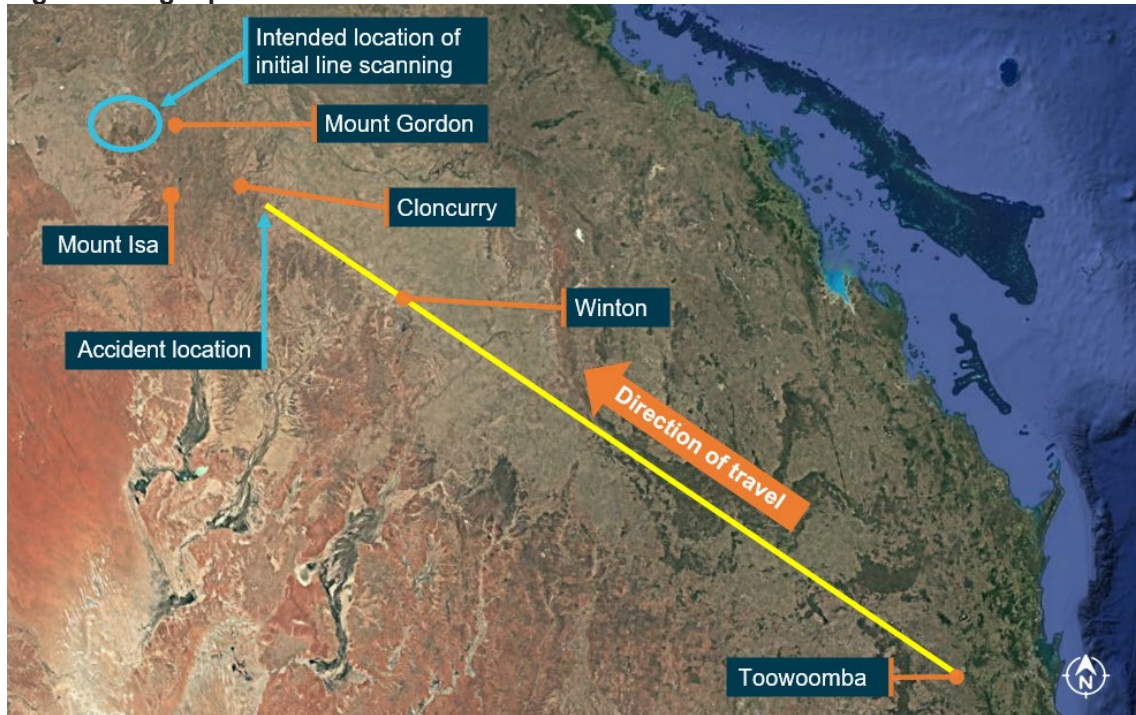
Figure 1: Flight path overview

A series of radio communications were exchanged between the pilot and ATC, during which the pilot was issued a clearance to undertake line scanning north of Mount Isa. The pilot did not respond to any further calls from ATC. The aircraft departed controlled flight and at 1427 (local time) collided with terrain 55 km south-east of Cloncurry (Figure 1). The 3 occupants were fatally injured, and the aircraft was destroyed.

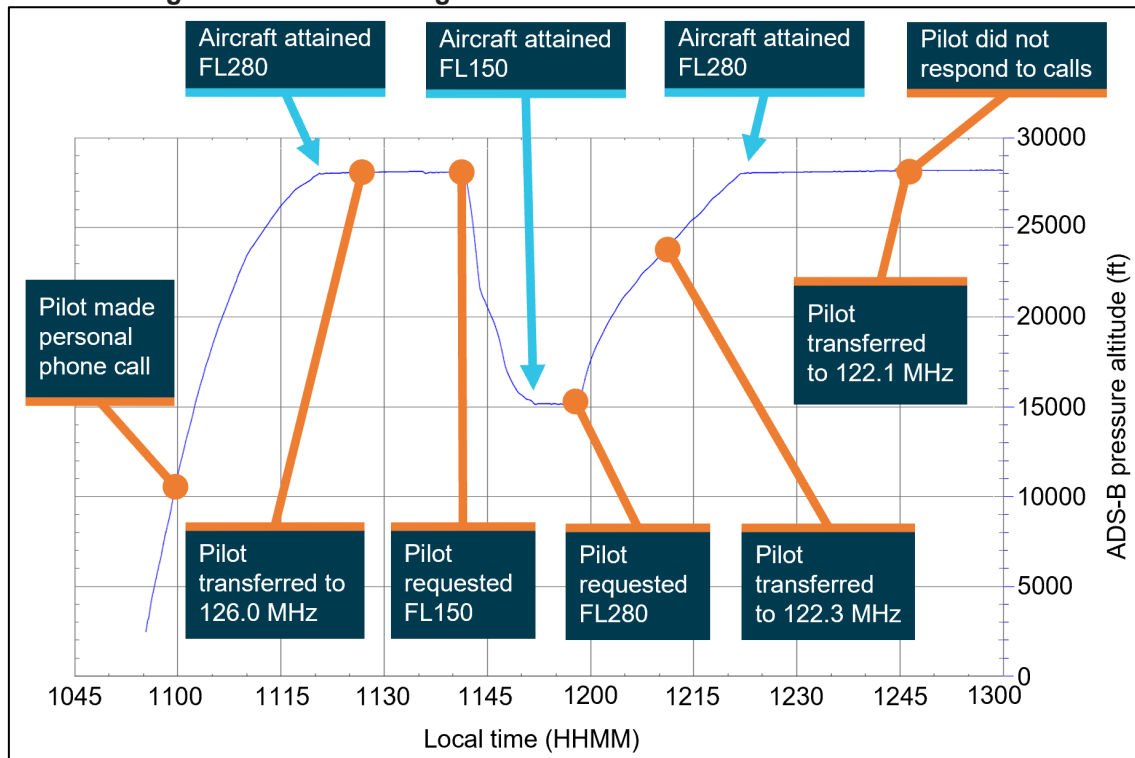
**Figure 2: Plot of changes in aircraft altitude and the sequence of radio communication events throughout the accident flight from 1045–1300**

At 1055 on the morning of the accident flight, the aircraft departed Toowoomba Airport with the pilot being provided an ATC clearance for the flight to track to Mount Isa. The pilot was initially cleared by ATC to climb to FL160 and was then issued further instruction to continue the climb to the planned cruise of FL280. The pilot made a brief personal phone call at about 1103 (see *Telecommunications*), and the aircraft reached FL280 at 1120:30 (Figure 2).

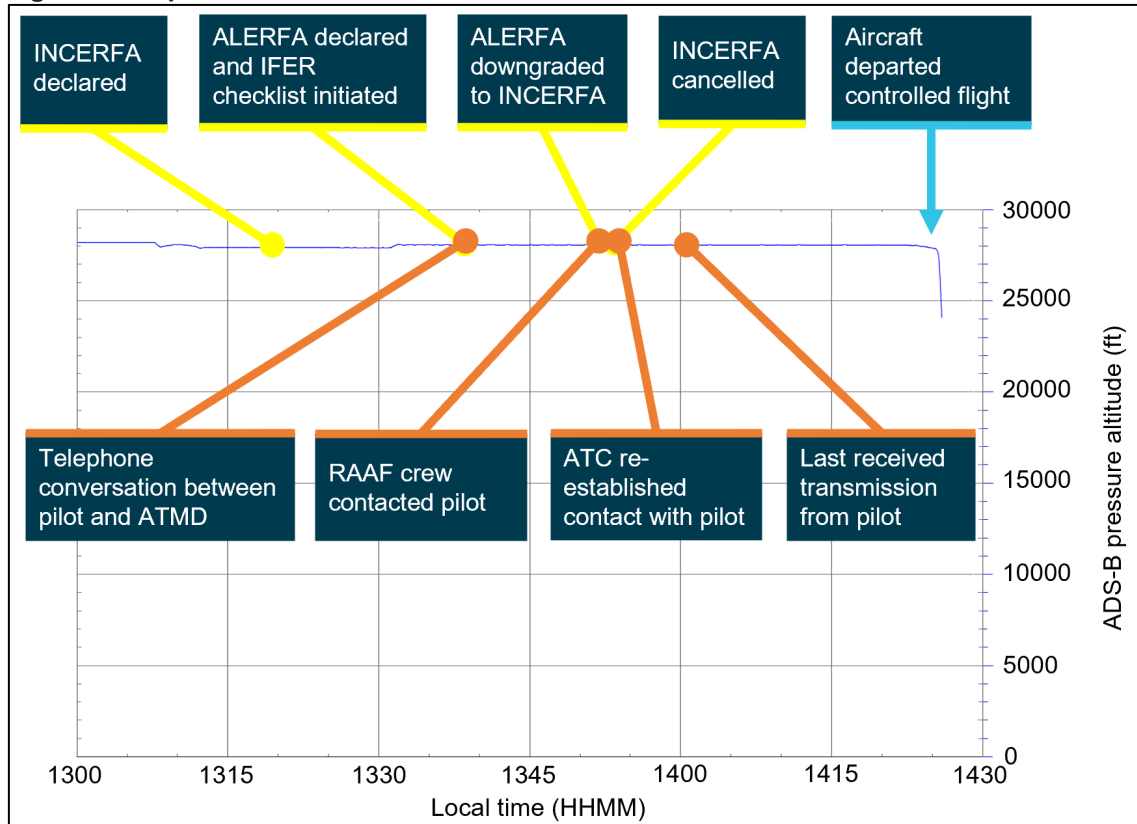
**Figure 3: Sequence of ATC actions and communication events between 1300–1430**

declared an uncertainty phase (INCERFA)<sup>4</sup> (see *Emergency phases*) and the air traffic management director (ATMD) was made aware of the developing situation (Figure 3).

At 1337:46, the ATMD attempted to contact the pilot using the mobile telephone number listed on the flight plan, but the pilot did not answer the call. At 1338:36, the pilot returned the ATMD's phone call, and they had a brief conversation during which the pilot advised that they had 'no joy' on radio frequency 122.4 MHz, rather than the instructed frequency of 122.1 MHz (see *Telecommunications*). The ATMD determined that the pilot's speech was 'slower' than normal and 'flat', and these concerns were shared with the SM at the conclusion of the call. At 1340:00, the INCERFA was upgraded to an alert phase (ALERFA)<sup>5</sup> (see *Emergency phases*) and the hypoxic pilot in-flight emergency response (IFER) checklist was initiated (see *Hypoxic pilot procedures*).

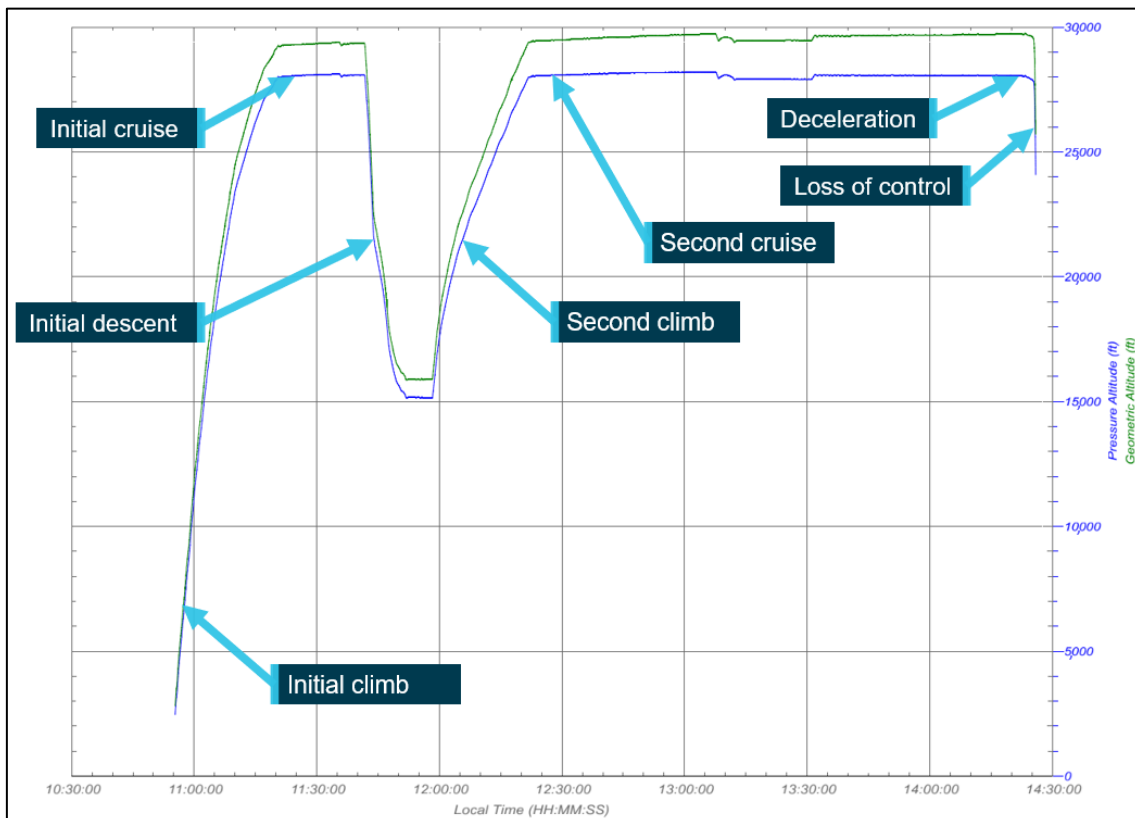
**Figure 8: Altitude profile of the accident flight throughout its duration with key moments (phases) displayed**

The ADS-B data provided the highest reporting frequency (~0.5 seconds), and altitude was reported to the nearest 25 ft. This data was captured from shortly after departure until the aircraft descended to about FL240 during its final descent (Figure 8).

The ADS-B data that was broadcast from the aircraft during the accident flight contained a discrepancy between the pressure altitude and the GPS altitude (Figure 8).<sup>22</sup> At the start of the second cruise phase, the broadcast pressure altitude was 28,000 ft while the GPS altitude was 29,400 ft. At the end of the second cruise phase (approximately 2 hours later), the broadcast pressure altitude was 28,050 ft while the GPS altitude was 29,750 ft. The difference in pressure and GPS altitudes over the entire flight varied with altitude and flight time and is shown on a scatter plot below (Figure 9).

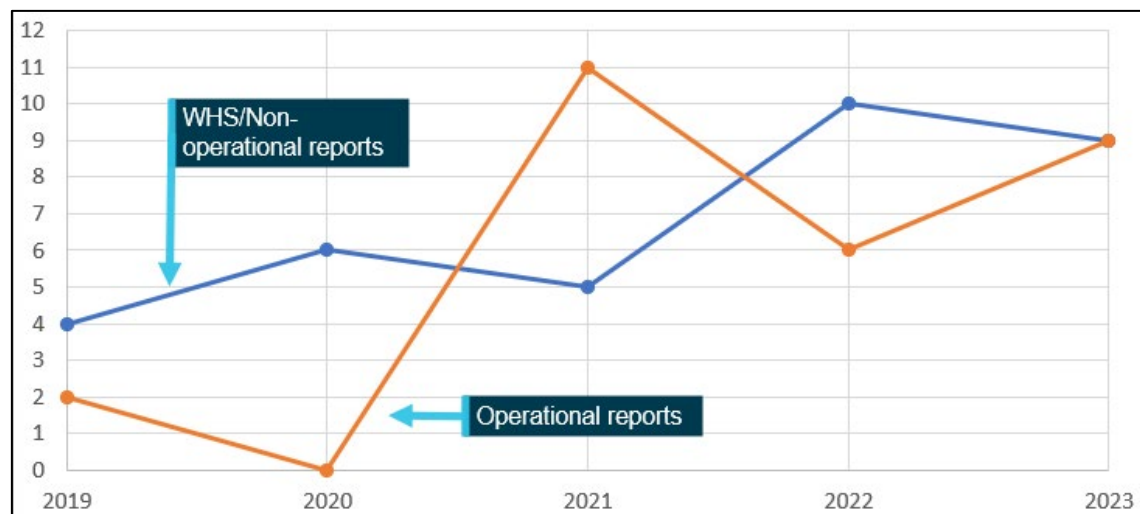
**Figure 21: AGAIR hazard and occurrence reporting data from years 2019 to 2023**

In the 5 years prior to the accident, a total of 62 reports had been submitted into the AGAIR reporting system. Thirty-four of these were work health safety (WHS) or non-operational reports including injuries and infrastructure issues. A total of 28 of the submitted reports related to aviation safety matters including wildlife and airspace issues (Figure 21). There were no instances of either the pressurisation issue or the continued operation of the aircraft with that defect raised within the system.

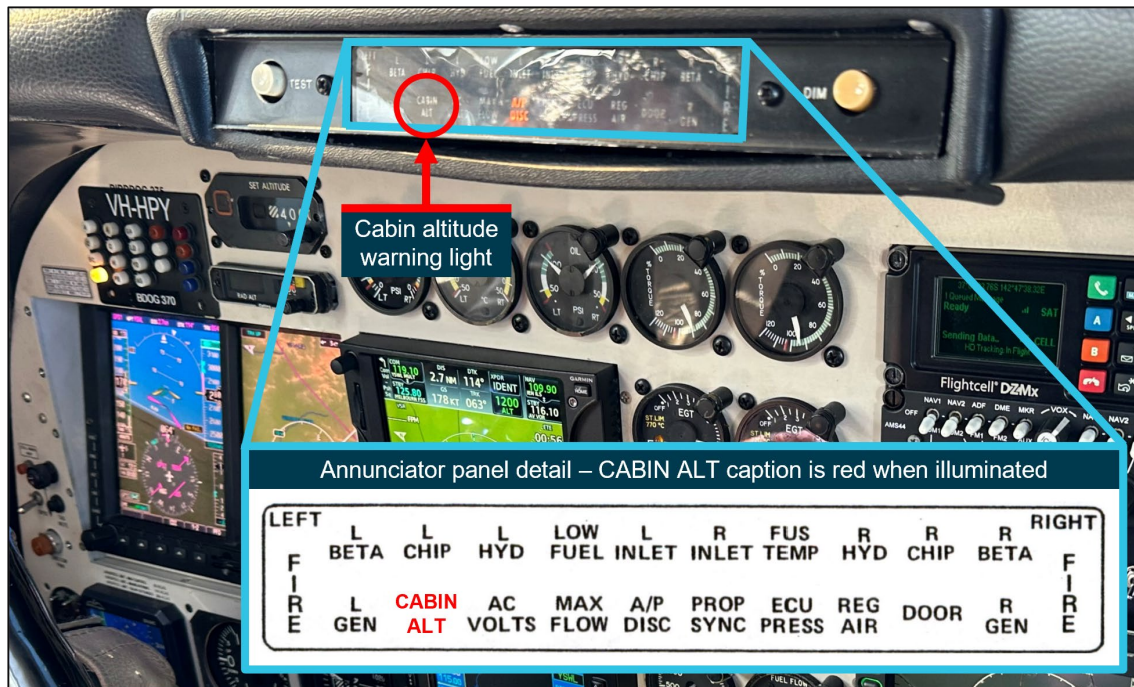
**Figure A4: Cockpit of VH-HPY showing annunciator panel cabin altitude warning light**

The Gulfstream 695A is fitted<sup>15</sup> with a cabin altitude visual and aural warning system that activates when the cabin altitude is at or above 11,000 ft ( $\pm 500$  ft) (Figure 6). When activated, 'CABIN ALT' illuminates in red on the glareshield annunciator panel and flashes for 10–20 seconds before remaining steady. This is accompanied by an aural tone that pulses 6 times per second. The aural warning can be silenced by pressing a button on the left engine power lever (see *Appendix A – Gulfstream 695A systems information*).

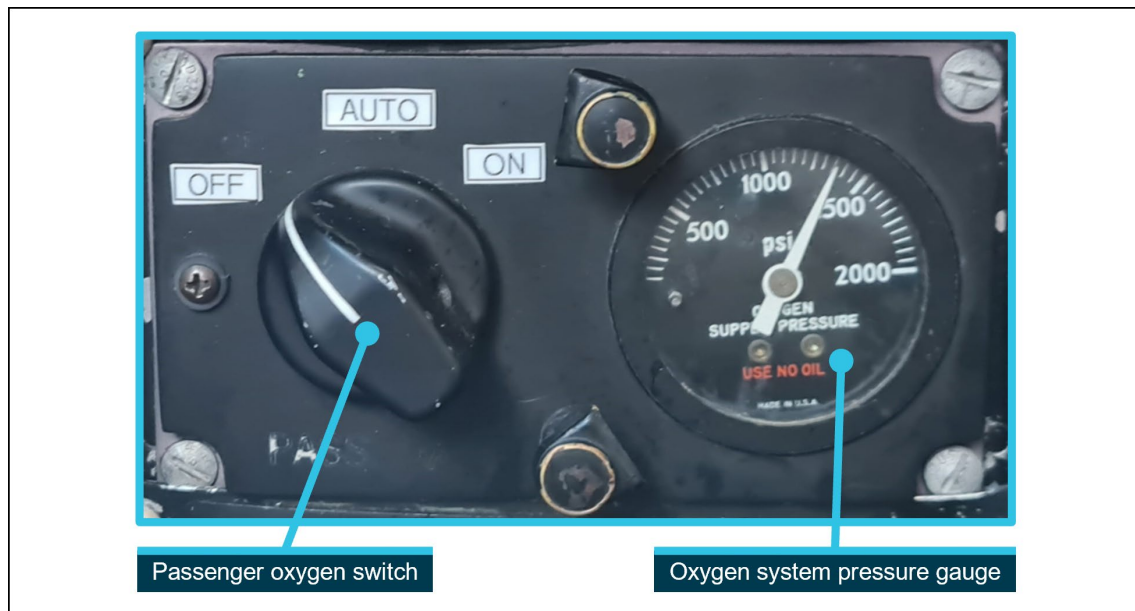
**Figure A6: VH-HPY cockpit oxygen gauge and passenger oxygen switch**

Aviator's dry breathing oxygen<sup>46</sup> is stored in a cylinder located in the rear fuselage and, when full, can supply oxygen to 3 people for about 29 minutes. The passenger oxygen system switch (Figure A6) is recessed into the sidewall on the right side of the cockpit, alongside a cylinder pressure gauge for the aircraft oxygen system.
