# **Collision with terrain during go-around involving Cessna U206F, VH-TDQ**

39 km south-east of Moora, Western Australia, on 1 September 2024

## **ATSB Transport Safety Report**

AO-2024-049

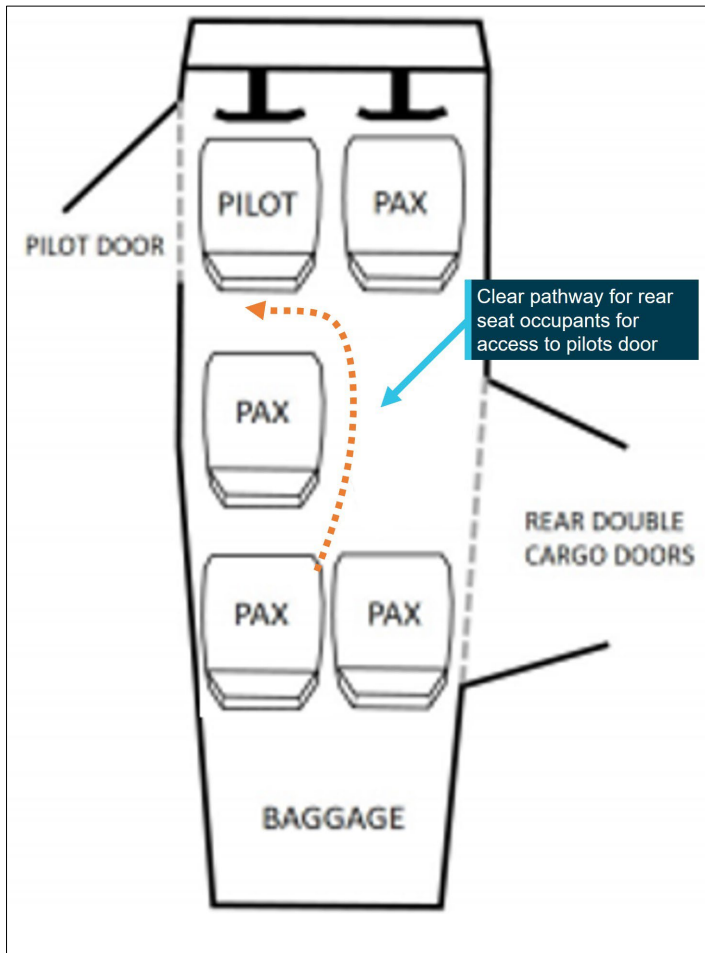
**Figure 11: Seating configuration for Canadian Cessna 206**

The AD CF-2020-10 limited earlier model Cessna 206 to 5 occupants and required the removal of one of the middle row seats if either rear seat was to be occupied. The removal of a middle row seat provided access for passengers seated in the rear seats to the pilot's forward left cabin door (Figure 11) for evacuation in the event the rear cargo door could not be opened quickly enough for egress. The AD also clearly stated that the vacant space left by the removal of a middle row seat must not be used for storage of cargo or baggage.

The AD also provided an alternative means of compliance through a supplemental type certificate (STC),<sup>9</sup> [STC SA1470GL](#), for the installation of an additional door, on the forward right side of the cabin and was applicable to all models of the Cessna 206. This commercially available alternative means of compliance allowed Canadian registered aircraft to remain in the original 6-seat configuration. If installed, the additional door provided immediate egress option for the passenger in the front right seat and an additional emergency egress for passengers seated in the middle row.
