Signal passed at danger involving passenger train TE43

Between Fortitude Valley and Bowen Hills, Queensland on 24 May 2023

ATSB Transport Safety Report Rail Occurrence Investigation (Defined) RO-2023-004 Final – 18 June 2025 Cover photo: Queensland Rail

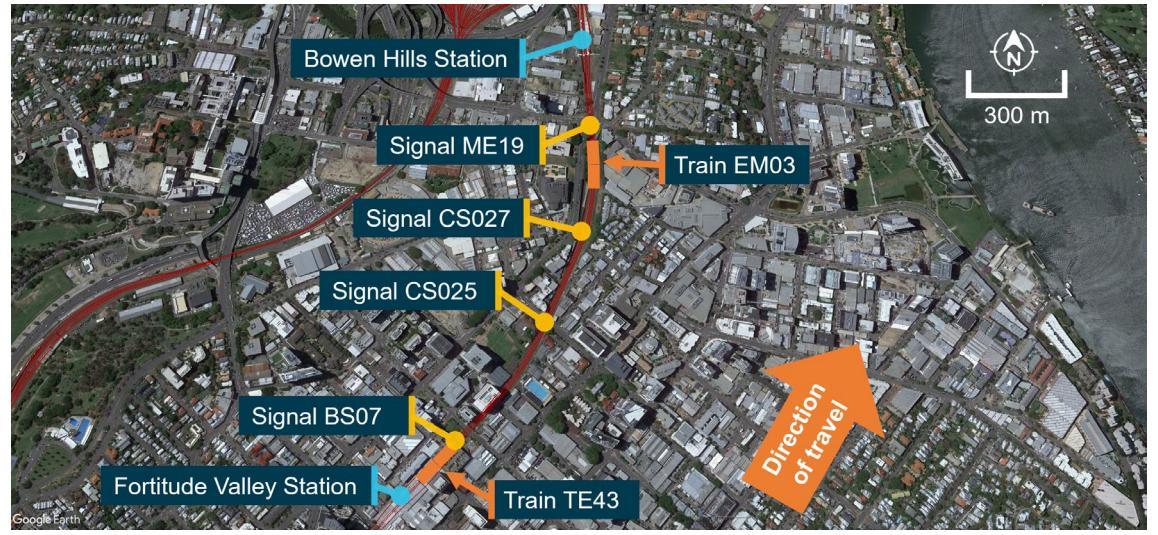
Figure 1: Midsection track layout of down suburban line between Fortitude Valley Station and Bowen Hills Station

Ahead of signal CS027, empty suburban passenger train EM03 was stopped at signal ME19, waiting to proceed into platform 2 at Bowen Hills Station. Signal ME19 had changed from a restricted indication to a proceed indication (green aspect), however train EM03 had not yet moved. Train EM03 was travelling in the same direction as train TE43 (Figure 1).

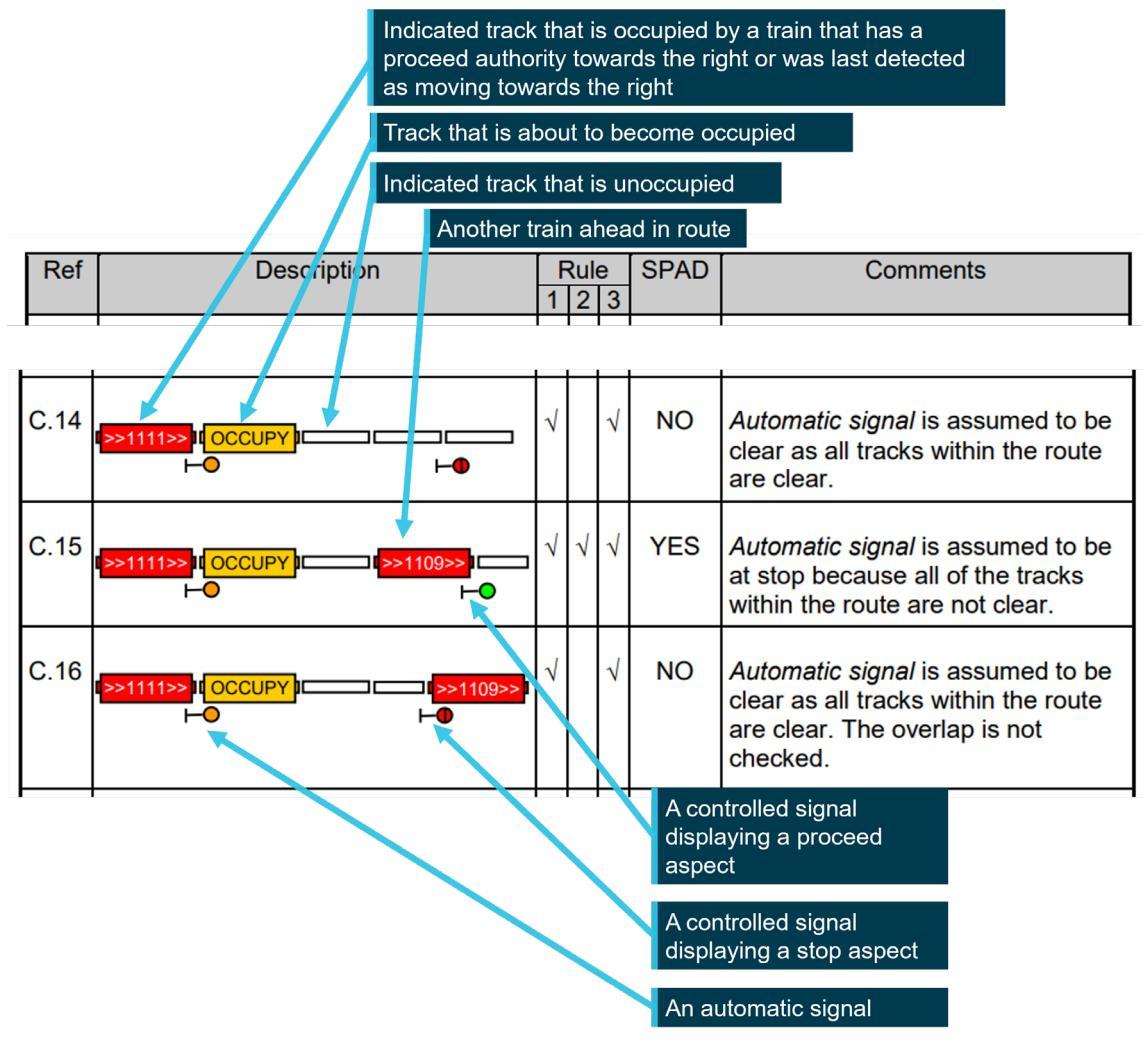
Figure 7: Extract from appendices of SR105 signal passed at danger alarm generation principles manual

To illustrate the application of the rules, several scenarios were included in the appendices of the manual (Figure 7).

If the replacement track⁹ of a signal is already occupied (e.g. by another train, gang or track fault), then a train passing the signal will not be able to be detected, and therefore a SPAD alarm will not be generated.
