# Safeworking incident involving MTM trains 3148 and 7255

Ferntree Gully, Victoria, on 25 February 2024

## ATSB Transport Safety Report

RO-2024-001

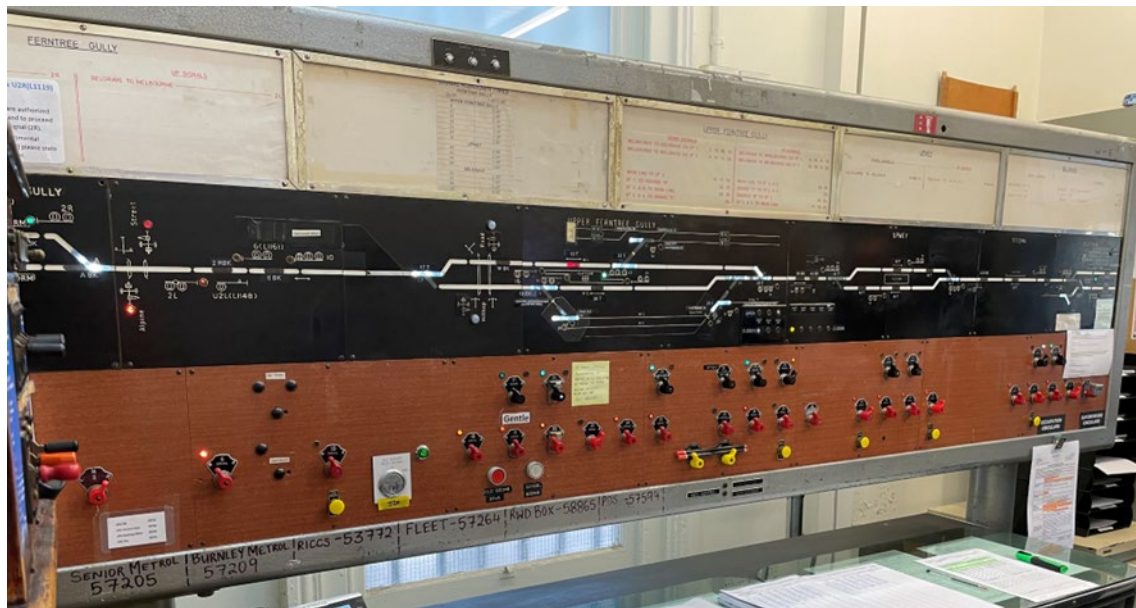
**Figure 8: UFG station signal control panel**

The signal control panel at the station showed the signal aspects and the position of the points (Figure 8). Installed in 1962, the incandescent indicators on the panel illuminated red when sections of track were occupied but did not display a corresponding train number to show which train occupied the section.

Switches, used to set points and signals were positioned close to the bottom of the panel. The panel was used to control points and signals between FTG station and the line's terminus at Belgrave station and was one of only five such panels operating on the MTM network.

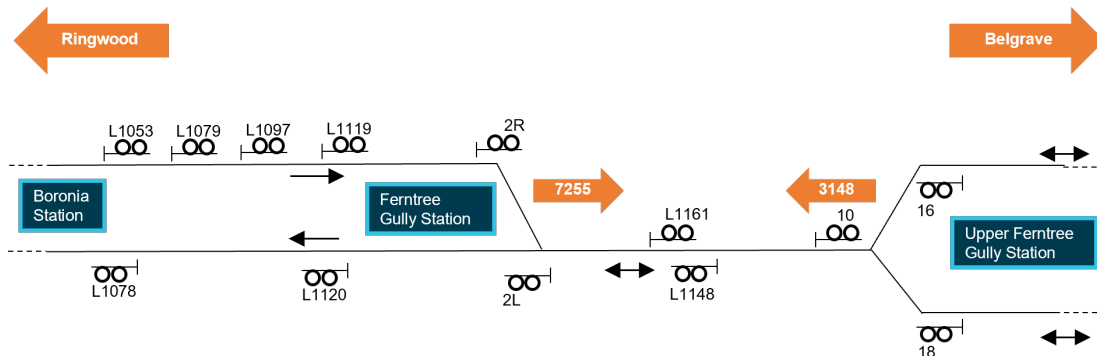
**Figure 13: Schematic of track and signals relevant to the incident location**

The annunciator bell was designed to ring once when a train departed Boronia station towards FTG and occupied a specific track circuit (track circuit in advance of signal L1053). However, the bell would only ring if the section of track between signal L1119 and signal 2R at Ferntree Gully was clear of rail traffic (Figure 13).<sup>11</sup> The station officer at UFG was not required to acknowledge receipt of the annunciator bell and its activation was not recorded.

Train 3148 was held at the platform at UFG by home departure signal 18 which displayed a stop indication. Due to their belief that the departure signal 18 would not clear because of a recurring track fault, the station officer issued a caution order to the driver of train 3148 to allow the train to pass signal 18 (Figure 13).<sup>15</sup>
