# **Collision with terrain involving Cessna U206G, VH-JVR**

124 km west of Norseman, Western Australia, on 3 March 2022

## **ATSB Transport Safety Report**

AO-2022-011

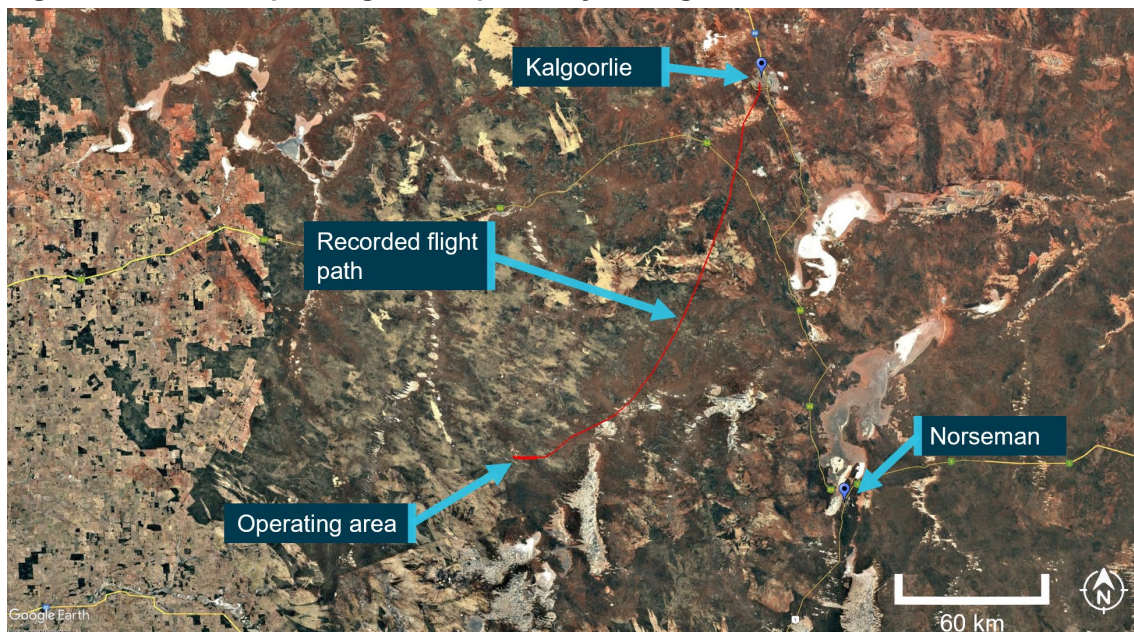
**Figure 1: VH-JVR's operating area in proximity to Kalgoorlie and Norseman**

On 3 March 2022, a Cessna Aircraft Company U206G aircraft, registered VH-JVR, was being operated by MAGSPEC Aviation Pty Ltd for low-level, geophysical survey flights of an area about 120 km west of Norseman, Western Australia (Figure 1).

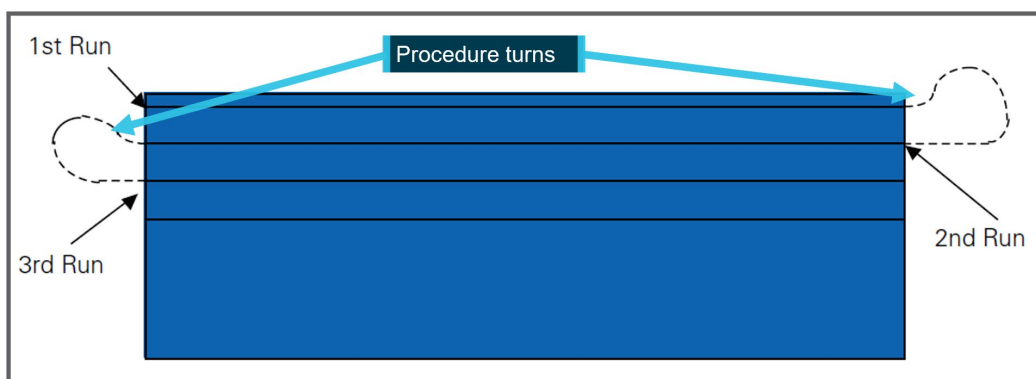
**Figure 6: Back-to-back pattern and procedure turns**

From the recorded data, the accident survey flight was flown in a back-to-back pattern, which was a series of consecutive parallel lines followed by a procedure turn used to establish the aircraft onto the next line in the reciprocal direction (Figure 6). This was the routine pattern used by the operator in its geophysical surveys. The client had specified 25 m spacing on east-west survey lines.

The CP explained that procedure turns consisted of an initial climbing turn to establish the aircraft at about 300 ft AGL and about 400–500 m lateral offset from the next line. After this, a level turn would be commenced (into wind) at a 45–60° angle of bank (referred to as a steep turn) to intercept the next line. Descent to the survey height commenced once the aircraft wings were established straight-and-level.
