Control issues and ditching involving RPA swarm of 500 Damoda Newton 2.2 RPA

Victoria Harbour, Docklands, Victoria on 14 July 2023

ATSB Transport Safety Report
Aviation Occurrence Investigation (Defined)
AO-2023-033
Final – 15 July 2025

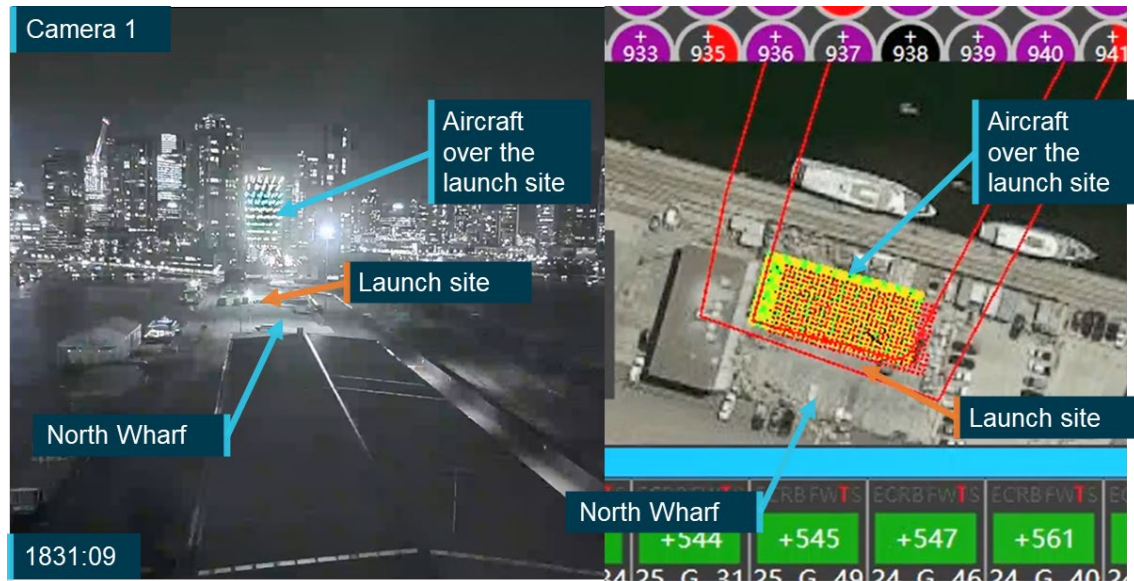
Figure 4: Comparison of GCS and recorded aircraft positions

GNSS spoofing is the process of tricking a receiver into reporting an incorrect position. Spoofing a signal requires 2 steps, first the incoming signal to the receiver needs to be jammed and then the receiver must lock onto an independently generated false signal providing incorrect information. In the lead-up to the display the GCS computer shows the position of each aircraft on the ground and in flight. These positions were shown over a base map and corresponded with locations recorded by CCTV footage (Figure 4). If the signal to the aircraft had been spoofed these locations would not have aligned.

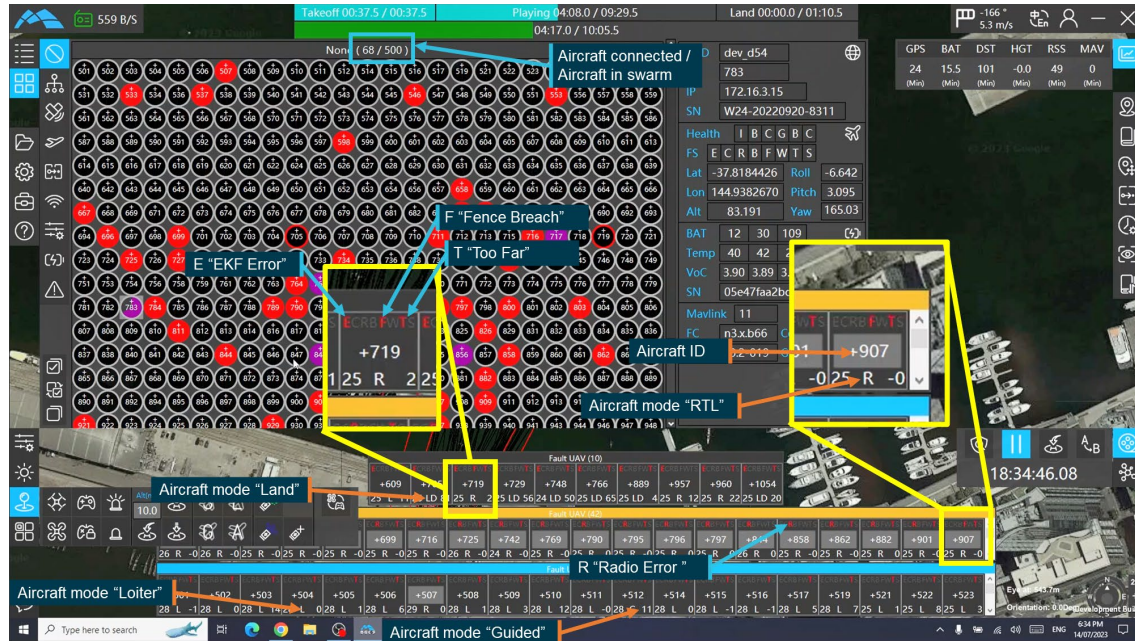
Figure 7: GCS screenshot showing individual aircraft errors

Errors related to individual aircraft presented on the GCS computer in an individual box as shown in Figure 7. These boxes showed the aircraft identifier, the error or errors and the mode the aircraft was operating in. They were then grouped by colour coded category depending on the required pilot response. Errors requiring immediate action

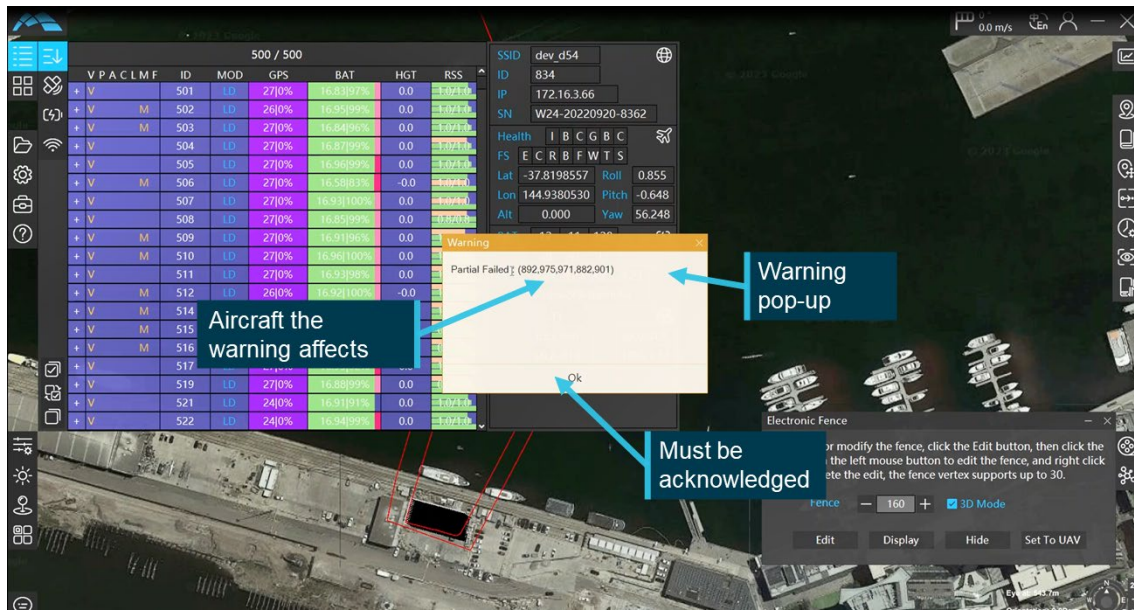
Figure 9: GCS screenshot showing a multi-aircraft warning pop-up

Errors that affected multiple aircraft were presented as a pop-up over other windows on the GCS screen (Figure 9) and required acknowledgement before any other action could be taken. These warnings were presented in instances such as a failure of data to successfully upload to aircraft or failure of a command to reach the aircraft.

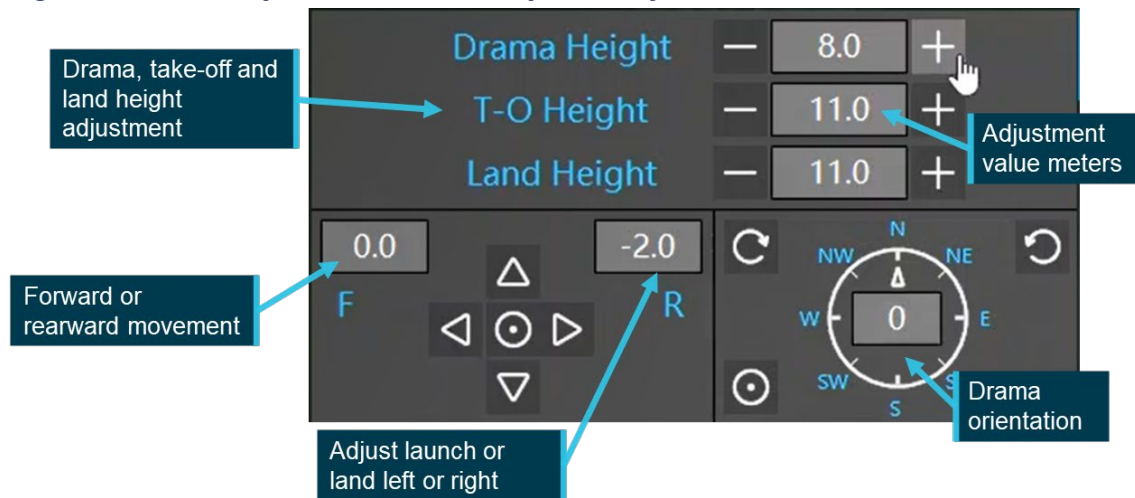
Figure 10: Drama adjustment functionality as set by the RPIC

Due to the boat mast hazard the RPIC, in consultation with one of company's other pilots, elected to adjust the position of the transition into the show area by increasing the height by 11 m and moving all aircraft 2 m to the left (Figure 10). To accommodate for these changes the total height of the show was also adjusted up by 8 m taking the maximum show height to 126 m.

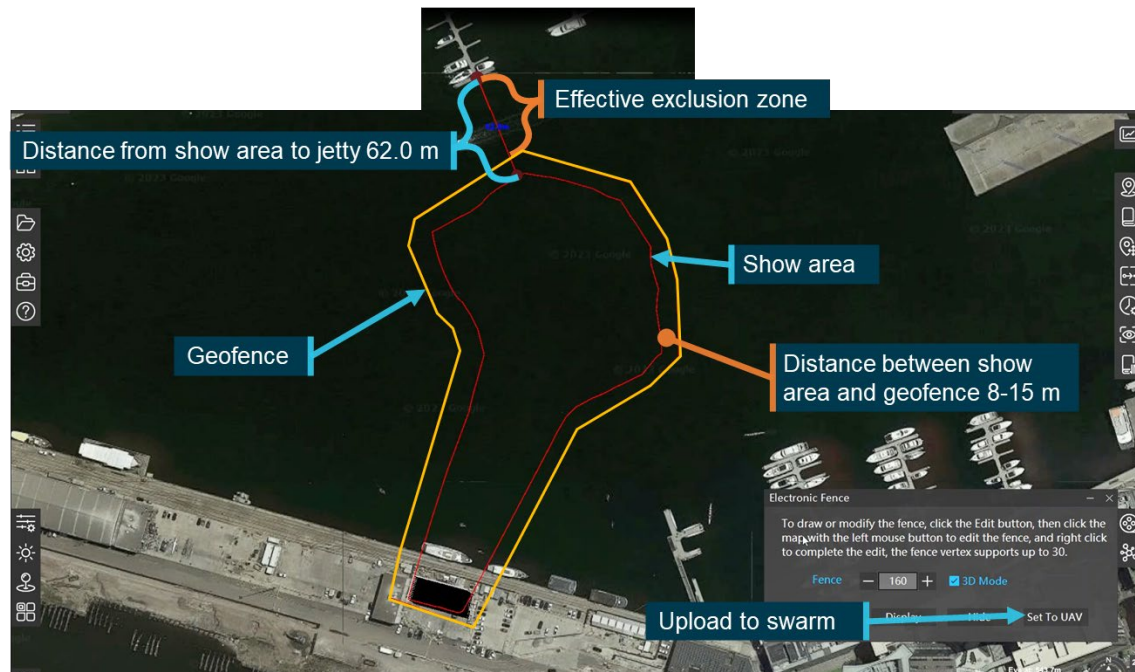
Figure 11: Development and placement of Geofence

The geofence is a polygon made of a series of GNSS locations surrounding the show area (Figure 11). It was manually created in the flight control software and then uploaded to the aircraft. Once in flight, if an aircraft passed through the geofence it automatically activated the RTL mode to bring it back inside the geofenced area and return to land. If the aircraft remained outside the geofence then the motors were shut down and the aircraft fell to the ground or water uncontrolled.

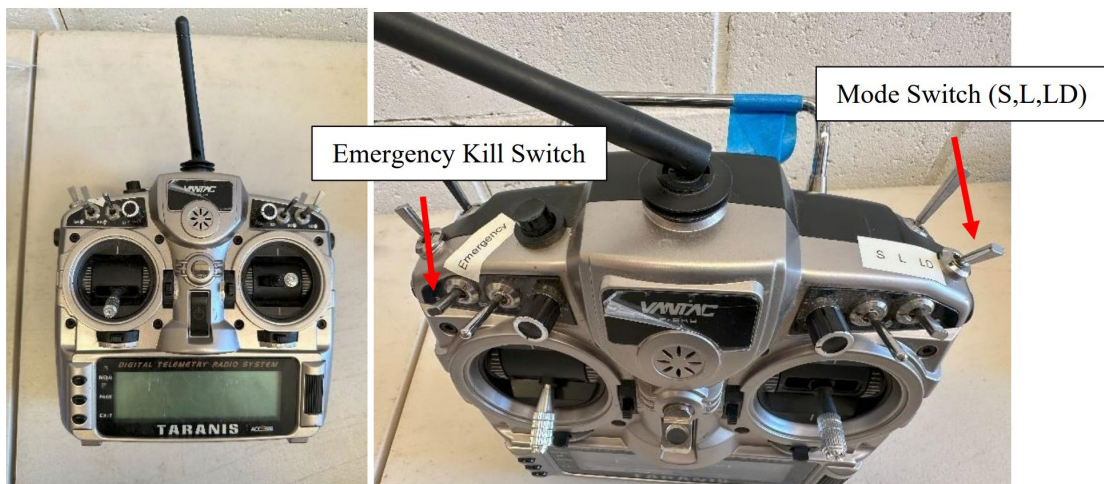
Figure 12: FrSky VANTAC Taranis controller

The manual controller employed by the operator was a VANTAC Taranis hand-held controller, manufactured by FrSky. The VANTAC (Figure 12) was a programmable, 24 channel, 2.4 GHz transmitter that could be used to control a range of remote devices, including RPA. The controller had 8 programmable control switches, (6 3-position and 2 2-position) that the user could assign to modes or operational settings. In support of the Damoda swarm operations the switches were assigned as per Figure 12. The mode switch allowed the operator to change the mode between land, loiter and stabilised modes. As part of the operator's pre-flight checklist the throttle (vertical movement on the left control stick) on the controller was to be set to 50% so that if the controller was required the aircraft would have sufficient power to hover.

The emergency kill switch was a 2-position switch. When activated it immediately shut down the motors, causing the aircraft to fall to the ground. This was the command that the copilot implemented once the RPIC instructed them to disarm the fly-away aircraft.

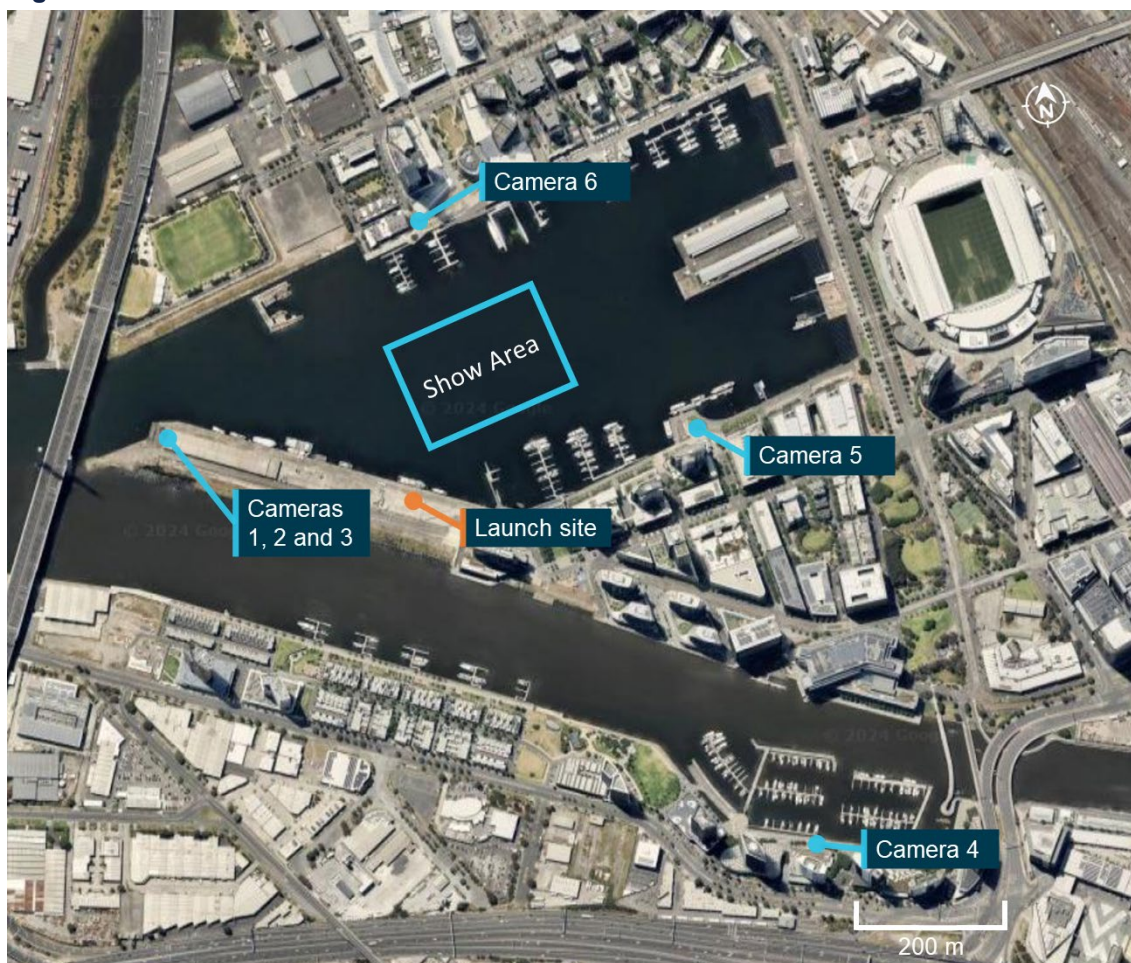
Figure 18: CCTV cameras around Docklands

A series of 6 closed circuit television (CCTV) cameras around Victoria Harbour (Figure 18) captured the show's launch, transition to the show area and some of the show. The footage captured the uncommanded movement of multiple aircraft, aircraft collisions, the aircraft landing in the water and the fly away aircraft (Figure 2).

Camera 1 captured the location of the boat mast that the RPIC had identified as presenting an obstacle to the swarm (Figure 2). Camera 4 captured multiple flags showing full extension at the time that the show was launching in the background. Noting that wind conditions varied with height, this camera was used to gain a general understanding of the conditions around the show site in the lead-up to, and at the time of, the show.
