# **Collision with terrain during go-around involving Cessna U206F, VH-TDQ**

39 km south-east of Moora, Western Australia, on 1 September 2024

AO-2024-049

Final – 30 June 2025

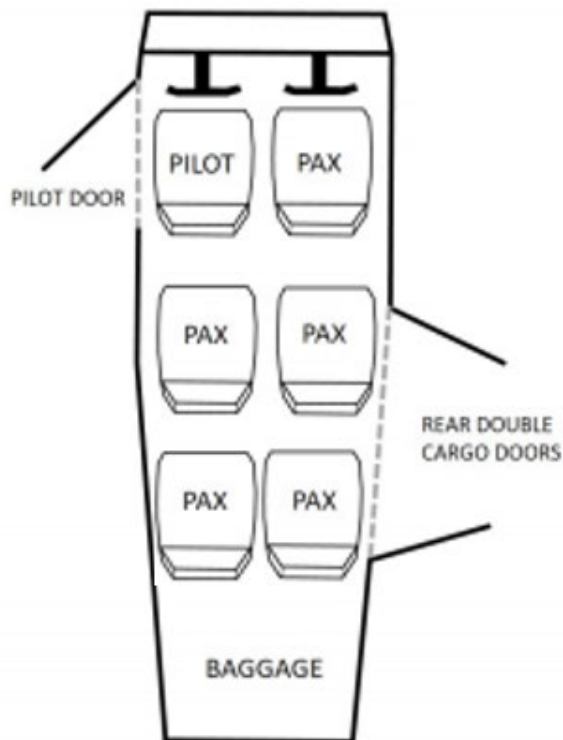
**Figure 5: Cessna 206 standard cabin seating configuration**

VH-TDQ was operated in a 6-person configuration with 2 front row (pilot) seats, 2 middle row seats and 2 rear seats (Figure 5).

VH-TDQ included 2 emergency exits, the pilot's forward left cabin door and a double 'clam shell' style cargo door located at the rear right of the aircraft cabin. Passengers seated in the middle row seats are able to access the pilot's forward left door when the pilot's seat is moved into a forward position. The forward part of the cargo door overlaps the rear cargo door as a preventative measure to stop the rear door (rear hinged) from opening in flight and damaging the aircraft. The rear cargo door cannot be opened independently of the front cargo door.
