# Collision with terrain involving Wolf Pitts S1-11X, VH-PVX

Avalon Airport, Victoria, on 28 March 2025

**ATSB Transport Safety Report**  
Aviation Occurrence Investigation  
AO-2025-017  
Preliminary – 9 July 2025

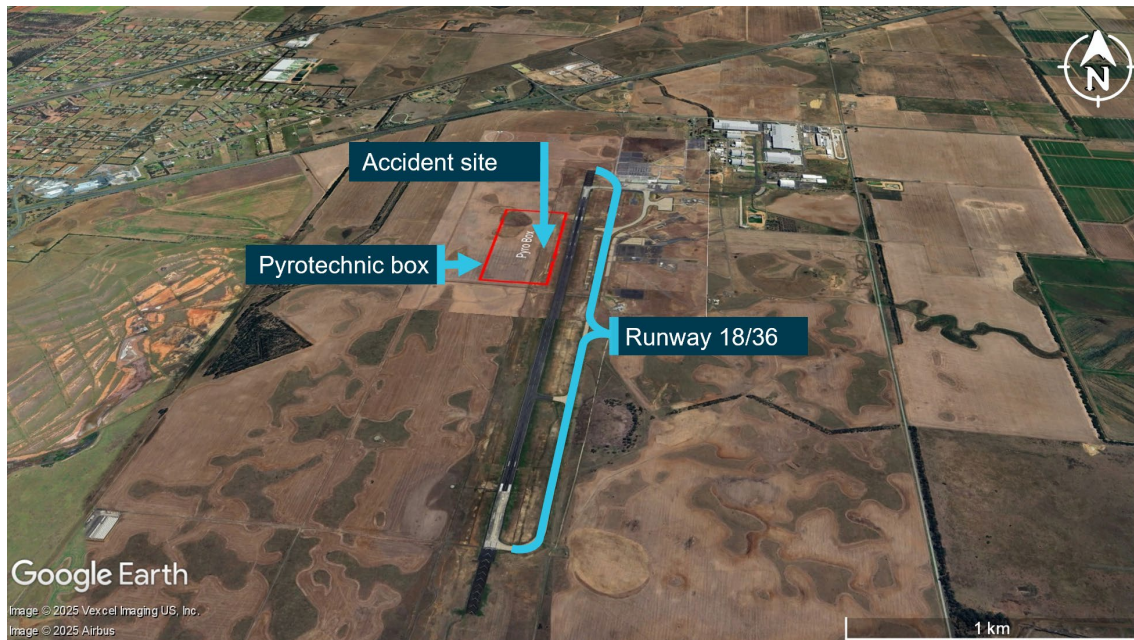
**Figure 2: Accident site location**

The aircraft collided with terrain on a grassed area west of runway 18/36,<sup>7</sup> in an area of the airport designated as the pyrotechnics box<sup>8</sup> (Figure 2) where multiple pyrotechnics were live and were planned to be used in the show. Additionally, there were many boxes of fuel positioned in the pyrotechnic box that were planned to be ignited during the ‘wall of fire’ display later that evening.
